On 15 October 2004 the Mapping AUV suffered an electrical short in the Forward Junction Box. The main power bus positive and negative lines were found shorted together.

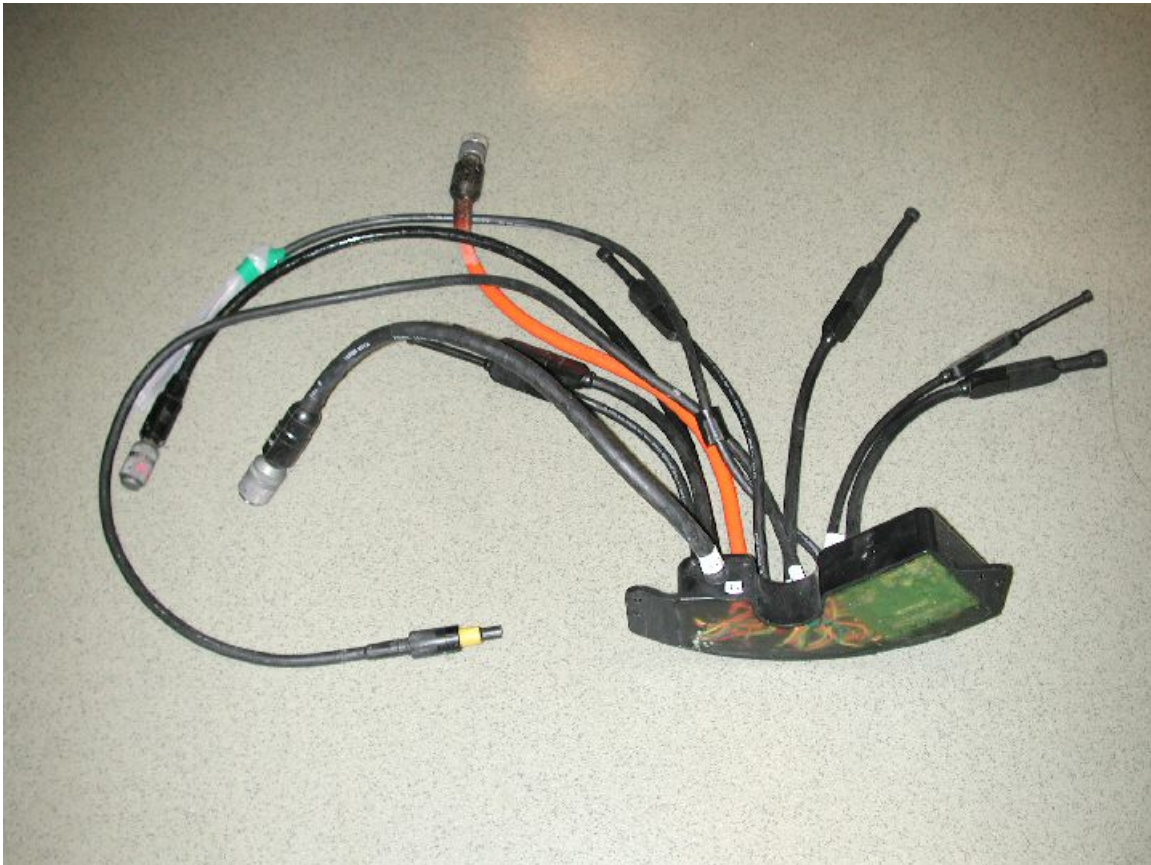
The junction box was removed from the AUV and closely inspected visually, but no external damage was evident.

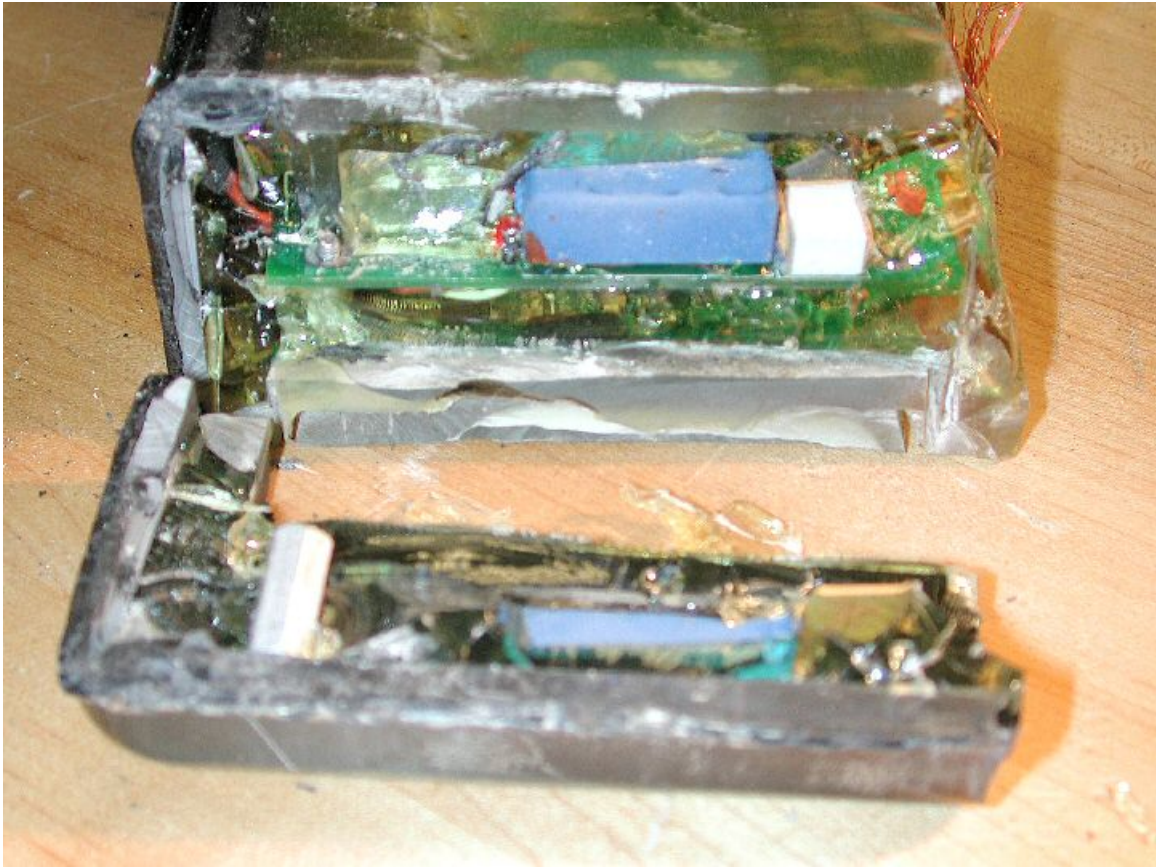
When dissection of the epoxied body was started, an air void was visible beneath a blue through-hole mounted DC-to-DC converter.

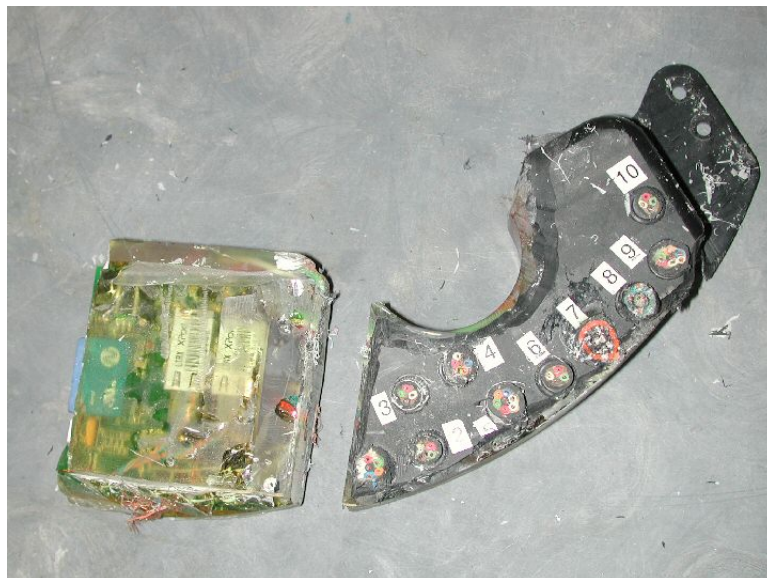
The power bus was still shorted, and a binary search was initiated; we cut the junction box in half, separating the “printed circuit board” portion from the “connector wiring” portion.

The electrical short was no longer seen on the “connector wiring” portion, but was clearly evident on the “printed circuit” portion.

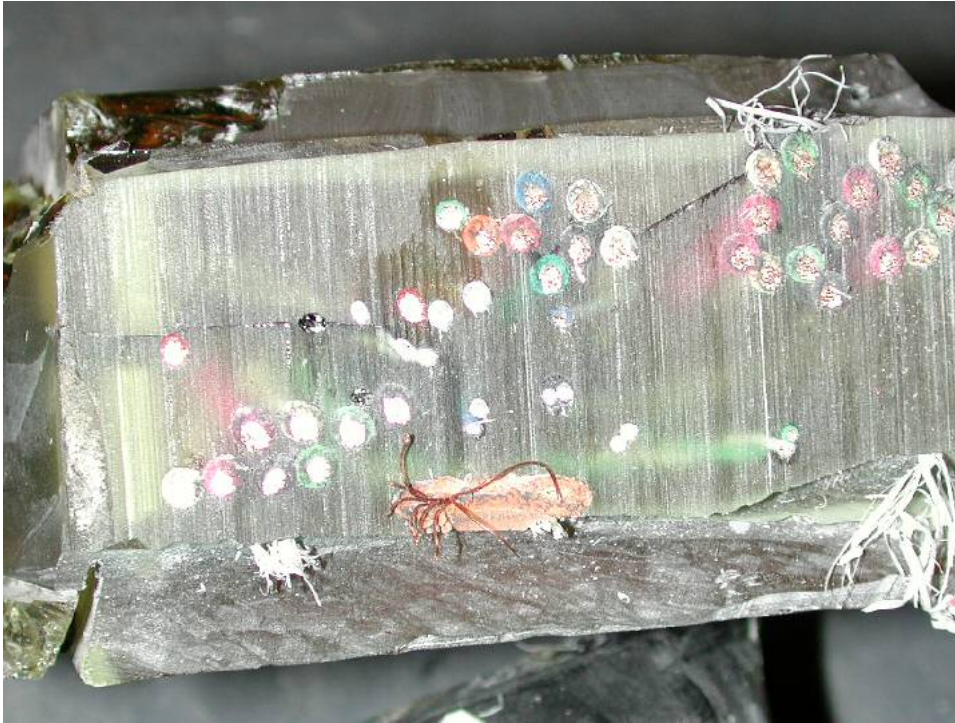
Close inspection of the printed circuit assembly revealed a dark crack in the epoxy horizontal to the circuit boards and normal to the sawcut. Most of the large (about 18 gauge) wires near the dark crack were shorted together.

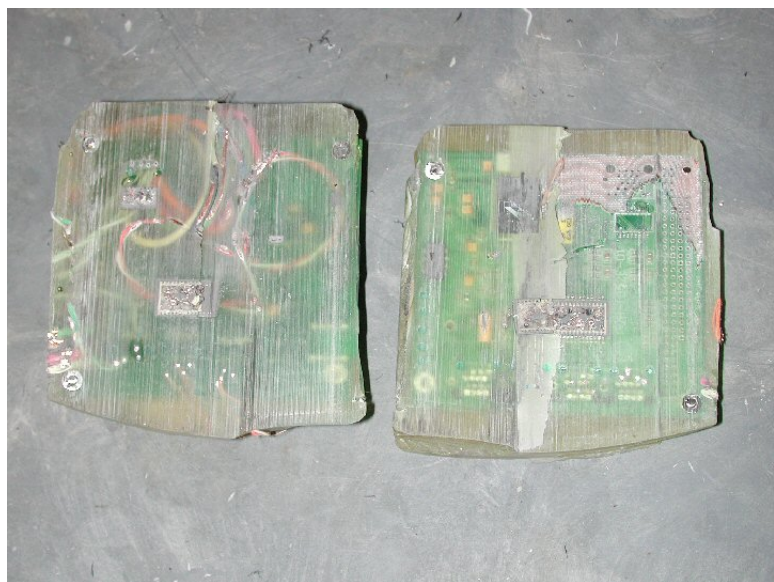
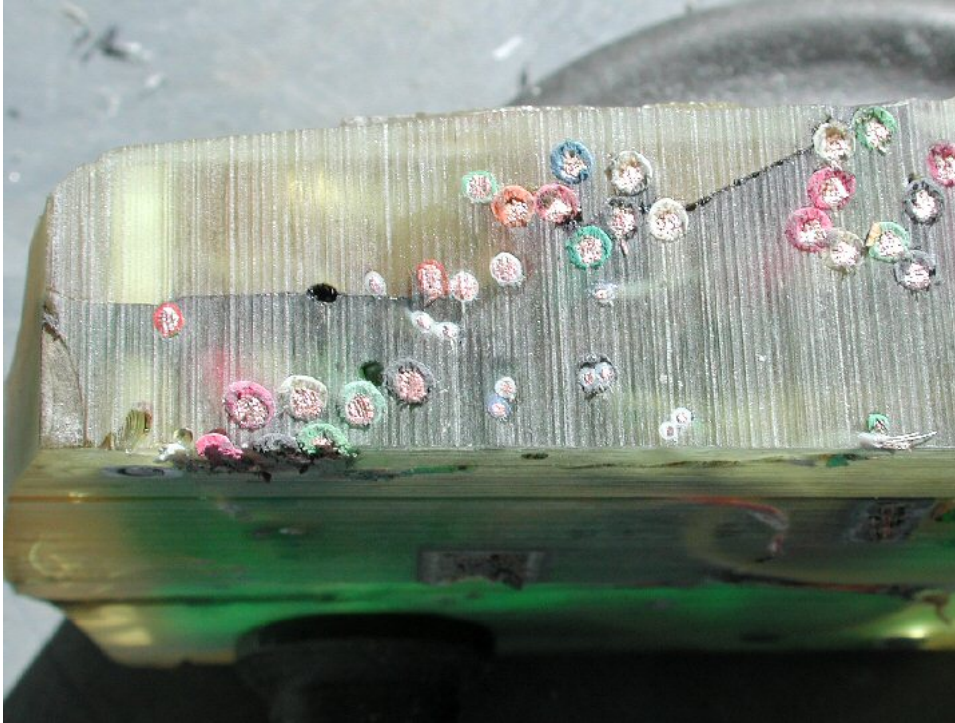
Next we cut apart the two printed circuit boards. The electrical short was still measurable on the wires near the dark crack in the epoxy.

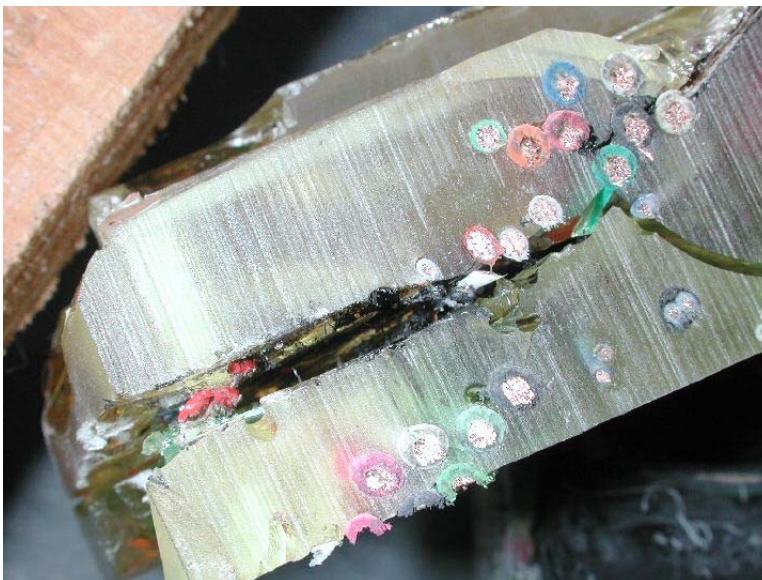
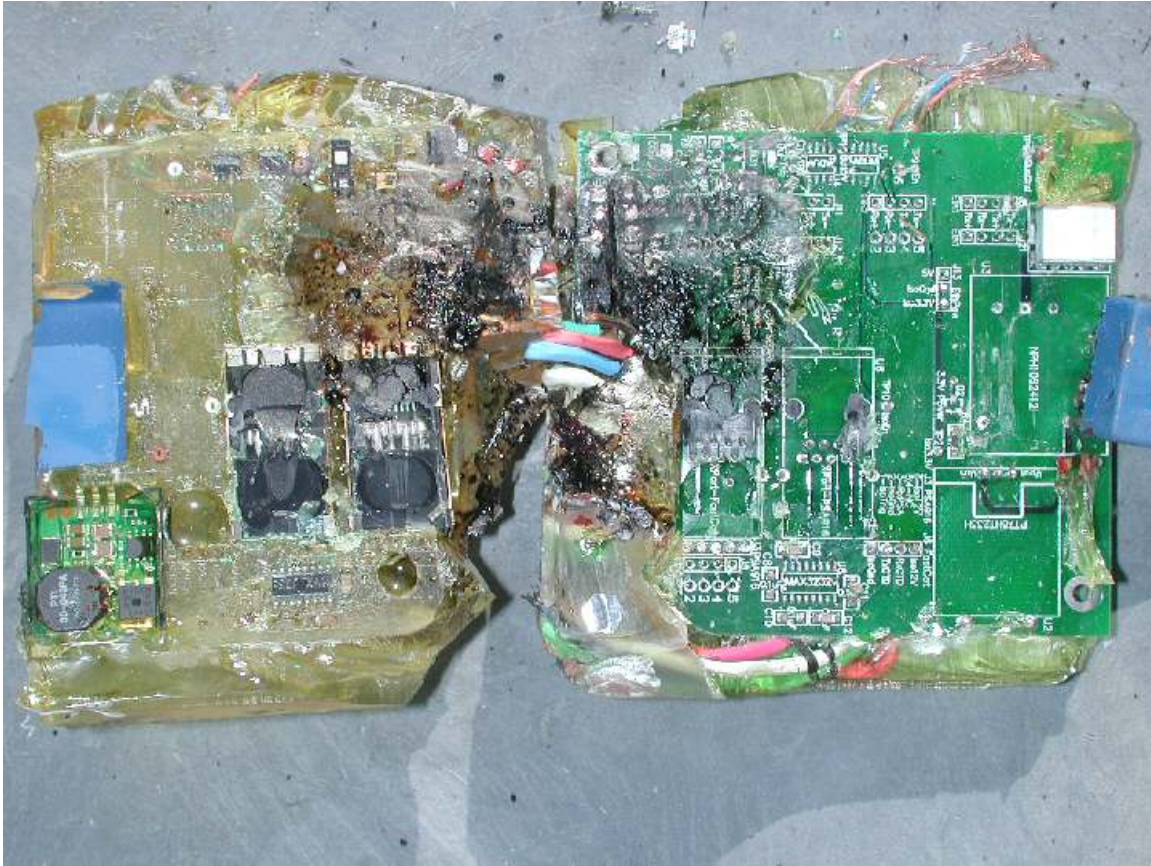
A hammer and chisel was applied to the crack, and with fairly little persuasion, the top portion of the epoxy separated from the printed circuit board, and the assembly fell apart like a sandwich.

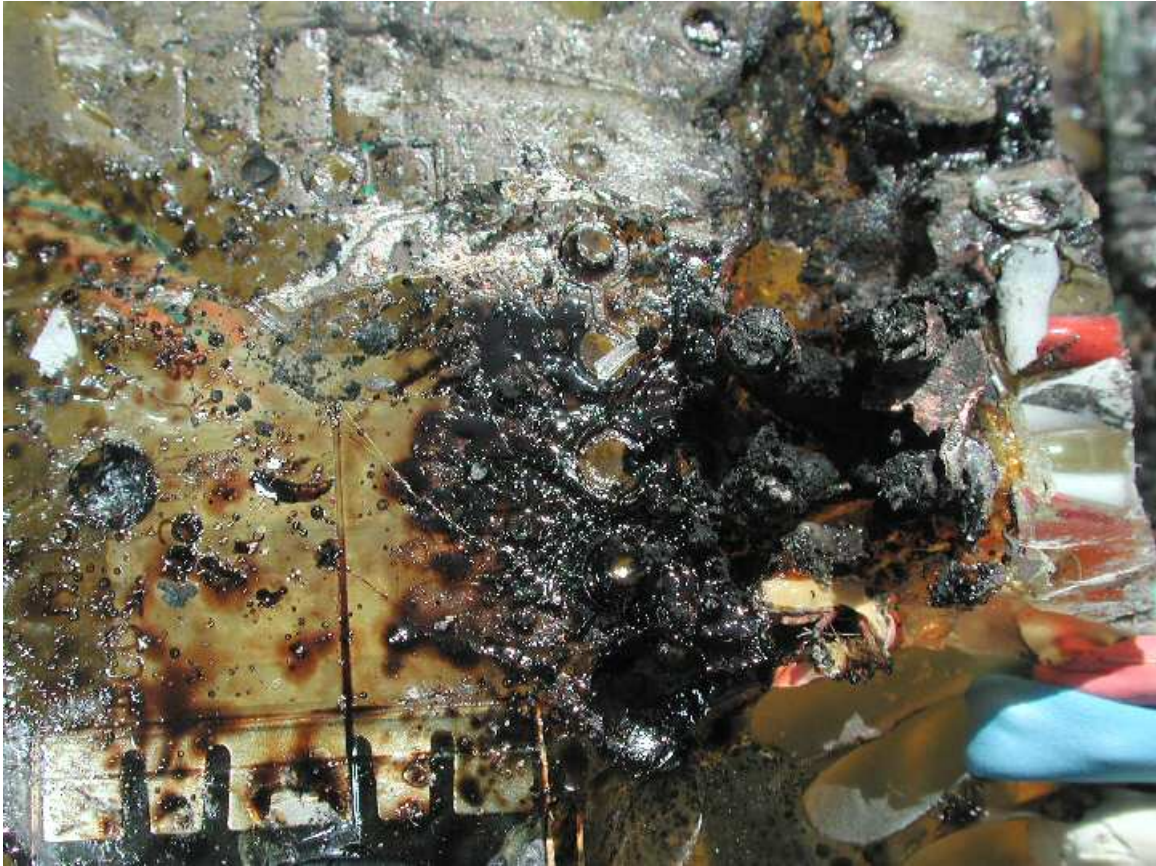
A strong scent of burned material became evident. Several bubble-shaped voids in the epoxy were clearly visible. The printed circuit board was charred in the area of several large wires, and the darkened surfaces of the board and epoxy were damp.
