## **Discharge Test for Bluefin Battery #0182/B6**

### ***Battery #0182 Test 5/26/2006 to 5/27/2006***

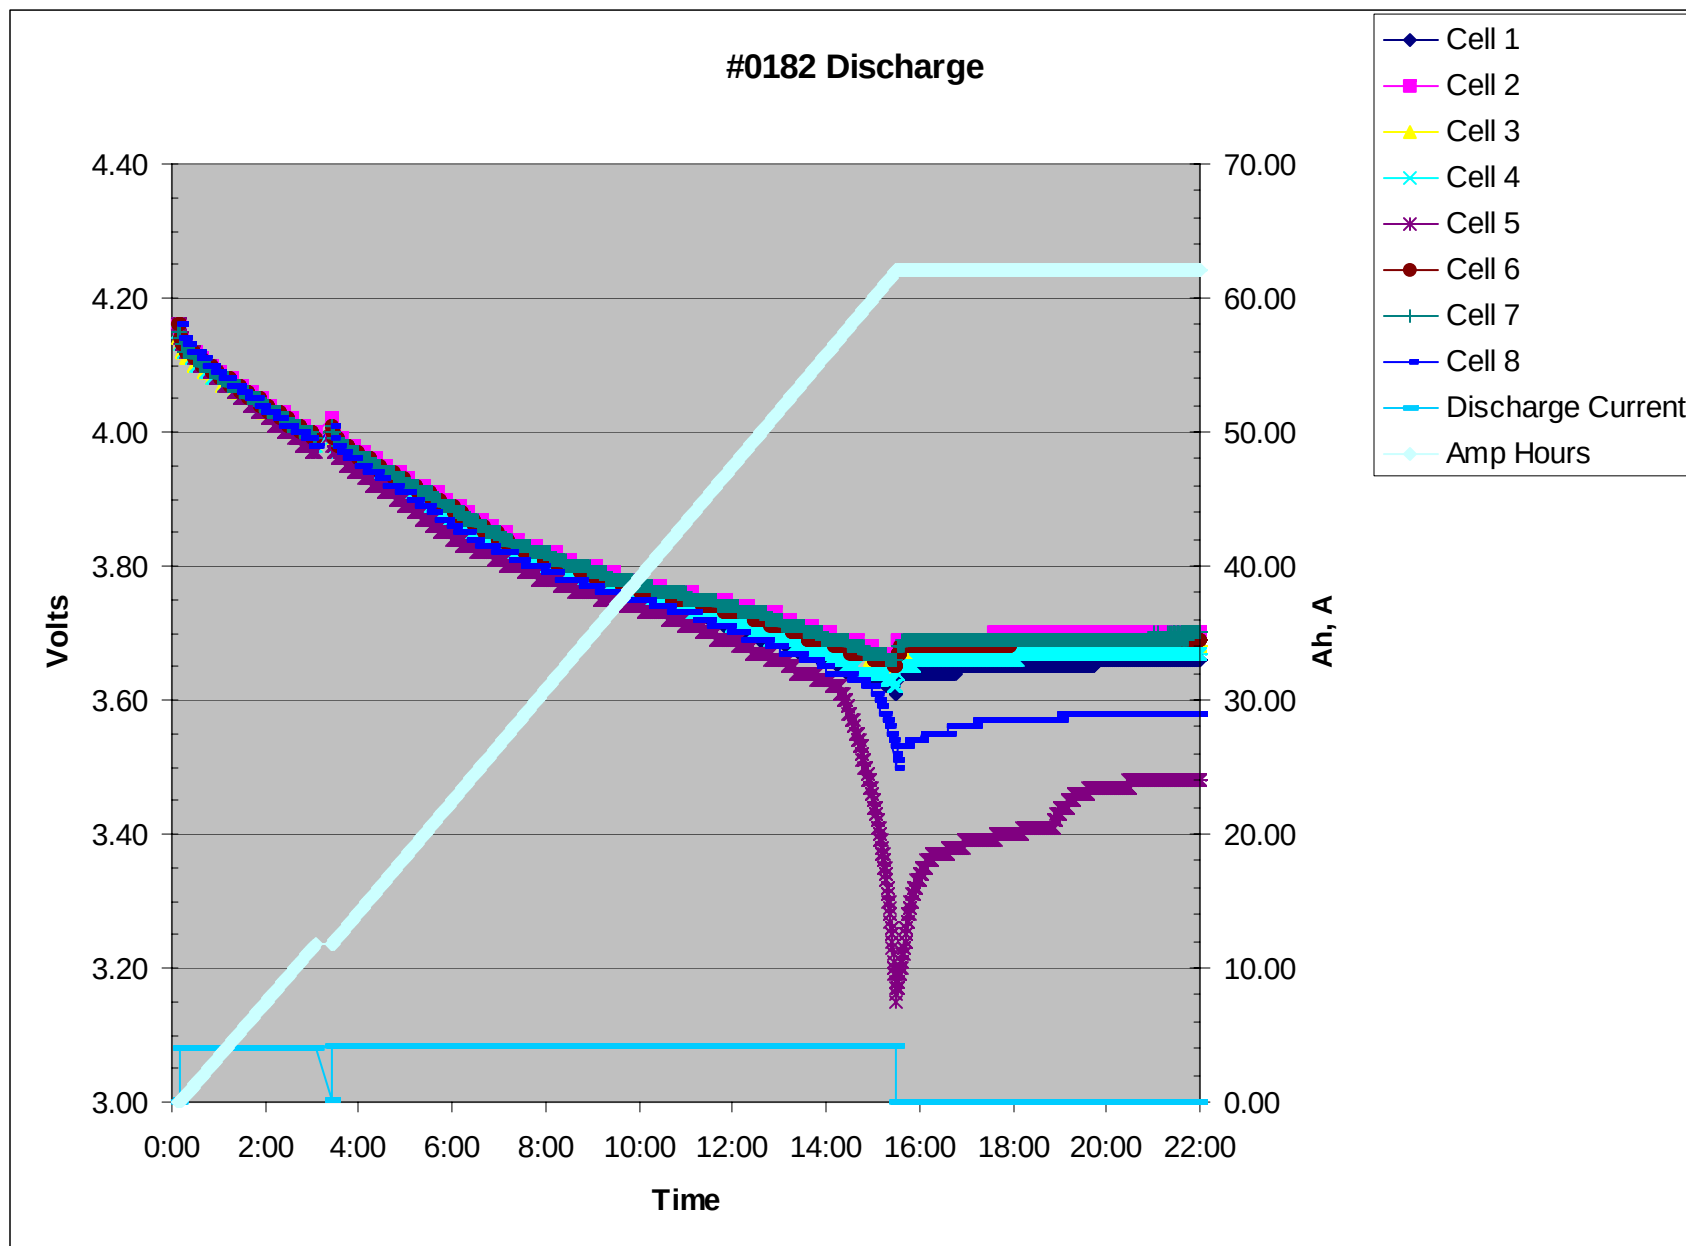
Figure 1 #0182 Discharge

Battery #0182 was discharged at a rate of 4.0A using a programmable DC load. The battery had been fully charged prior to the test using a 4A/3A/2A charge profile, to a cell voltage between 4.14V and 4.16V. The discharge test was interrupted at ~3 hours elapsed time, for ~25 minutes, due to a computer glitch; the discharge current was set to 0A during this period. The discharge test ended after an elapsed time of 15:10, when the battery turned off due to low voltage on Cell 5. A graph of the discharge is shown in Figure 1.

Based on the data collected during this discharge, battery #0182 retains a capacity of 62Ah/1900Whr. The original test data for the battery showed a capacity of 76.8Ah/2332Whr. A capacity loss of almost 20% has occurred. Similar overall capacity changes have occurred in the other two batteries. This is well outside of what would be expected from the limited number of discharge cycles the unit has undergone. A review of operational discharges shows that this change has accelerated with unattended operations. These runs incur substantially more undulations. It should also be kept in mind that our discharge test was done at a substantially lower current than the data reported in the acceptance test. Had we conducted our test at higher current, the measured capacity would have been slightly lower due to cell impedance.

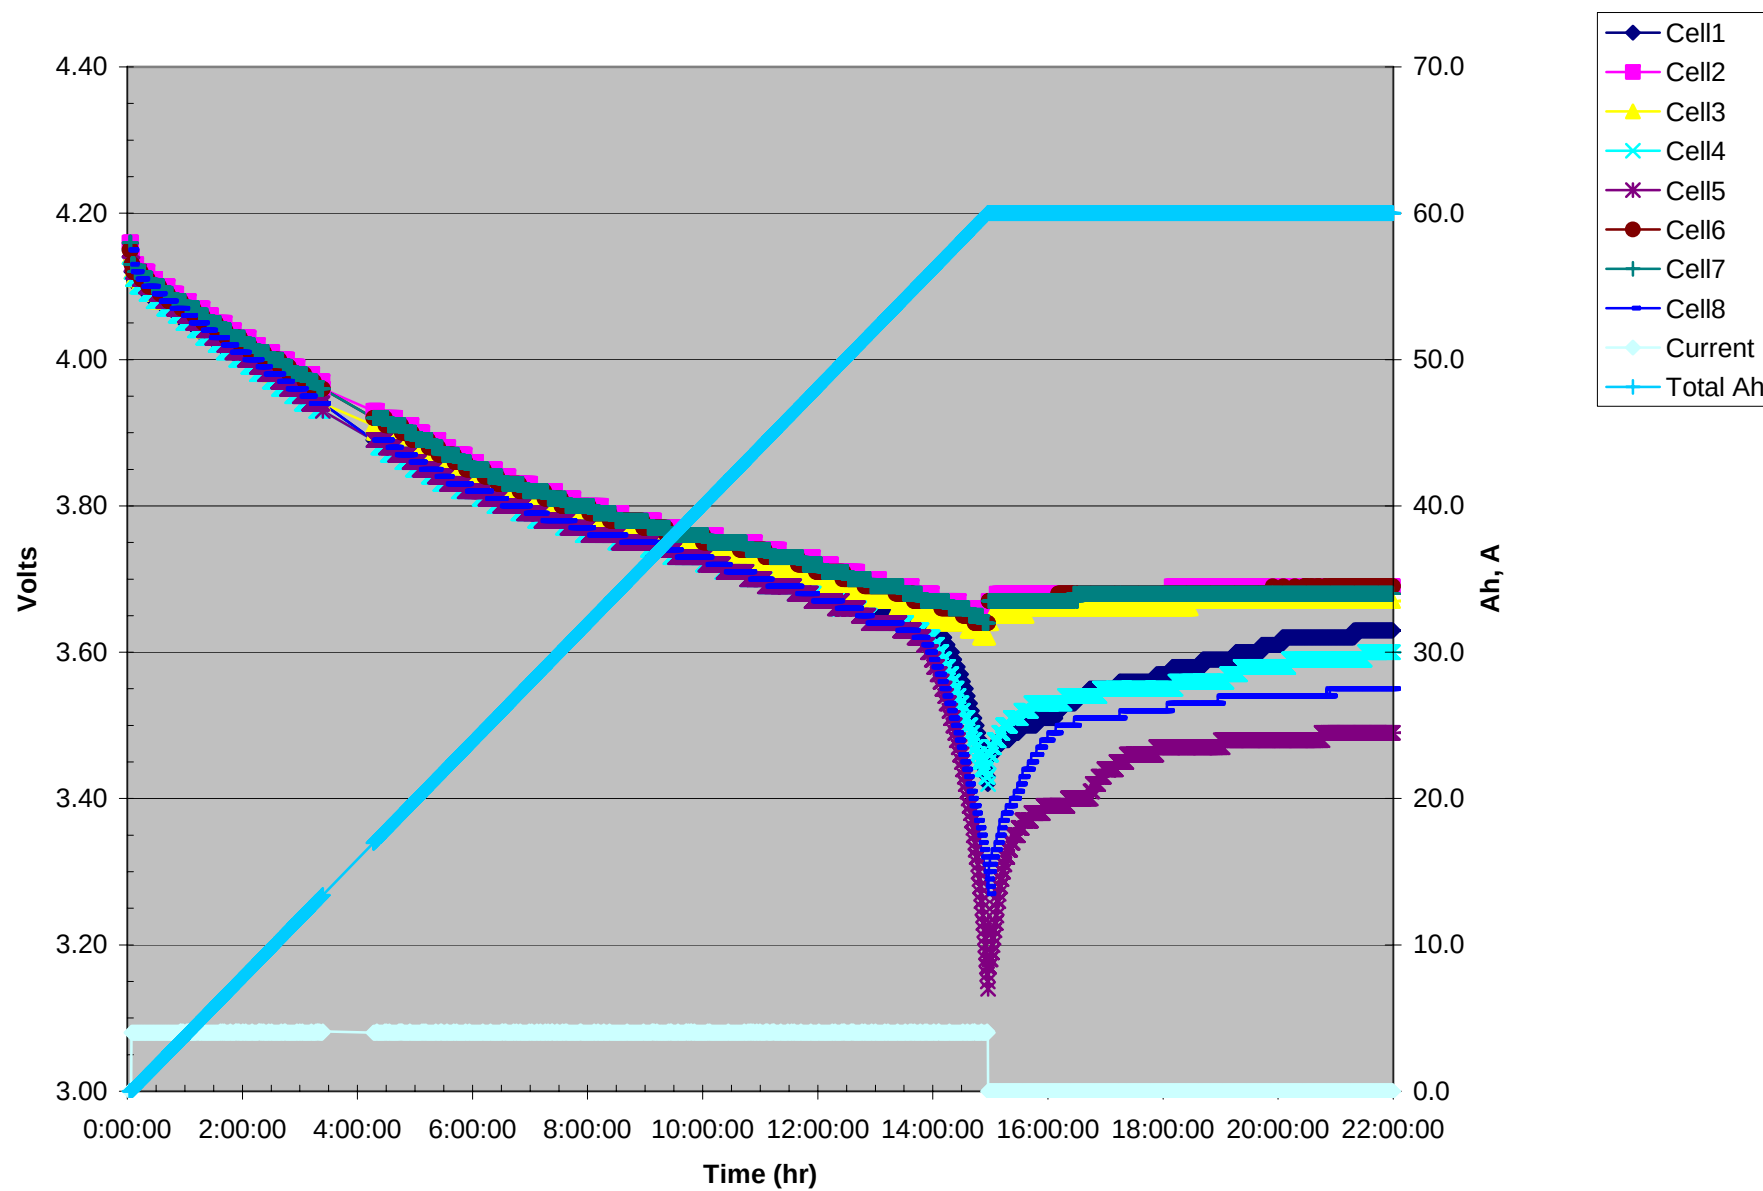
Figure 2 #0179 Discharge

Battery #0179 was discharged at a rate of 4.0A using a programmable DC load. The battery had been fully charged prior to the test using a 4A/3A/2A charge profile, to a cell voltage between 4.14V and 4.16V. The discharge logging was interrupted for 30 minutes at 3.5 hours elapsed time due to a problem with the logging program. During the glitch, discharge was maintained at 4.0A. Discharge ended after an elapsed time of 14:57, when the battery turned off due to low voltage on Cell 5. A graph of the discharge is shown in Figure 2.

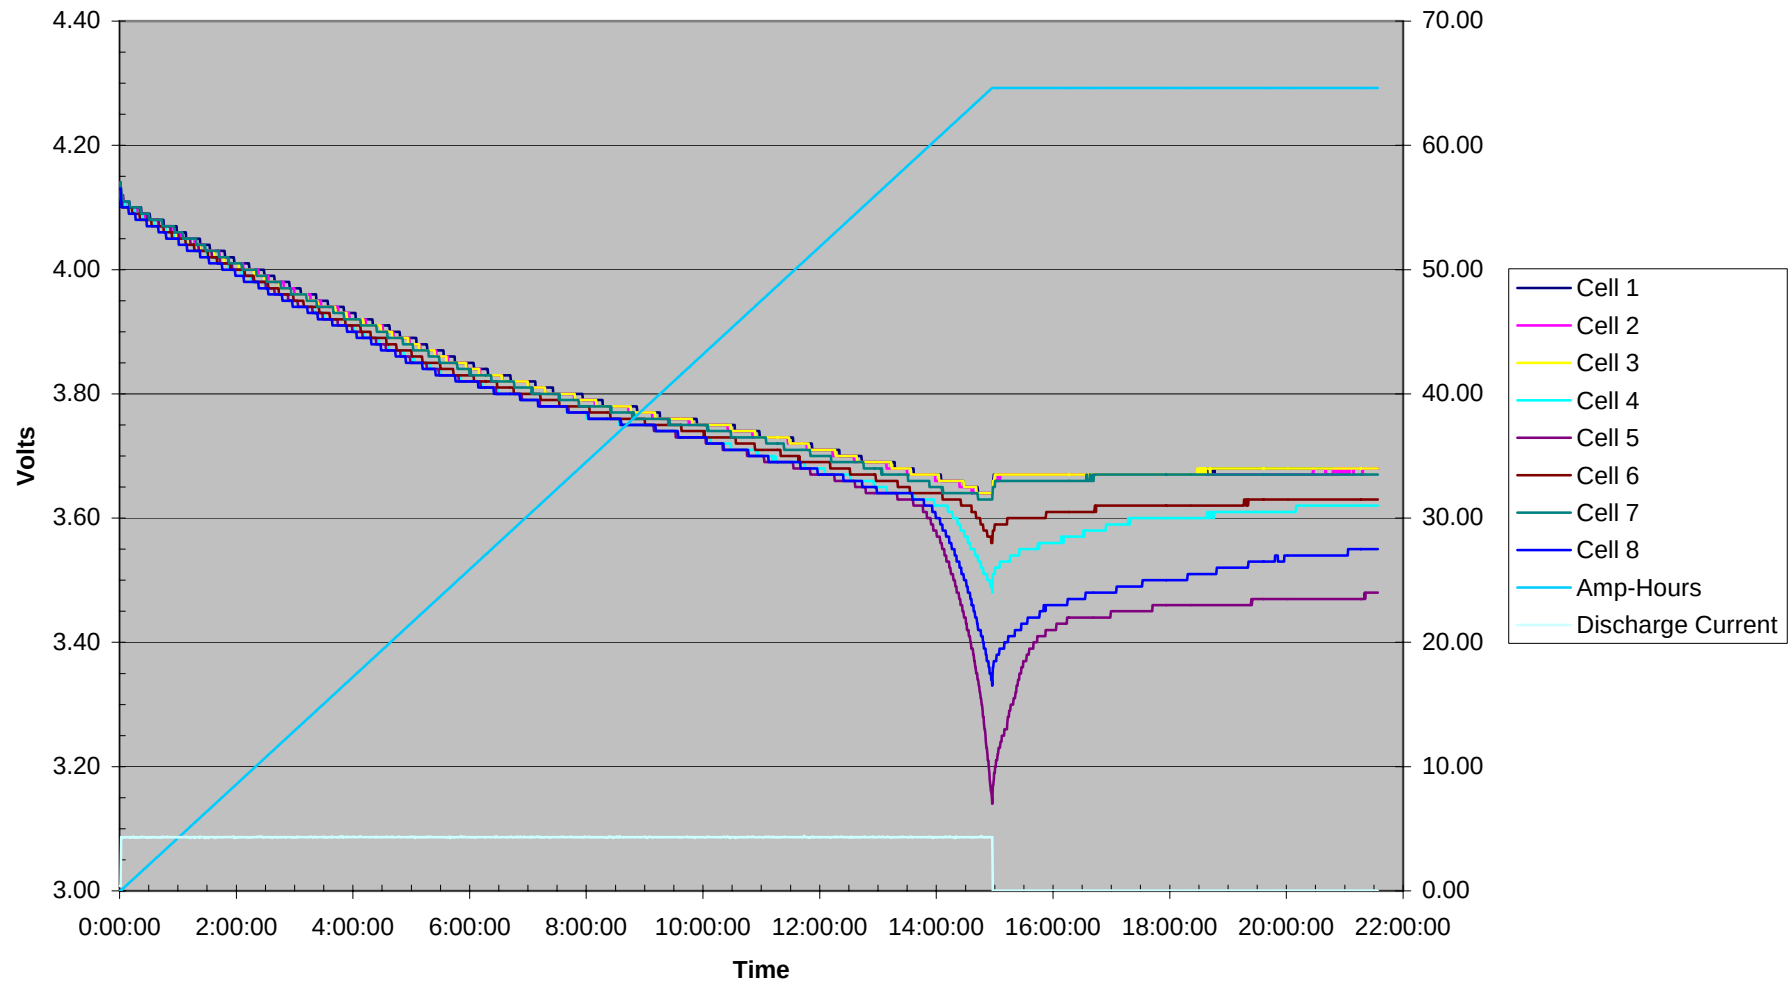
Figure 3 #0180 Discharge

Battery #0180 was discharged using the same procedure as the other two batteries. Initial cells voltages were between 4.13V and 4.14V. There were no interruptions in the discharge. Data is plotted in Figure 3.
