## **Discharge Test for Bluefin Battery #0182/B6**

### ***Battery #0182 Test 5/26/2006 to 5/27/2006***

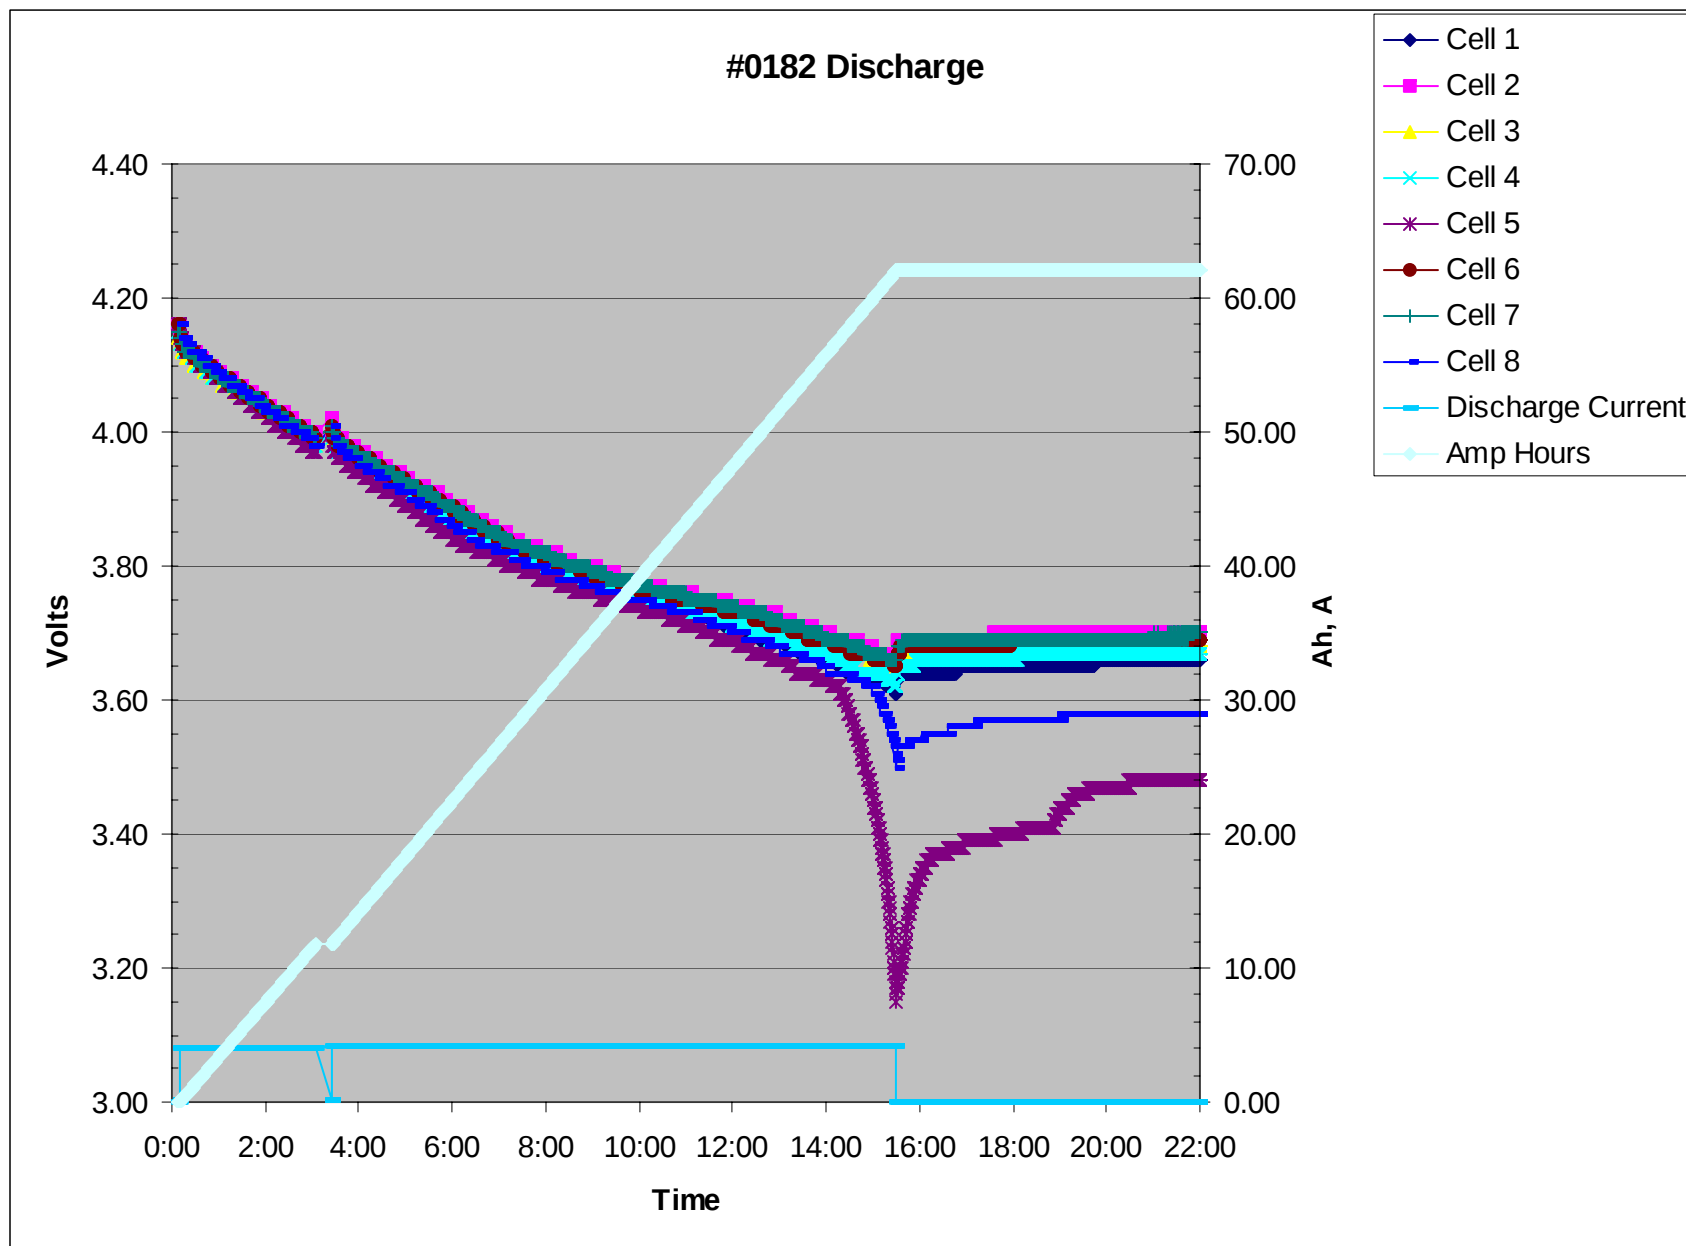
Figure 1 #0182 Discharge

Battery #0182 was discharged at a rate of 4.0A using a programmable DC load. The battery had been fully charged prior to the test using a 4A/3A/2A charge profile, to a cell voltage between 4.14V and 4.16V. The discharge test was interrupted at ~3 hours elapsed time, for ~25 minutes, due to a computer glitch; the discharge current was set to 0A during this period. The discharge test ended after an elapsed time of 15:10, when the battery turned off due to low voltage on Cell 5. A graph of the discharge is shown in Figure 1.

Based on the data collected during this discharge, battery #0182 retains a capacity of 62Ah/1900Whr. The original test data for the battery showed a capacity of 76.8Ah/2332Whr. A capacity loss of almost 20% has occurred. This is well outside of what would be expected from the limited number of discharge cycles the unit has undergone. It should also be kept in mind that our discharge test was done at a substantially lower current than the data reported in the acceptance test. Had we conducted our test at higher current, the measured capacity would have been slightly lower due to cell impedance.

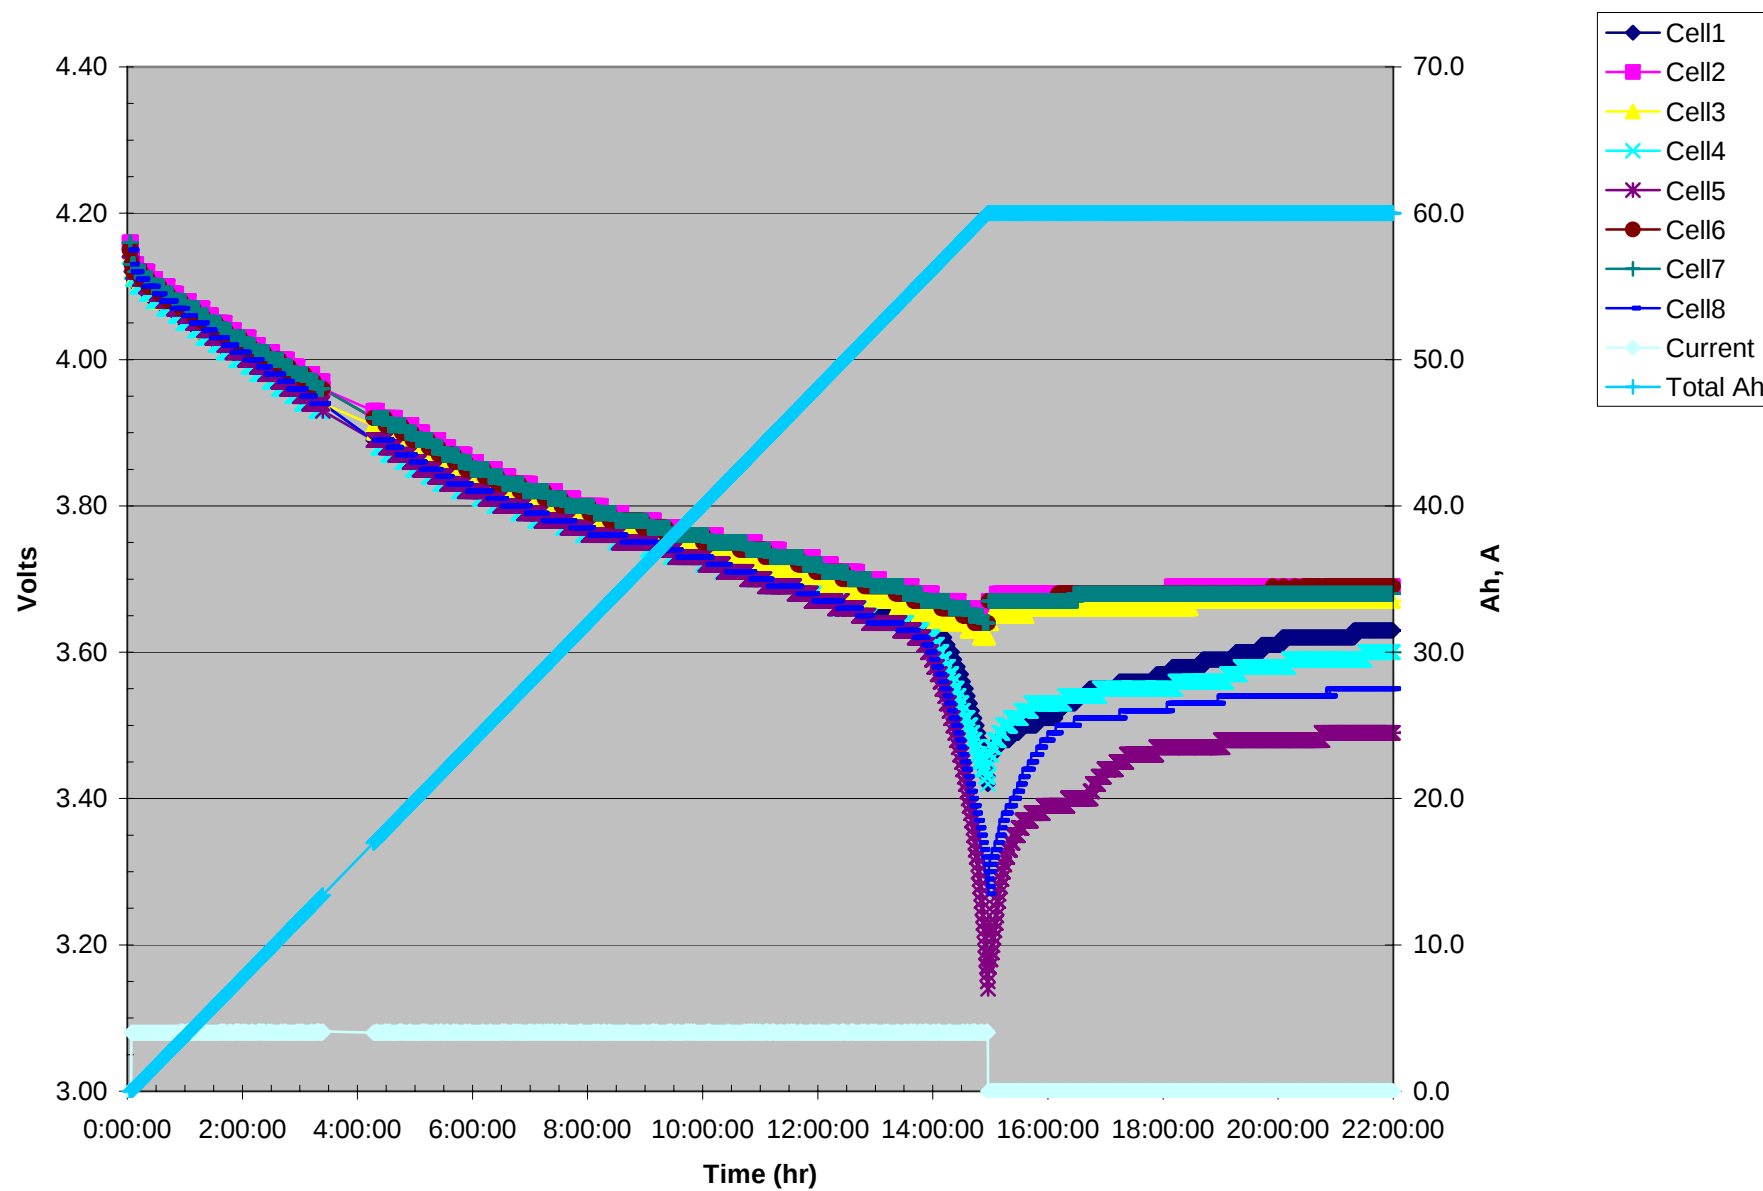
Figure 2 #0179 Discharge

Battery #0179 was discharged at a rate of 4.0A using a programmable DC load. The battery had been fully charged prior to the test using a 4A/3A/2A charge profile, to a cell voltage between 4.14V and 4.16V. The discharge logging was interrupted for 30 minutes at 3.5 hours elapsed time due to a problem with the logging program. During the glitch, discharge was maintained at 4.0A. Discharge ended after an elapsed time of 14:57, when the battery turned off due to low voltage on Cell 5. A graph of the discharge is shown in Figure 2.

The discharge tests show a large decrease in capacity of cell 5 and cell 8 of both battery #0179 and #1082. Cells 1 and 4 of #0179 also show a large decrease in capacity. Given that MBARI has now seen problems with low voltage/capacity cells in three batteries (#0179, #0182, and SIO #0162), there is a likelihood of a systematic flaw in assembly or construction of the batteries which is aggravated by a large number of pressure cycles.
