## Engineering Change Order (ECO)

ECO #: 50244

Title: KCF Compass board new revision

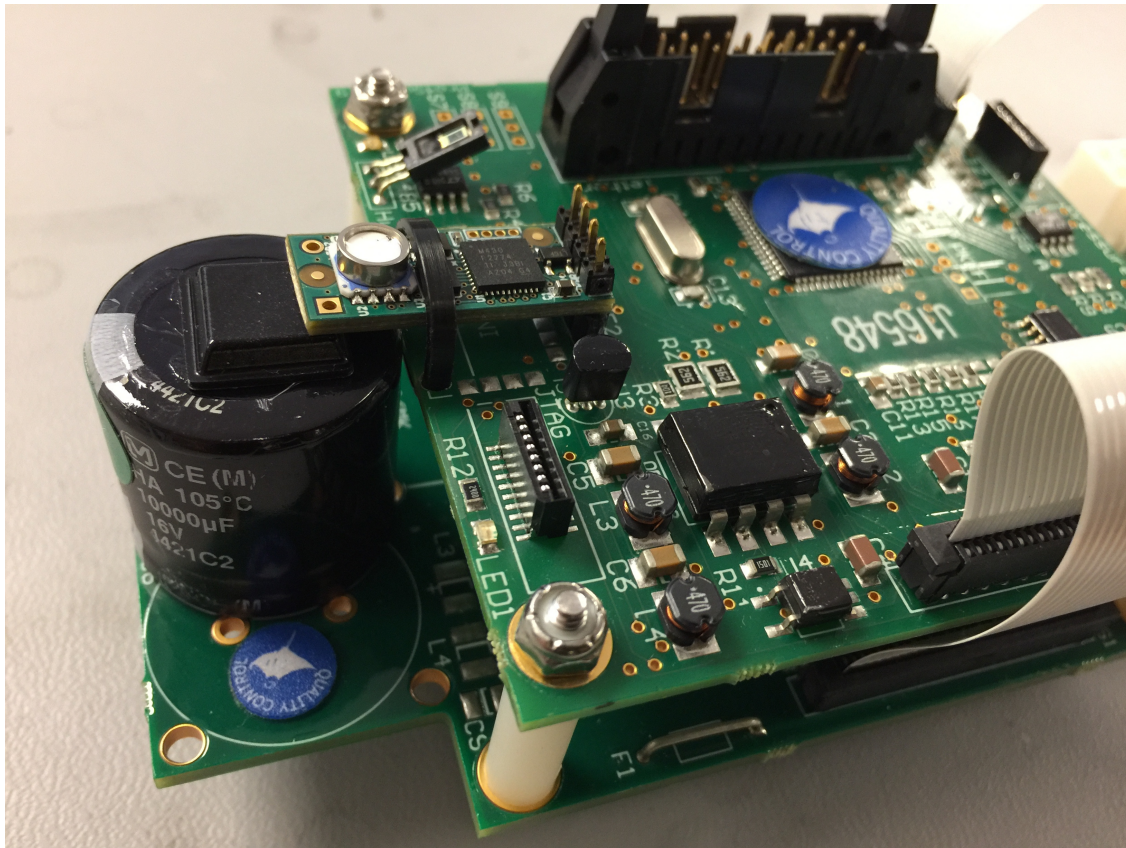
Mounting onto the PRO4 CPU boards remains nearly identical with just minor adjustments for relocating the rubber bumper closer to the compass so the compass can rest on it See figure 1.

(Figure 1. Mounting of new compass KCF compass module)
