| | Doc or ECO #: | ECO-70654-002 | Date: | 12/3/2019 | Author: | JMV |

| <b>Title:</b> | Tilt arm revisions | | |

## 1.0 Purpose / Summary

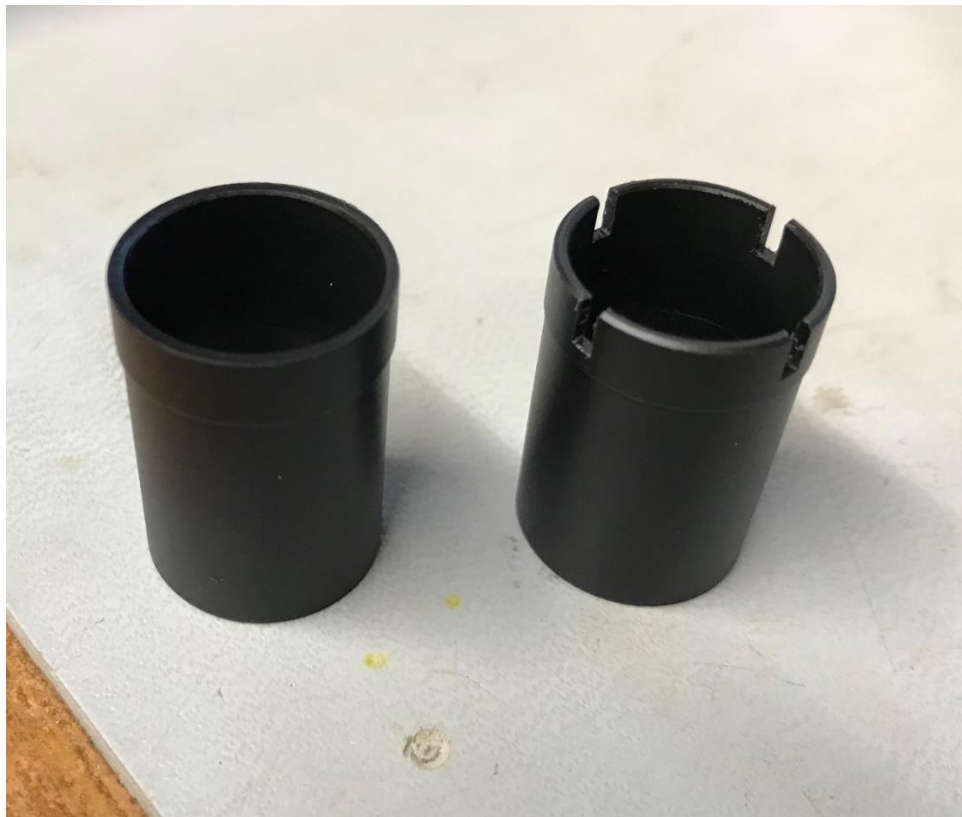
Tilt arms have been known to get locked from over tightening. The modifications to ARM-001 and ARM-012 solve the locking issue. Relief slits were added to the clamping surface of ARM-012 to keep the pinch from occurring. This modification can be seen below in a cross section view of the tilt arm.

Prior to modification

no-pinch modification

| Part Number | Notes | Removed | Added | Modified | REV |
|---|---|---|---|---|---|
| Arm-012 | Collet slits added to avoid tilt arm lock | <input type="checkbox"/> | <input type="checkbox"/> | <input checked="" type="checkbox"/> | B |

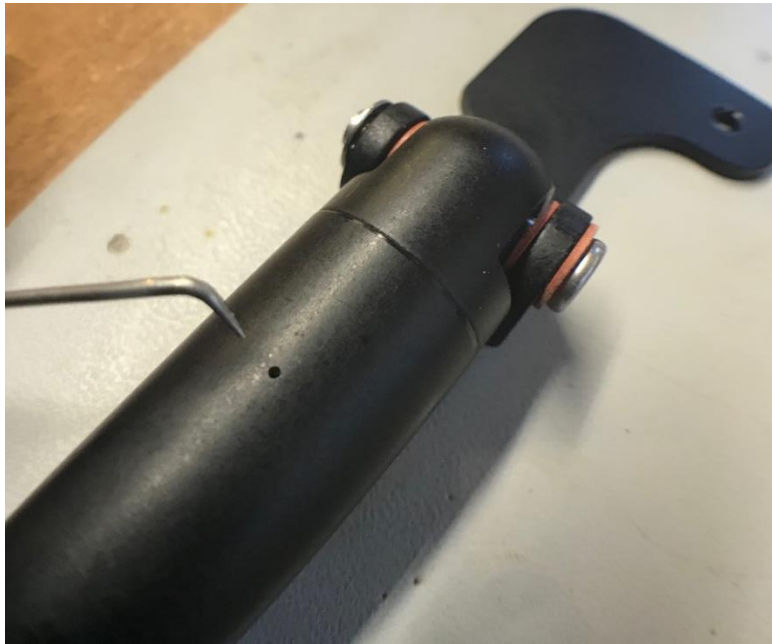
A very small relief hole has been added to ARM-001 to keep from vacuum locks and relief unwanted pressurized air. This can be seen below.

| Part Number | Notes | Removed | Added | Modified | REV |
|---|---|---|---|---|---|
| Arm-001 | Relief hole added | <input type="checkbox"/> | <input type="checkbox"/> | <input checked="" type="checkbox"/> | B |

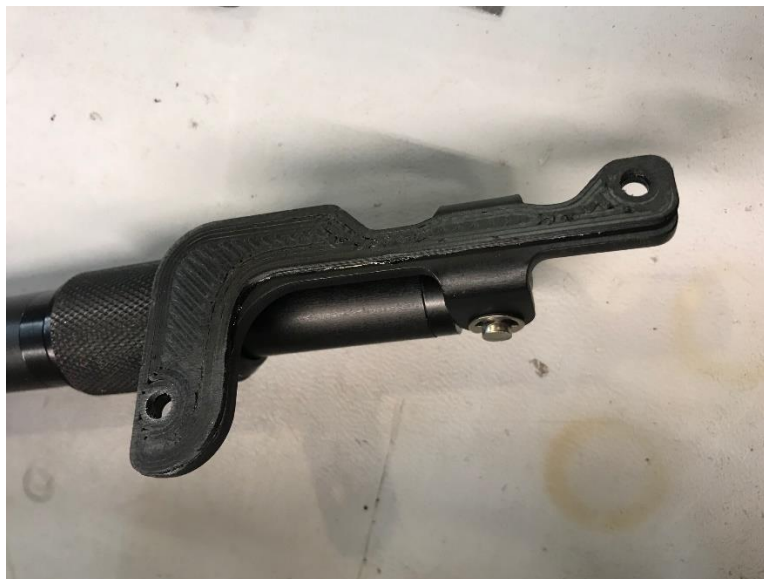
For all waived monitors, 70654 should have a small shim glued onto the back of ARM-004. See JV for more details. This is controlled in QC, The shim is seen below. Until the monitor is officially replaced, this shim must be present on every 70654.

ARM-004 may be built into 70654 for use with the waived monitors. But as long as its going on a waived monitor, it should have a shim glued to the back of it.

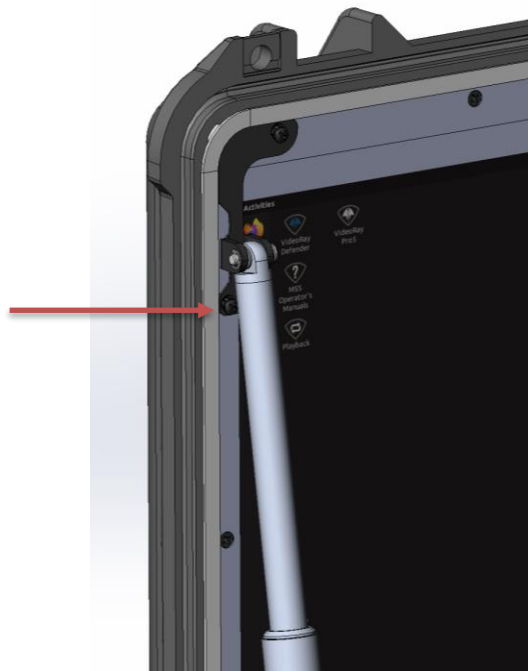
The other change that occurred was to ARM-004. This change affects 70654 directly. When the locking collar is unscrewed all the way and the case is shut, the pan head screw contacts the locking collar and damages the annodizing. Currently we are reworking on ARM-004 to have the one chamfer where it is critical, shown with an arrow below. However, both holes on ARM-004 will come chamfered for future orders and the mounting screws will both be replaced with a #6 x 3/4 black oxide flat head.

| Part Number | Notes | Removed | Added | Modified | REV |
|---|---|---|---|---|---|
| Arm-004 | Countersinks added to holes | <input type="checkbox"/> | <input type="checkbox"/> | <input checked="" type="checkbox"/> | B |
