| | Doc or ECO #: | ECO-70683-002 | Date: | 05/07/19 | Author: | SCL |

| <b>P/N #:</b> | 70683 | <b>Effective Date:</b> | May 9, 2019 |
| <b>Title:</b> | Ruggedized MSS Power Supply Capacitor Reverse Modification | | |

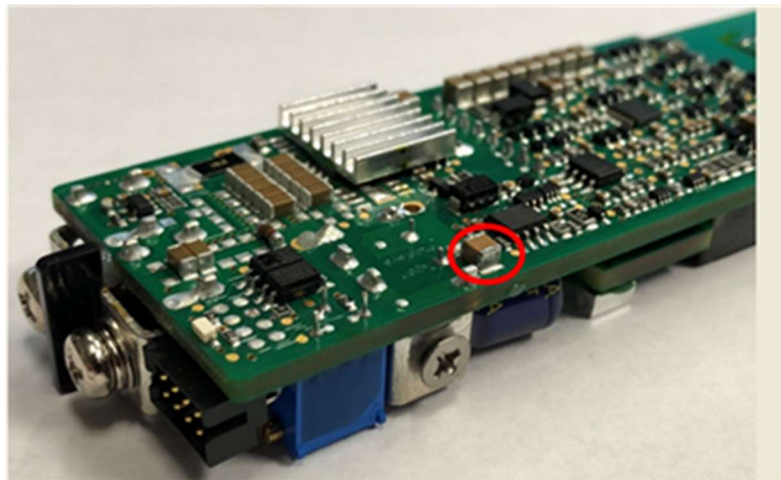
MSS power supplies previously had an ac coupling capacitor removed to reduce leakage that was causing GFCI's to trip (ECO-70683-001)

The removal of this capacitor had the side effect of degrading the the connection quality on our m100 communications modem. Replacing this capacitor allows the m100 to function correctly and at full performance. In a previous ECO GFCI's were replaced with ELCI's, which will prevent the circuit tripping from returning.

Systems with older generation power supply chassis averaged 25ms and did not indicate degraded link performance, and the issue was isolated to the power chassis. The suspicion is that increased EMI adversely effects the M100.

Figure 1 Power module with Capacitor highlighted.

Engineering replaced the removed capacitor and retested the system. All communication issues were resolved, signal strength was strong (determined by the green status LED on the m100 modem signifying 80+mb/s, and the TX\_DT was averaging 26ms.

It was determined that the capacitor will be replaced moving forward.
