| | Doc or ECO #: | ECO-70847-001 | Date: | 9/8/2020 | Author: | MW |
| Engineering Change Order (ECO) | Engineering Approval: | aeg | Date: | 9/8/2020 | Quality Approval | aeg |

| <b>P/N #:</b> | 70847 | <b>Effective Date:</b> | September 8, 2020 |
| <b>Title:</b> | Thruster prop tool handle pin hole depth correction | | |

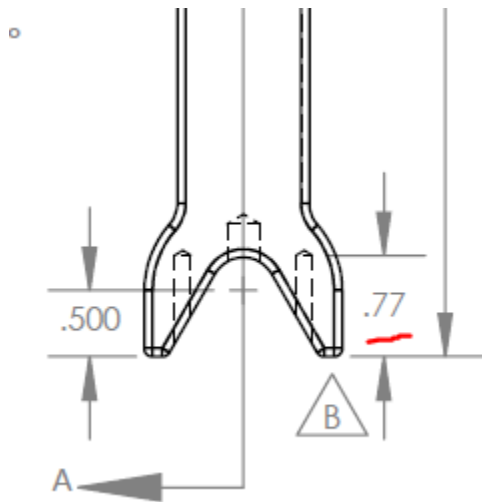
The hole depth for the pins at the end of the handle was too deep. Assemblers were sinking the pin in too deep.

The pins need to be flush with the bottom of the handle but can be installed deeper. This is because the hole depth was .86". It has now been reduced to .77" to inhibit this.

Use existing stock until depleted then switch over
