| | Doc or ECO #: | ECO-71152-004 | Date: | 06/14/2021 | Author: | SL |

| <b>P/N #:</b> | 71152 | <b>Effective Date:</b> | June 15, 2021 |
| <b>Title:</b> | Pro 4 Ultra USB Hub Replacement | | |

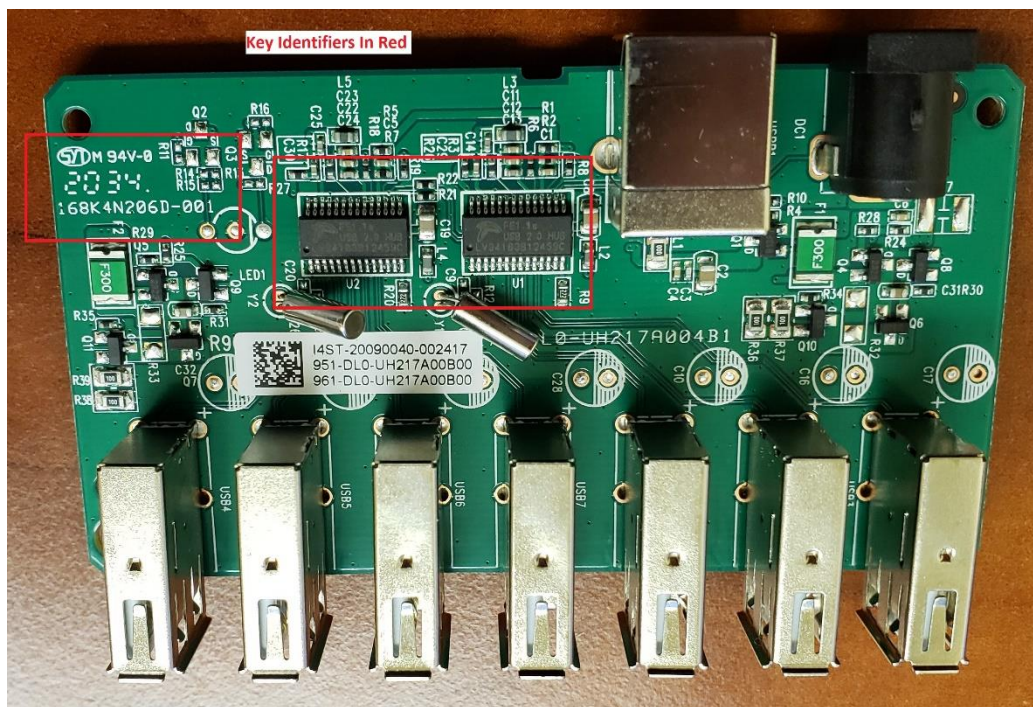
- Due to a PCB Revision update on the D-Link USB Hub **[PN4-014]**, the system was no longer stable and conflicting with Windows 10 Updates. The D-Link Hub was replaced with the Saberant USB Hub which comes standard on the base Pro 4 ICB.
- The Pro 4 Ultra Accessory Board **[71122]** has been updated to accommodate the Hub change.

- All current stock of the Pro 4 Ultra ICB [71152] including those in process in production should be updated to the standards of this ECO.
- Added Missing Shrink Tube Part Number to BOM
- Any Pro 4 Ultra system in the field exhibiting the following issues that a standard driver reinstallation does not fix should be inspected for the problematic USB Hub. If the problematic USB Hub is discovered in the system, the ICB should be sent to VideoRay for a warranty replacement. Due to the nature of the replacement, in field replacements are not advised. The photo below should be used to identify the problematic USB Hub.

- No video in VideoRay Cockpit
- No text overlay in VideoRay Cockpit
- No USB devices in Device Manager (USB 2861 & VideoRay Ultra Serial Device)
- Video Capture Device Driver Issue in Device Manager

- There appears to be a conflict with current windows updates and the USB hub used in the ultra panel.
- The purpose of this ECO is to replace USB Hub previously used on the Pro 4 Ultra Lite Panel with our standard Pro 4 USB Hub
