| | Doc or ECO #: | VR-PRO4-10-0001-001 | Date: | 11/18/2020 | Author: | aeg |
| <b>Engineering Change Order (ECO)</b> | Engineering Approval: | aeg | Date: | 11/18/2020 | Quality Approval | SL |

| <b>P/N #:</b> | VR-PRO4-10-0001 | <b>Effective Date:</b> | November 18, 2020 |
| <b>Title:</b> | New cable for termblock | | |

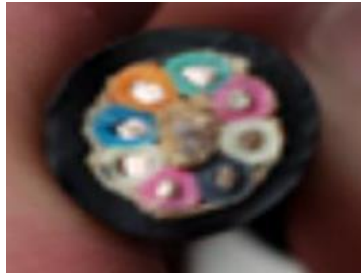
VideoRay sourced a new custom cable [72936], specifically designed to be more robust. This cable has TPEE insulation and sheath, a smaller diameter, and no central conductor.

Termblock assemblies made with the new custom cable exceeded 300,000 cycles in our cyclic fatigue test. One sample did fail in under 5000 cycles, but Birns ascribes that to a manufacturing error (poor solder connection) that has been corrected.

The new cable is has a smaller diameter and a harder/glossier finish than older cables. Term blocks made with the new cable are more rigid as well. They are easily identifiable. The cable is marked, but markings may not align with the termblock terminations.

Due to the robustness of the new cable the up-armor assembly will no longer be used.
