# Shepard Meander 2006-2007 MOOS Science Experiment: Data Return and Lessons Learned

1.9 8SEP08 Final version with plots. Mark Chaffey

## 1. Summary

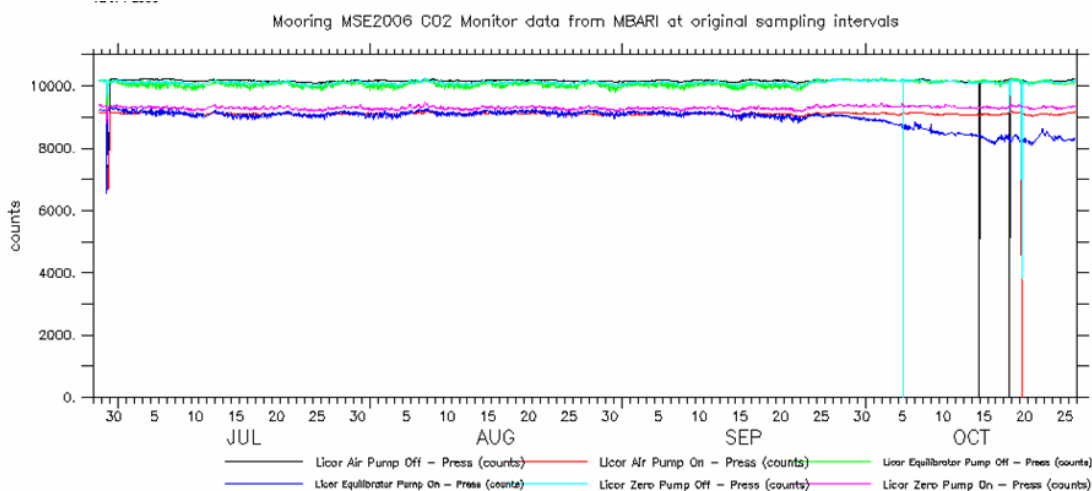
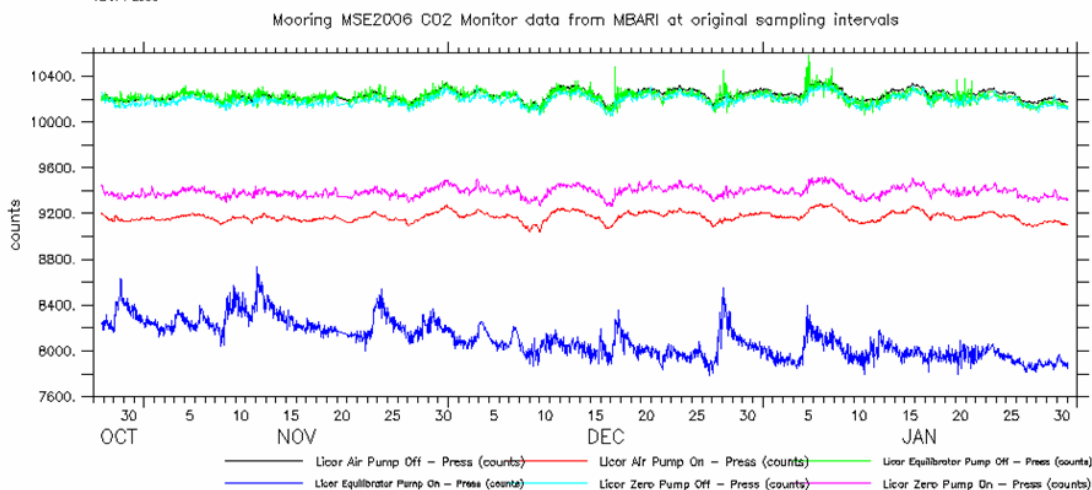
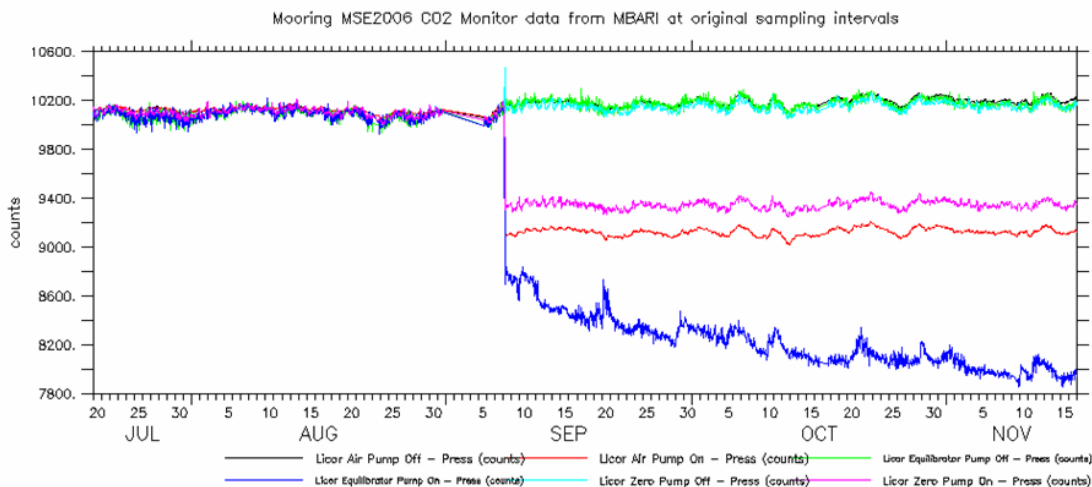
**1498 and 1610 - SOON pCO<sub>2</sub>** Example data plots. There is a large data gap following the February 2007 power shutdown due to the instrument not being properly shutdown and depleting the instruments internal batteries. The instrument was fully restored to operation on a Zephyr maintenance trip in July 2007. Overall it returned data for 63% of the deployment. The sample period was 1 hour.

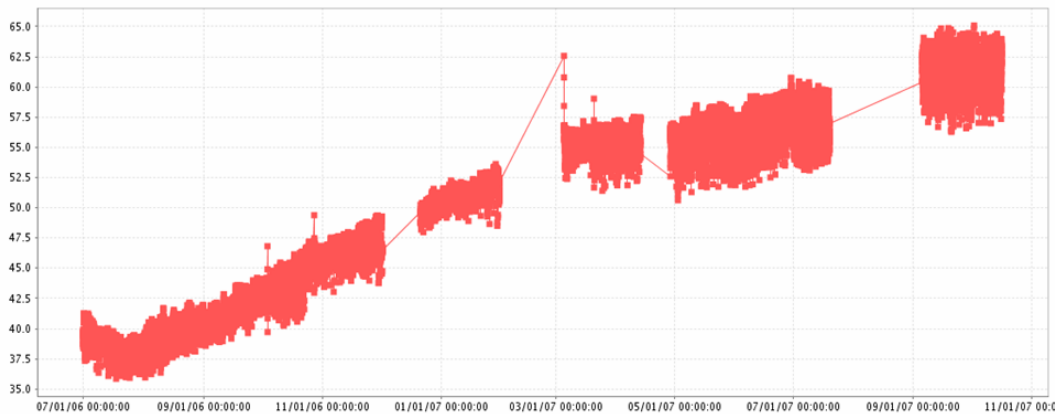
The Snubber node has large data gaps. Several times the node failed to boot after a power cycle. Attempts to restart the node are generally not successful, although it has restarted on a cold boot on occasion. In mid October 2007 the node was power cycled during a reboot and did not restart. Subsequent attempts to restart it failed. When in failure mode it does not appear to draw nominal power from the Surface DPA switch. The humidity shows an increasing trend that reached 63% at 20 degrees C. before operation ceased, but after recovery the internal electronics were dry with no evidence condensation at room temperature. Evidence points to a power supply start-up problem on the MMC and possibly Medusa cards, possibly humidity related. The graph below shows the Snubber housing internal humidity trend.

Snubber housing internal humidity trend over the course of the deployment.

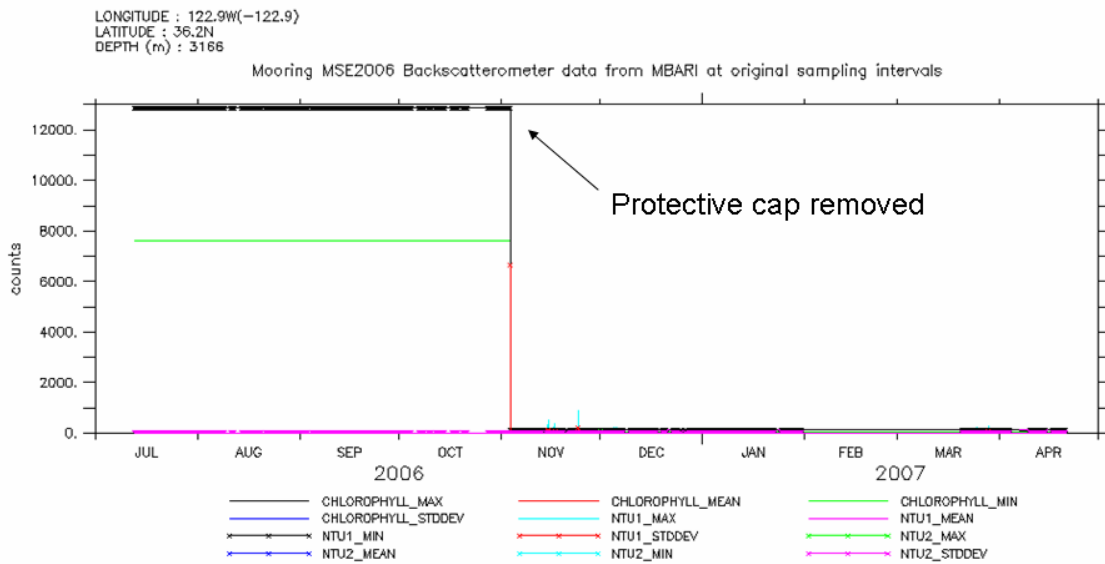
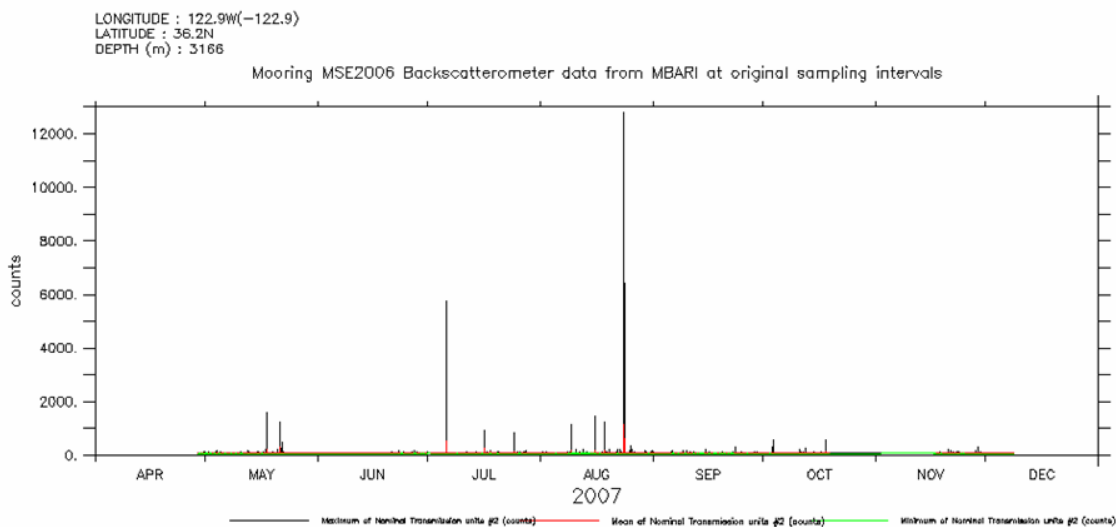
**1535 and 1536 - WETLabs ECO-Triplet.** 1536 replaced ID 1535 on April 28, 2007. The large step in the data is due to the protective cap being accidentally left in place over the optical port on deployment. The cap was subsequently removed by the ROV Tiburon during the Axis deployment dive in early November 2006. The large data gap in February and March 2007 was due to the loss of the surface wind power turbine and the subsequent system power emergency. The plots below shows data returned and where there are gaps in data. Instrument 1536 stopped sending data for unknown reasons on several occasions and resumed when the instrument and service were restarted. The instrument ID was inadvertently left off of automatic "failmail", which caused the long October-November data outage when the missing data stream was not noticed. This instrument returned 53% valid data over the deployment and 19% bad data, mostly due to having the protective cap in place. The sample period was 5 minutes with one hour summaries for telemetered data. Quick look data plots are shown below, showing the data return history.

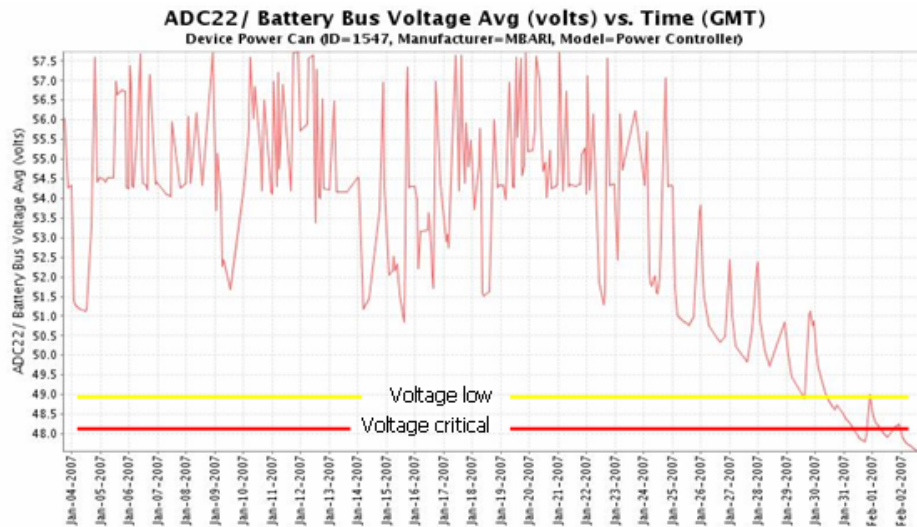
Figure 1. Voltage levels leading to the January 2007 low power shutdown event.

- b. **Low power emergency shutdown and subsequent wind turbine failure.** As designed the MSE power system was to deliver full system power with 95% "availability". This figure was chosen as a tradeoff between science loads, battery capacity and wind and solar collection areas. There was the probability that during any deployment there may be periods of minimum winds and very poor solar insolation that exceed the capacity of the batteries to sustain the full system load for a few days. The probability was that this would occur about once in a years period. In fact this occurred twice during the deployment, for 5 days in December of 2006 and for about an equal time in late January 2007 (see figure 1, below). In each of these cases the MSE system was partially shut down to prevent an uncontrolled shutdown as the available energy reached a critical level. When the wind and sun returned after the January shutdown the wind generator did not restart and was deduced to be frozen. This in fact turned out to be the case and the available system power was severely impacted during this relatively sunless season. The wind generator was replaced by OSG after about 30 days but the protective fuse in the power system simultaneously failed. The cause is suspected to be miss-plugging of the connector. The system then remained in a low power, minimal operation state for 14 more days until the power can was replaced, restoring full functionality. Better system documentation in the form of labeling the deployed connectors, having clear instructions and possibly a step-by-step checklist and strictly adhering to these resources might have prevented the failed fuse and subsequent 14 days of additional data gap. In addition the instrument loads could have been more carefully managed to get some data during this period. Our difficulty with the satellite telemetry and the subsequent delays in command execution discouraged us from putting more effort into day-to-day power load management.

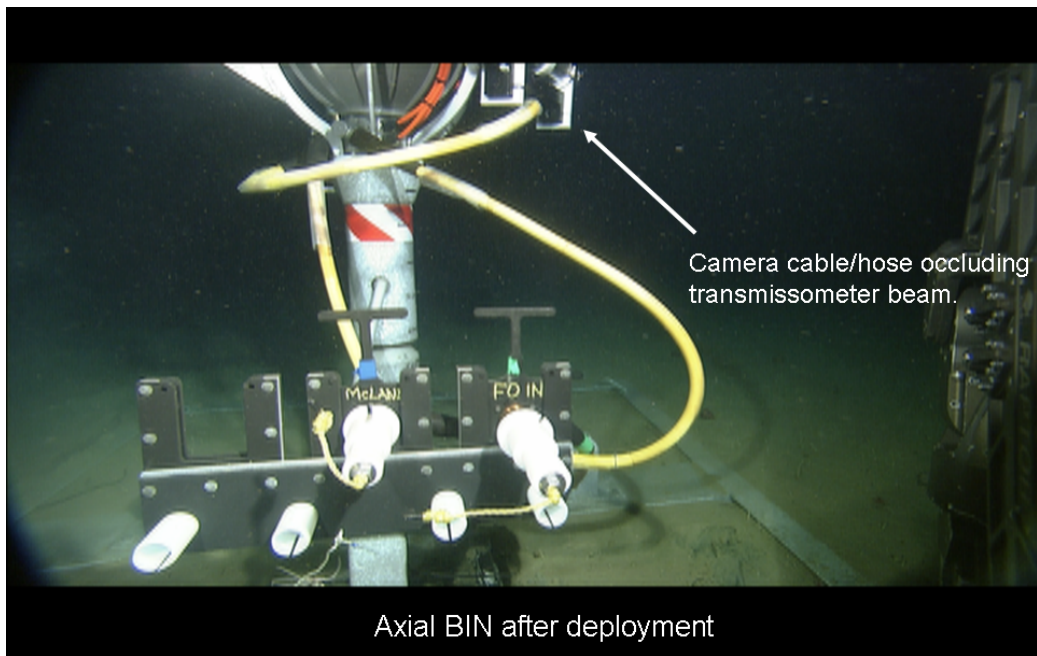
- f. **Hoses occluding optical sensors (Axial transmissometer).** In a on-the-spot decision during the subsea hook-up of the Axial BIN, it was decided to leave the ROVmate cable plug for the future addition of a camera system fastened to the BIN sphere, rather than remove from the sphere and place in the “window pane” cable holder. The rationale for this was that the camera was unlikely to be installed before the BIN was replaced and by leaving the cable in place about a half an hour of ROV time could be saved. Unfortunately it was not anticipated that this allowed the cable to float up and partially occlude the transmissometer beam causing intermittent spikes in the data (see figure 2 below). The corrective action for this is to consciously designate the cable and ROVmate connector locations desired after installation and choreograph the ROV manipulator moves required to achieve this rather than leaving the manipulation of the BIN cables to adhoc decision making during deployment. The use of checklists should be extended to the subsea installation and include a final check that all instrument sensing area are free from interference.

**Figure 2. Image of the Axial BIN after deployment showing the hose interference with the transmissometer.**
