# **MTM4 (MSE) Axis BIN Failure Report**

1.0 16AUG07 – initial draft. Mark Chaffey  
2.1 14AUG08 – added ODI results.

3.0 18AUG08 – early released version.  
3.1 19AUG08 – final released version

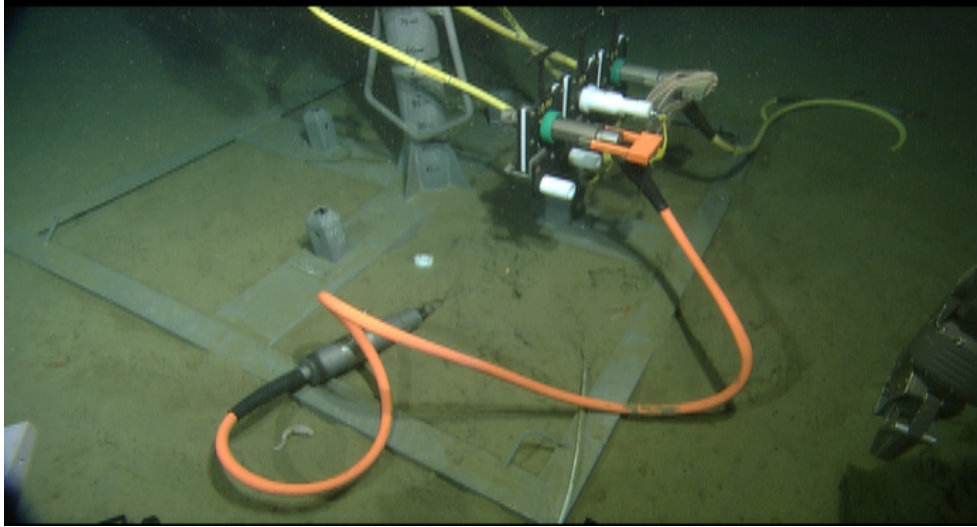
The two FITA’s and connectors in the failed cable segment were returned to ODI for examination. The units were X-rayed and inspected by disassembly. In email on November 19, 2007 Pat DiPersia reported that burn marks and a broken wire in side the FITA pointed to an internal FITA short and failure. This was confirmed in a phone conference between Pat DiPersia (ODI account manager), William Mudge (ODI engineer) and Mark Chaffey on May 19, 2008. The FITA failure was blamed on “the combination of FITA design issues, the benthic cable construction including electrical conductor insulation thinness, the possibility of movement between the strength member and the conductors, and possible assembly workmanship”. The hypothesis is that a pressure

difference between the oil-compensated portion of the FITA and the one atmosphere side caused the electrical conductors to piston into the metal shell and press through their insulation. ODI agreed to replace the failed FITA's with a new design at no cost.

**Figure 2. Photograph of the ODI connector, cable, and Field Installable Termination Assembly (“FITA”) that ultimately failed. The FITA is the cylinder laying in the mud at the end of the orange cable.**

To prevent this type of failure from occurring in the future it is recommended that each subsea assembly such as the benthic cable/connector/FITA assembly be pressure tested prior to deployment, not just to qualify the design but to qualify each individual component.

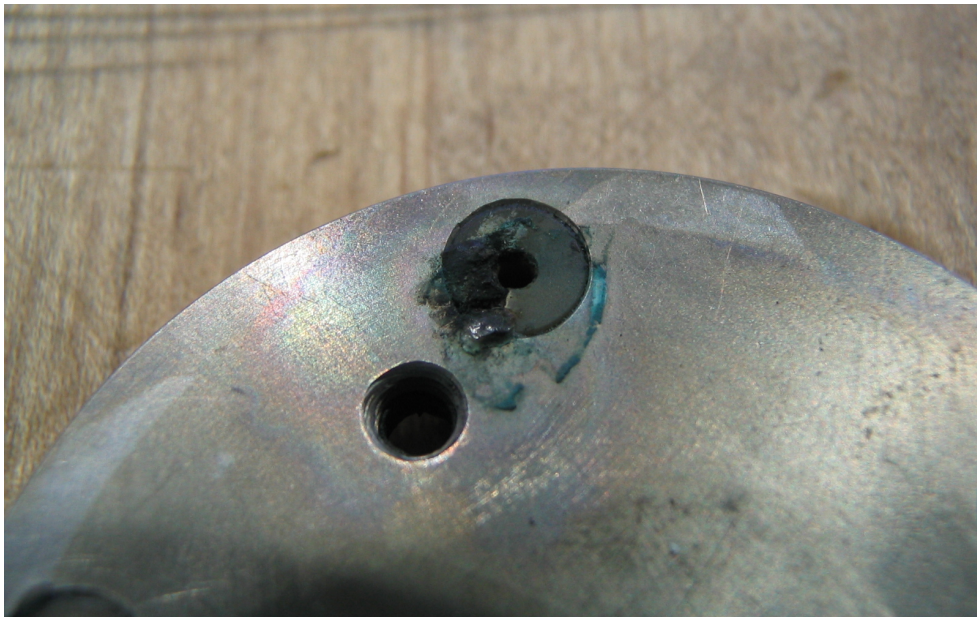
- A) A process of elimination: no other recovered component besides the FITA's showed any evidence of electrical insulation breakdown.
- B) The terminal electrical failure was isolated in-situ to a specific benthic cable, connector and FITA assembly, i.e. the Shelf-to-Axis benthic cable/connector/FITA assembly.
- C) Post-recovery inspection by ODI of the suspect FITA showed signs of electrical breakdown, erosion of insulation and metallic plating that are consistent with electrical leakage from an energized circuit. This electrical leakage damage must have occurred before the cable cutting operation associated with recovery, which was done with the system de-energized.

**Figure 3. Photograph of internal bulkhead in the failed ODI FITA showing evidence of insulation breakdown, erosion and copper plating. This is the evidence that points to the FITA having failed during powered operation, not after being cut from the non-powered cable assembly during recovery (photo from ODI).**

- Specific recommendations from Ocean Design Inc. for changes in the benthic cable design to create a more reliable field splice with their termination design:

- Change the conductor insulation material to cross linked polyethylene
  - Increase the conductor insulation thickness
  - Remove the plastic rods from the middle of the conductors

- Use tin plated copper in the conductors (this is not a dire need but a best practice)
  - Increase the conductor size and lower circuit count if possible

- Increase the thickness of the fiber tube (it is a little flimsy right now and cannot support much loading)
  - Remove the aramid from around the conductors

- Mold the conductors and fiber tube in a solid low density polyethylene (or some other nice cable jacket)
  - Apply the strength member (aramid is good) to the outside of this over molded cable bundle

- Over mold the aramid with the outer layer of polyethylene (or some other cable jacket)

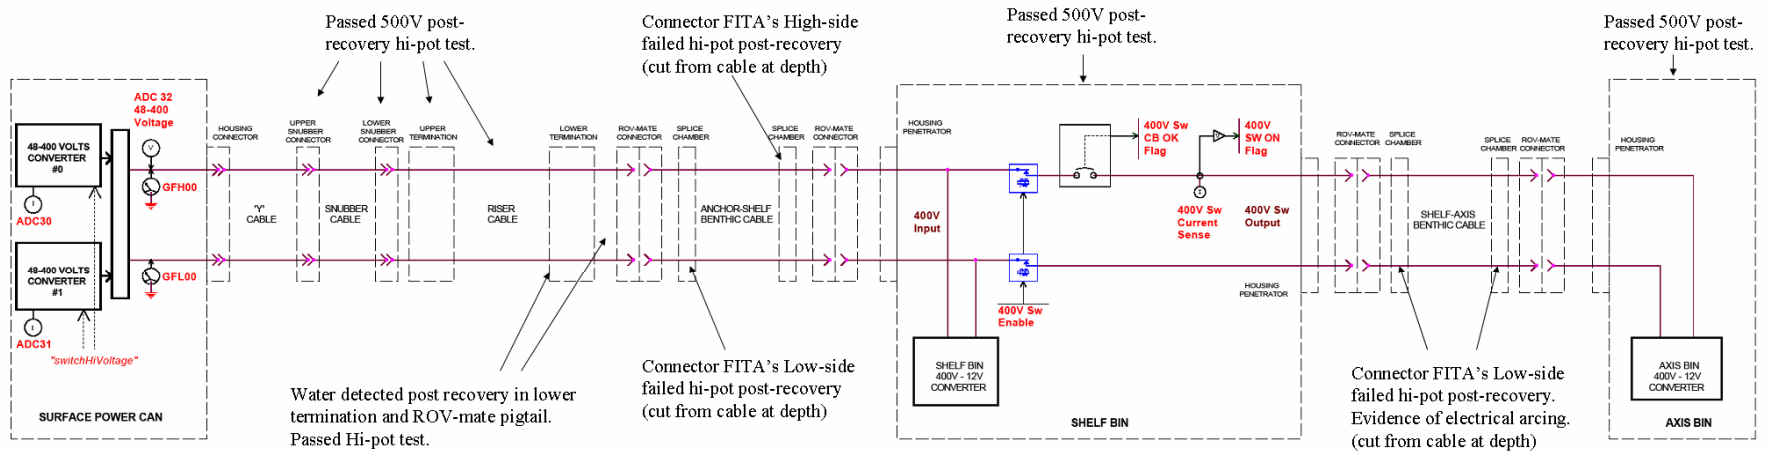
Two line diagram of the MSE experiment power system as it runs from the Surface buoy through the Shelf and Axis BINs. As discussed in the text, all of the system components except the two benthic cable/connector/FITA assemblies passed post-recovery testing. The two failed segments had been compromised during recovery operations by cutting the benthic cable, however there was evidence of electrical bridging and conductor break-down in the Shelf-to-Axis segment that probably occurred while the system was still powered up and before total failure (see appendix B).

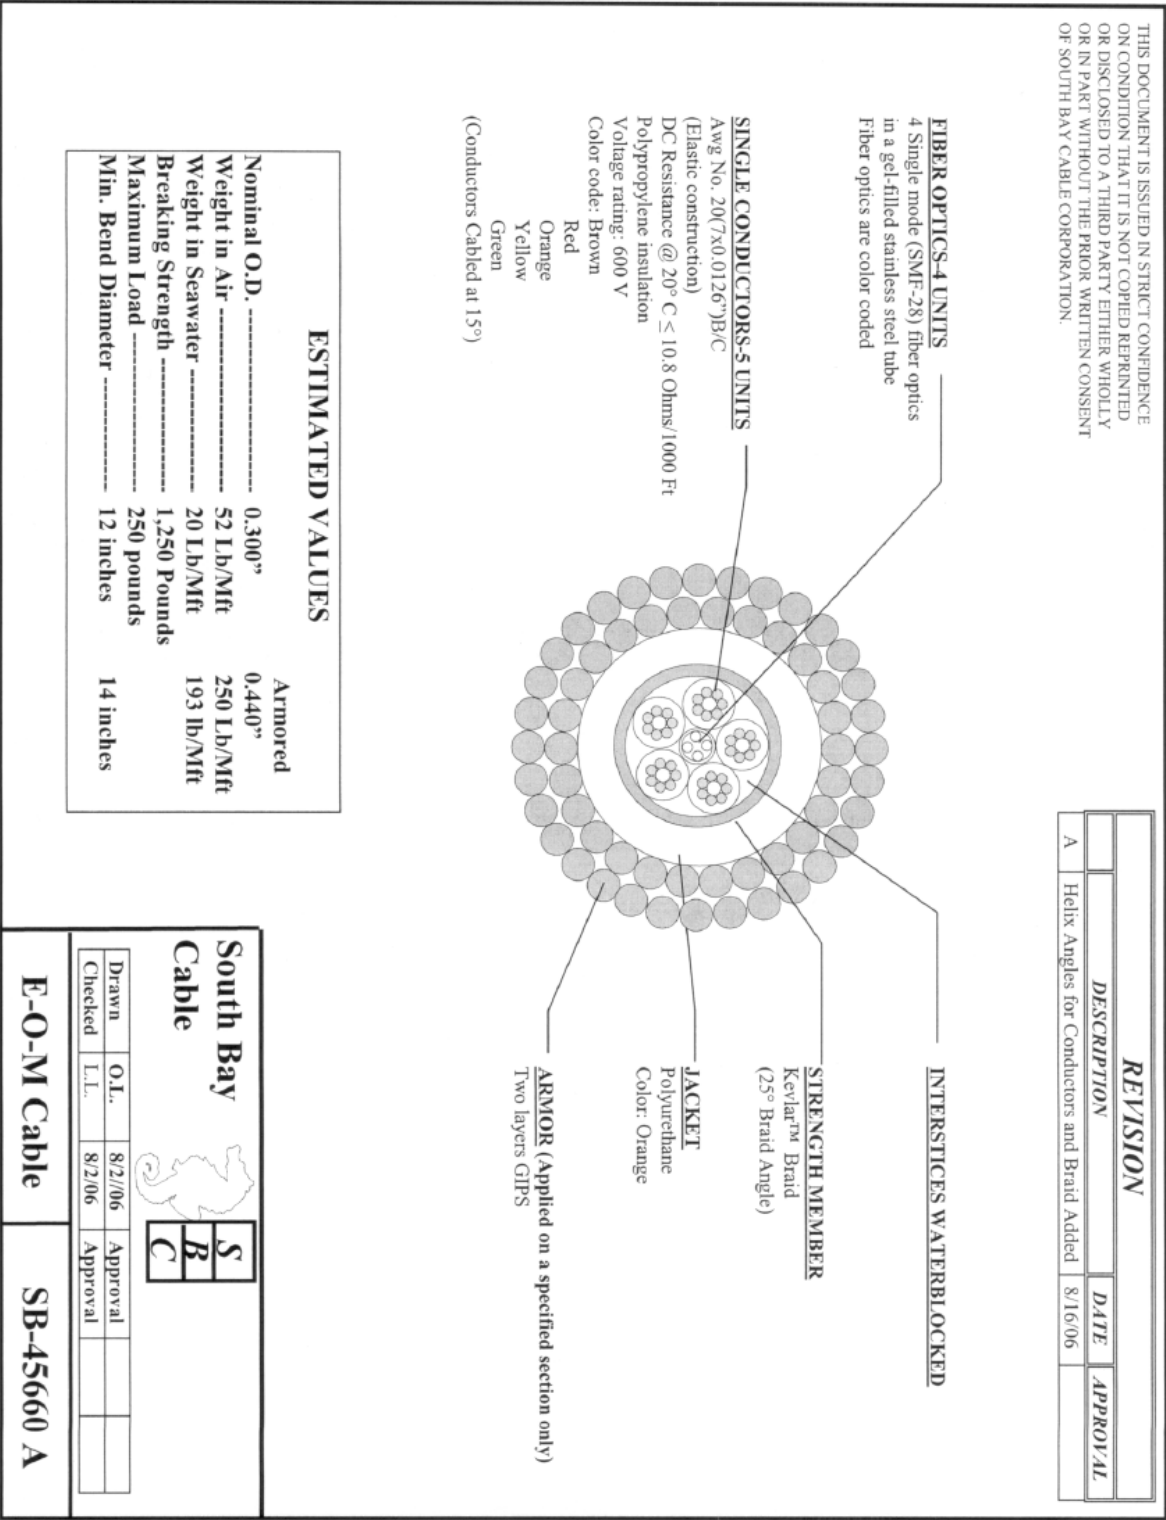
Figure 5. Improved cable design used for Shelf-to-Axial cable run (armor section). This cable had better torque performance at MSE depths then the previous design which tended to form numerous loops during cable laying operations. It is the cable design that was used on the failed segment.
