## MTM2 Breakaway and Redeployment Report

Rev. 1.0 14JAN05 mrc

1. The purpose of this document is to capture the cause and effect of the MTM2 breakaway on the night of January 10, 2005 and the lessons learned during the subsequent towing and redeployment of the mooring January 12.
2. The time of the breakaway (PST) as shown in SSDS records (note: SIAM clock was 34 minutes fast at time of redeployment):

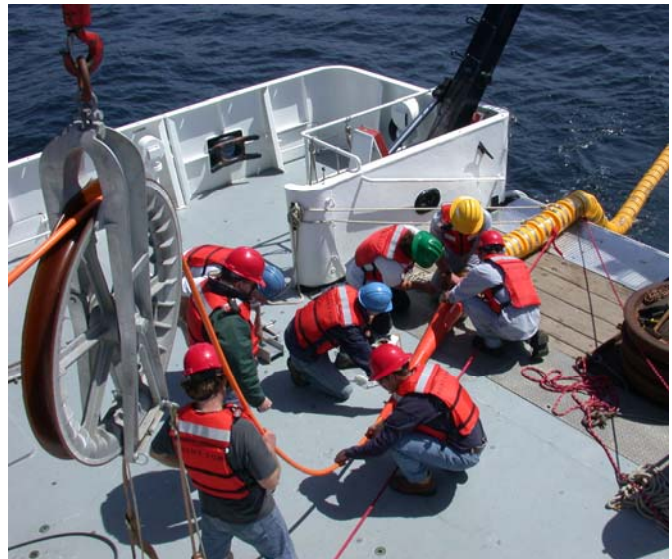
**Figure 1. Illustration from deployment showing large radius snatch block.**

2) The large diameter sheave is an accident waiting to happen. The cable jumps the sheave and then bends extremely tightly over the edge (1" bend radius). This happened several times yesterday, more than once leaving a visible kink in the cable. Not sure of the effects on the cable strength.

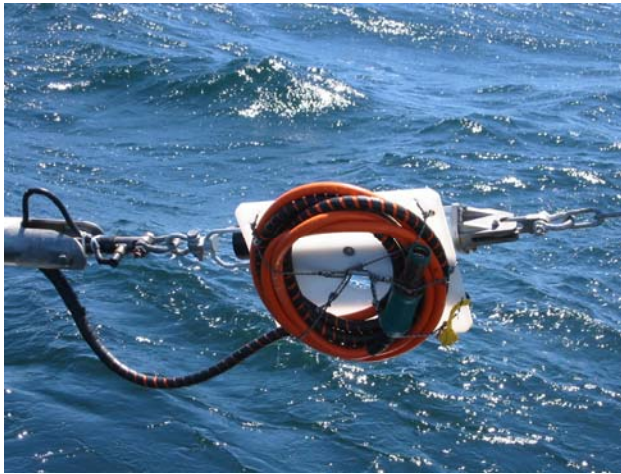
5. When the end of the riser cable was reached it was noted that the release had broken at the load cage around the acoustic transducer. Evidence suggests that at some point in the deployment the release may have become caught on or under the anchors causing a large side load on the cage. On at least one ROV dive the release was seen to be trapped under the edge of the anchor. The galvanized shackles and pins connection the load cell to the release had extensive corrosion although the cotter pins were still in place. See Figs. 2 and 3.

**Figure 2. Lower termination and release at the time of deployment.**

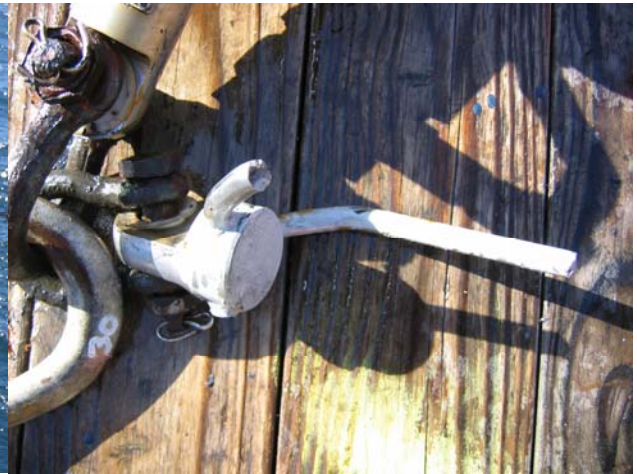
**Figure 3. Load cell to release connection showing release cage failure.**

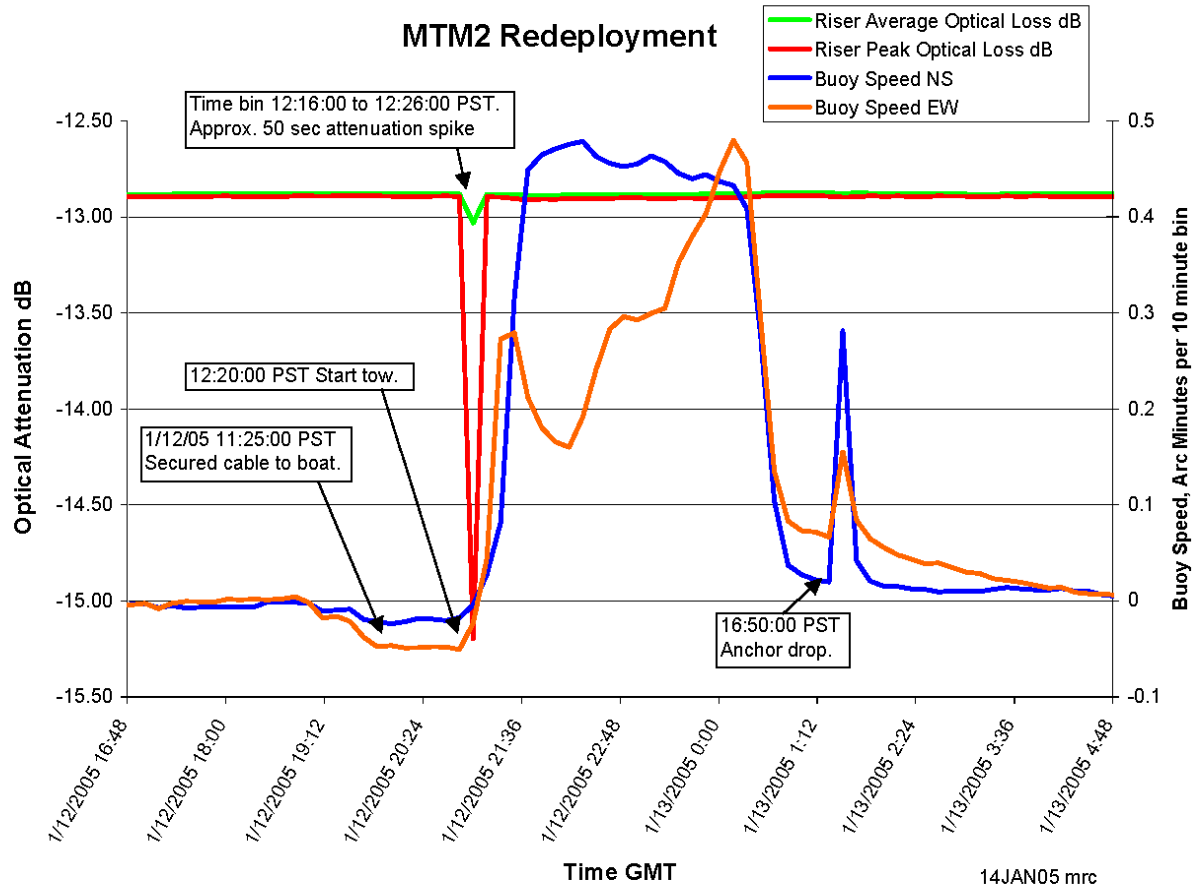
8. During the redeployment an optical attenuation “spike” lasting approximately 50 seconds was noted in the riser cable of approximately 3dB. This spike occurred at the same time as the Pt. Lobos began to make way towing the buoy, as shown in fig, 4. What caused this spike? The nature of the optical fibers in the JDR riser cable is such that one would expect that a sharp increase in attenuation could not occur without seriously damaging the cable. The optical fibers are protected in a Laser Armor Tech stainless steel tube about the size of a hypodermic needle. For the tube to impinge on the optical fibers it must either collapse or buckle. One would expect that this type of damage would cause

permanent changes in attenuation although we have a previous experience where the laser Armor Tech tube actually broke but two of the four fibers inside showed little attenuation increase. In addition to optical damage one can expect that handling the cable severely enough to cause fiber attenuation would most likely also cause some damage the cable strength members.

**Figure 4. Redeployment optical attenuation and buoy speed.**

10. Could the optical attenuation spike observed during the beginning of the redeployment buoy tow have been caused by the snubber kinking at the base of the buoy as the riser cable came up tight? This is a possible cause, although no subsequent spikes were noted

during the tow. Two lessons can draw from this: 1. Perhaps the snubber construction should have additional reinforcement at the flange end bolted to the base of the buoy. This short section most likely sees the most severe repetitive bending of the entire assembly. 2. Towing the buoy in such a way as to cause a large heeling angle when the snubber is tending straight down is probably not the best method as it may be causing a kink in the snubber hose under the buoy in some conditions. If this was not the cause of the attenuation spike and instead the riser cable itself was the cause then the riser cable is likely to be permanently damaged.

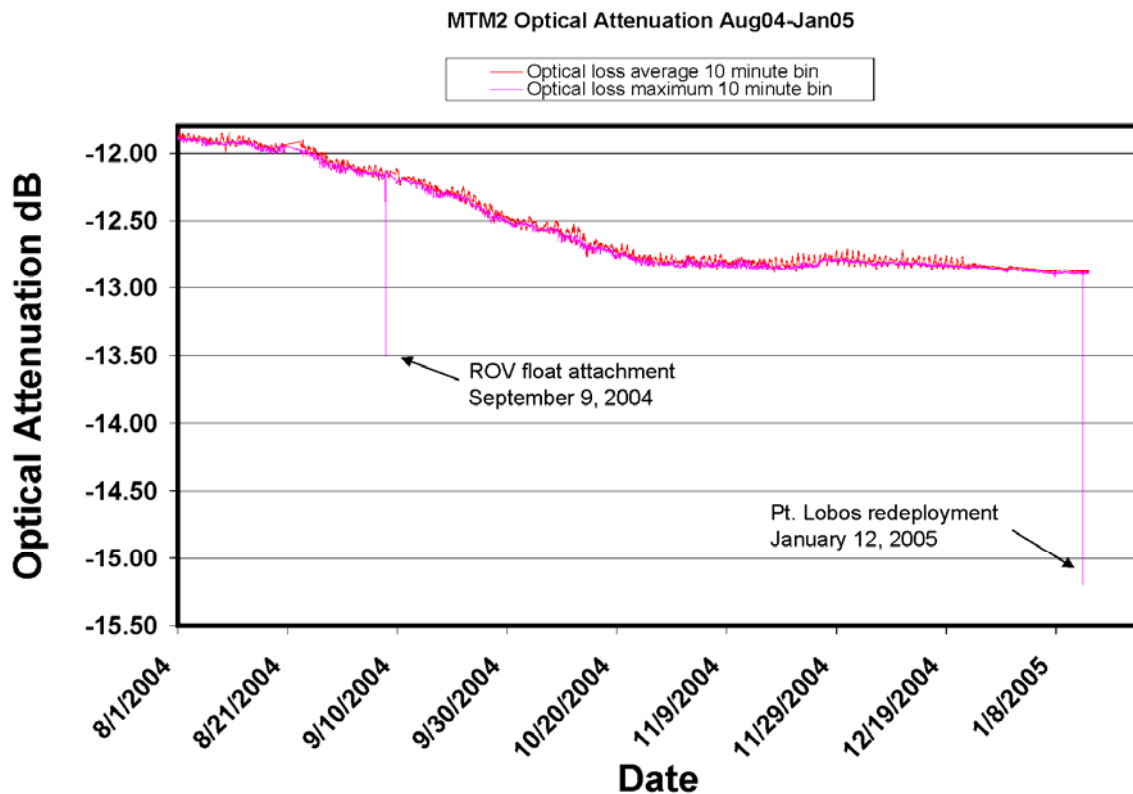
- The entire record of optical attenuation has been examined since deployment, and interestingly, one additional 1.5dB attenuation spike was noted on September 7, 2004, as shown in fig. 5. Examination of the record show that this happens to correspond to the day the Pt. Lobos/Ventana attached additional floatation elements to the base of the riser. The Zephyr was employed to clear the surface buoy from the dive area over the anchor site. In order to move the buoy a towline was attached to the top of the buoy tower and the buoy slowly towed. The pull of the line tension so high on the buoy caused it to cant over about 45 degrees, see figs. 6 and 7. One can speculate that with the static load of 1200 lbs. pulling down on the snubber and the buoy being pulled over sideways, at one point the snubber may have briefly kinked, causing a tight bend radius in the internal

coilcord and subsequent optical attenuation spike. This effect on the optics could be non-catastrophic and could correct itself when the kink was removed.

Figure 5. Optical attenuation since August 2004.

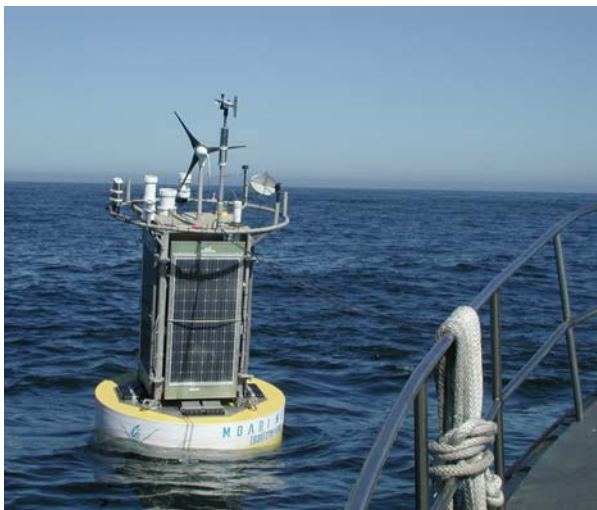
Figure 6. Towline attached to tower ring.

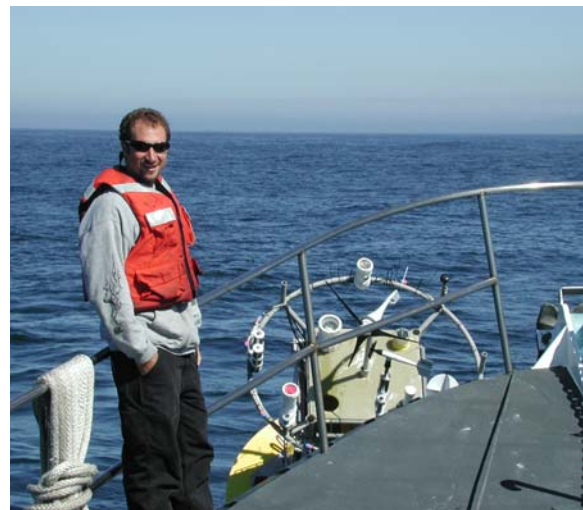
Figure 7. Buoy heel when towing.
