## Field Service Bulletin      FSB-132

### Pressure Sensor Insert

Date: December 7, 2000

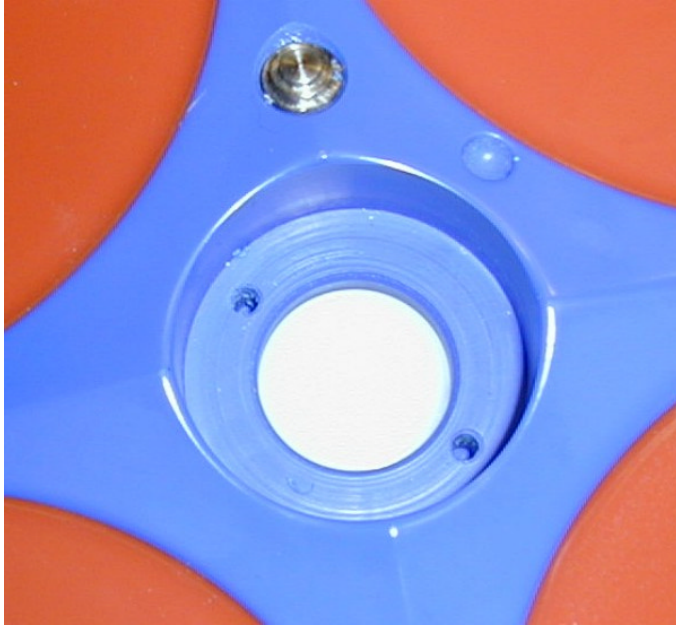
**Figure 3. View of Pressure Sensor/Insert Plug with Cover Plate Removed**

- d. Wipe the area under the cover disk with alcohol (best) or water. Look very carefully for any signs of a seam indicating that an insert was used. There may only be a slight difference in color between the transducer head and the insert. If available, use a strong light source and magnification.

- e. If the insert is on your ADCP, return the ADCP to RDI for a free warranty replacement. If you are not sure if the insert is installed, return the ADCP to RDI for a free inspection. If necessary, the ADCP will be replaced under warranty.

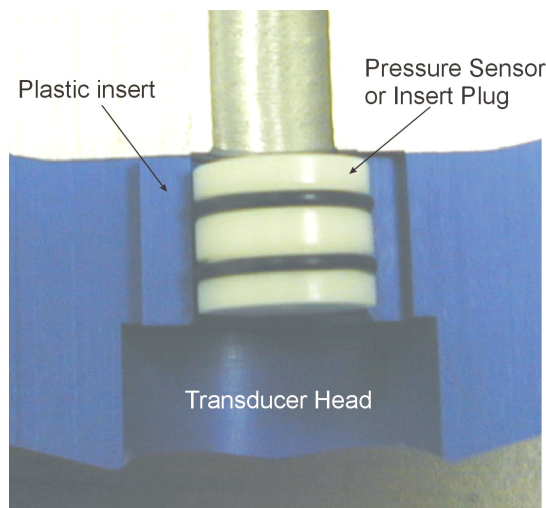
**Figure 5. Cutaway side view of insert**

Ten systems delivered between July 15, 2000 and October 31, 2000 have this potentially defective plastic insert ring assembly. The plastic insert bond may fail, causing the ADCP to leak.
