# **DAT installed in Daphne (tests at MBARI)**

Jan/Feb 2013

M. J. Stanway, B. Kieft, B. Hobson

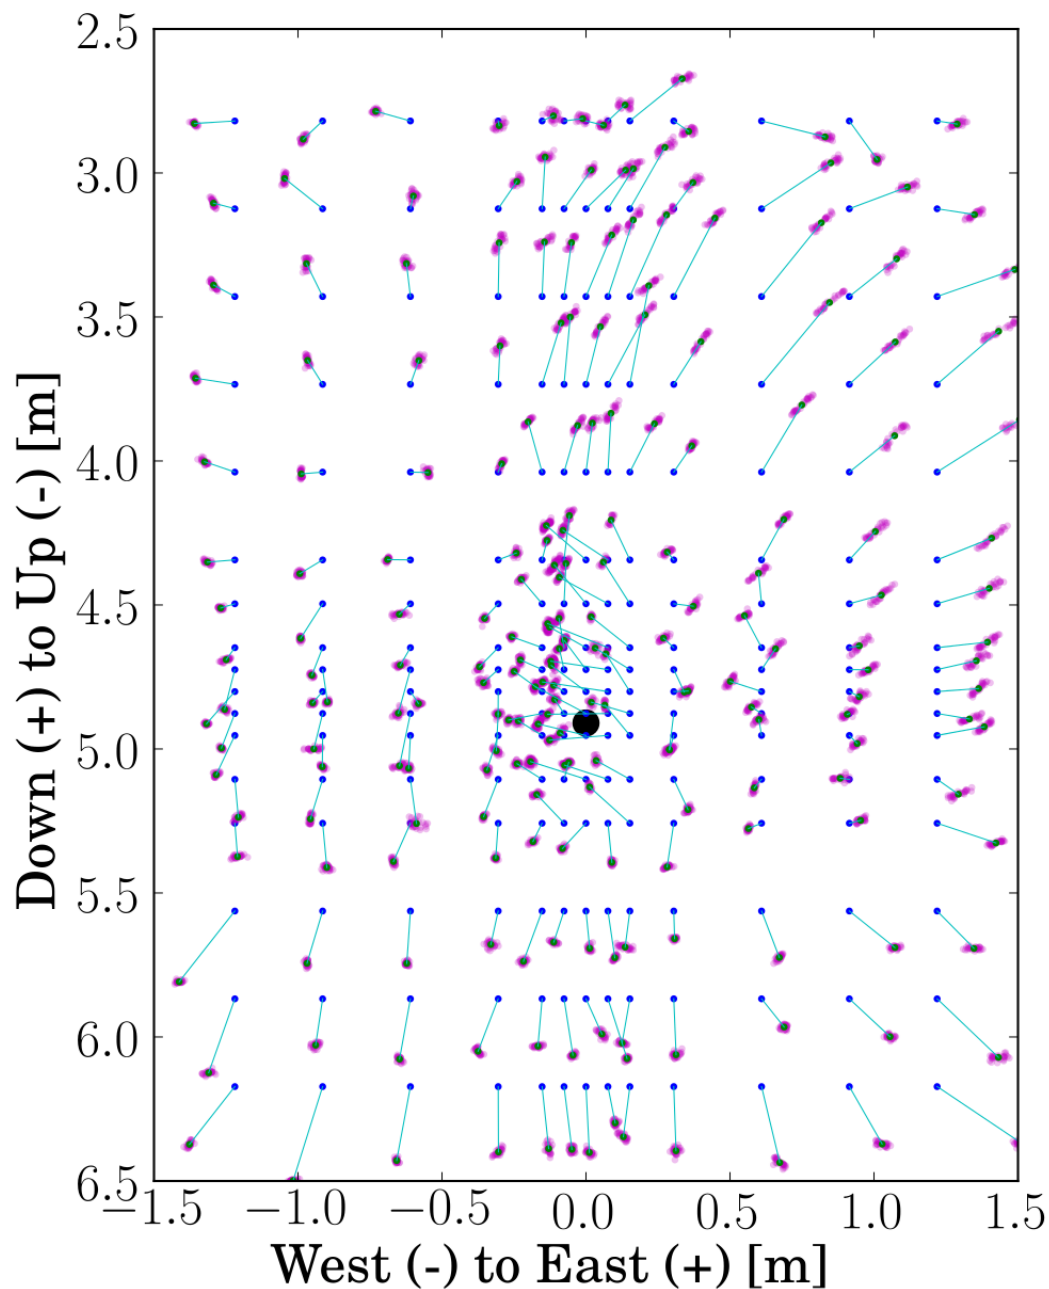
*uncalibrated* intersections

- **[OK]** There are many areas where the *uncalibrated* direction calculated from the phase measurement is off by *several* degrees.
  - **[BAD]** These can't be corrected by a simple linear transform.
  - **[GOOD]** It looks like these might be correctable using a lookup table or another general approach. (Benthos usually uses a lookup table.)
- **[UGLY]** There is an intermittent problem with saturated hydrophones, which significantly degrades performance, and we're not sure what the root cause of that was.
  - **[GOOD]** We can partially mitigate this problem by setting the AGC manually.
  - **[GOOD]** We can identify symptoms of saturated hydrophones, by eye or automated, using the LVL debug output values.
  - **[GOOD]** This isn't a fundamental problem with the Benthos DAT system, but more likely an intermittent cable failure or something else we can eventually isolate and solve.

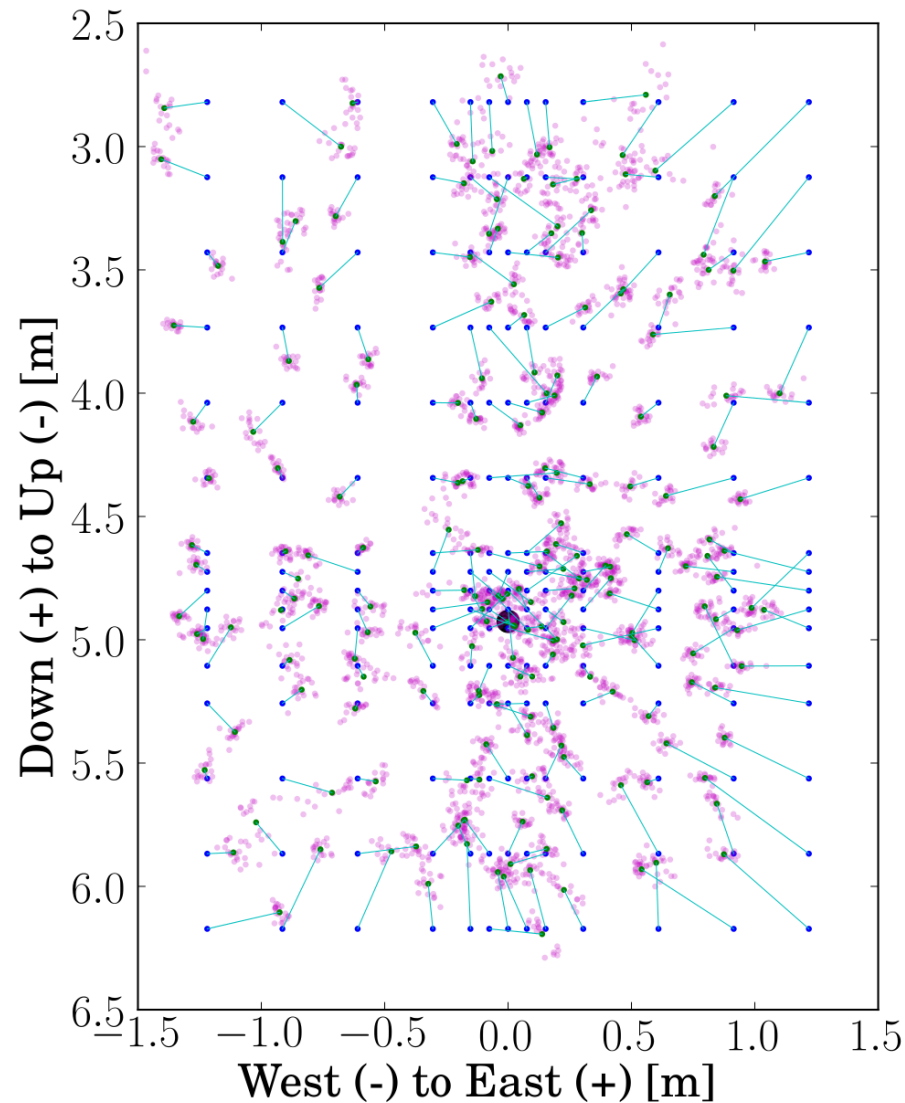
# Details: signal saturation on multiple hydrophones -- possible intermittent issue with cabling?

# Peak wave levels examined for clipping and problem with 3 of 4 hydrophones is discovered

Levels on the first 3 hydrophones are railed while the 4th is at the expected value:

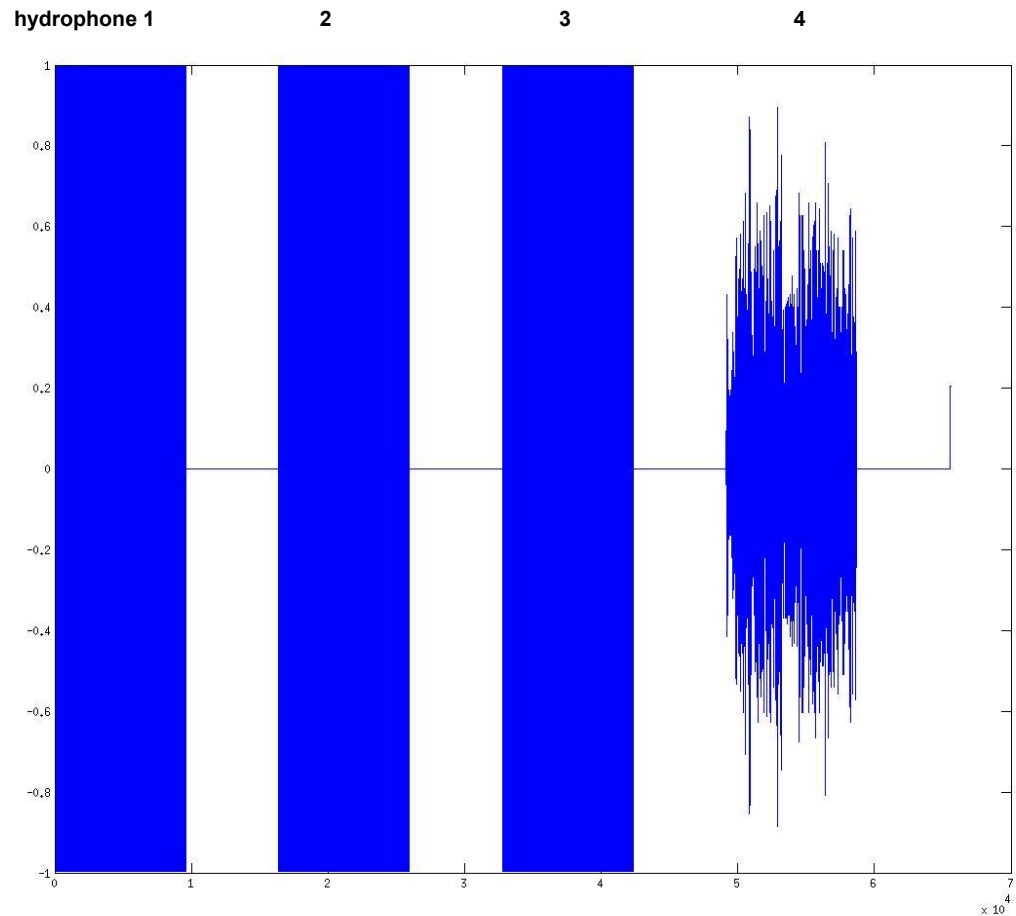
# Waveform sample was taken and visualized

**this has a characteristic signature in the debug output of the DAT, using the LVL variable**

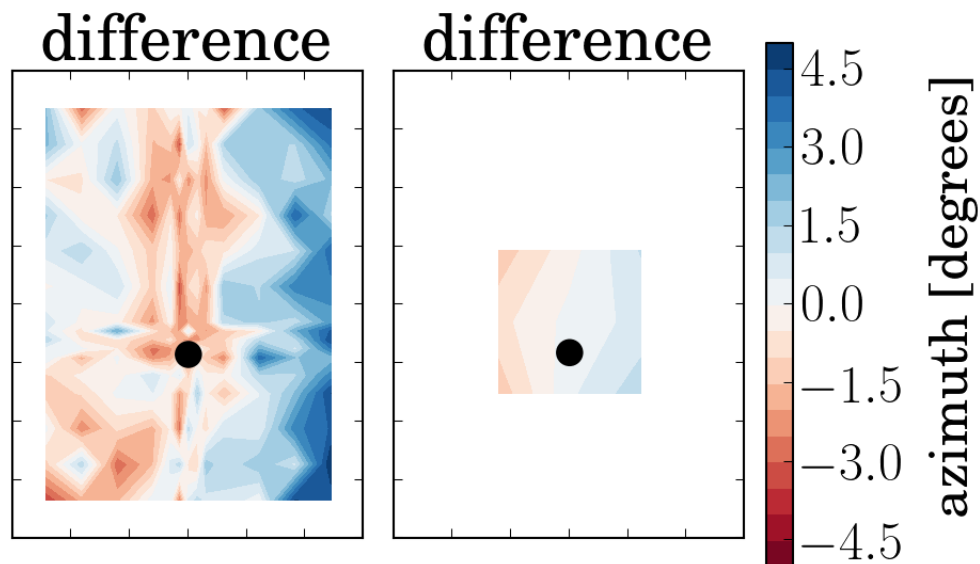
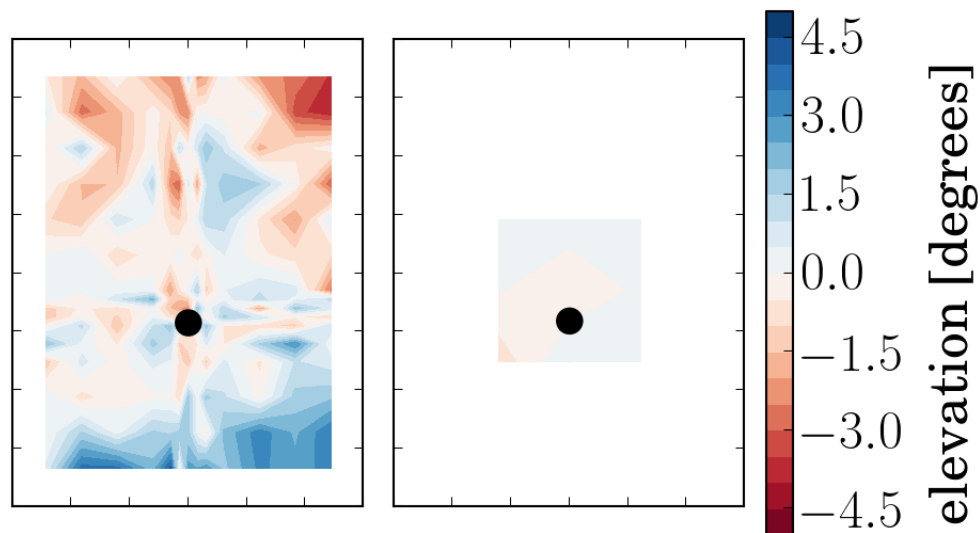
**even without sampling densely enough to resolve the same levels of variation, the magnitude of errors is lower using the bench power and boardset with the assumed wiring change**
