# MARS Cable System Repair

## Final Report

### Fall 2008

Document N<sup>o</sup>: F0113-15001-00

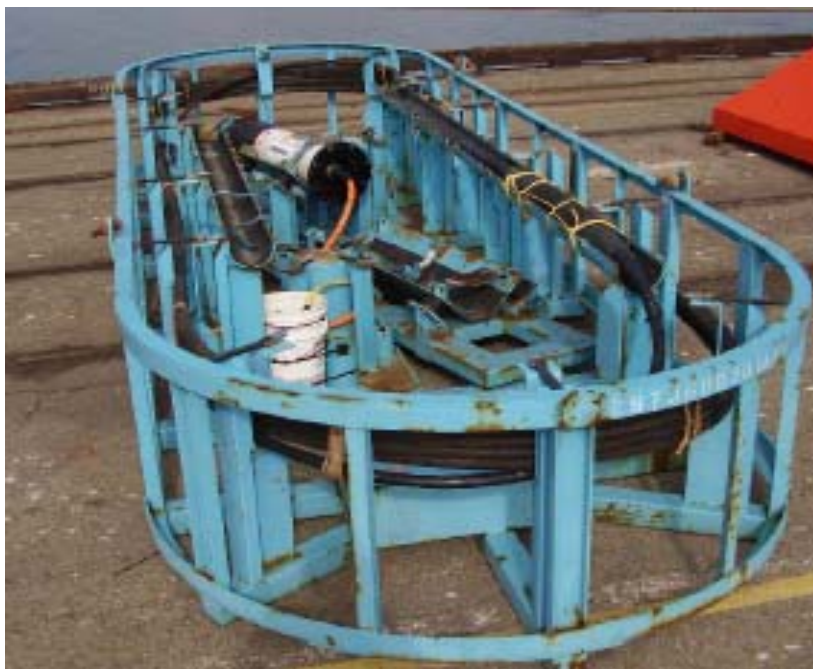
Fig. 1 – CTA, Tail & Transportation Box

The new cable termination assembly (CTA) is shown in figure 1.

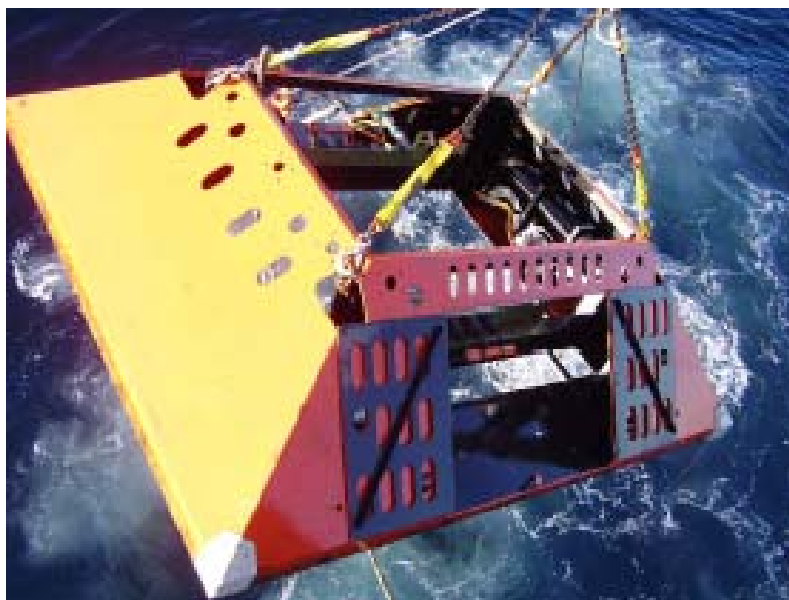
Fig. 3 – TRF Being Inboarded

The TRF was found to be undamaged, the cable leading to the beach was satisfactorily tested both optically and electrically and operations were commenced on the CTA replacement. The client requested an additional 1000 m of cable be recovered to determine its condition as a result of the TRF fall. This, as explained to the client, would result in detrenching previously plough buried cable with subsequent reburial via ROV. However it was felt by the client to be worth the effort.

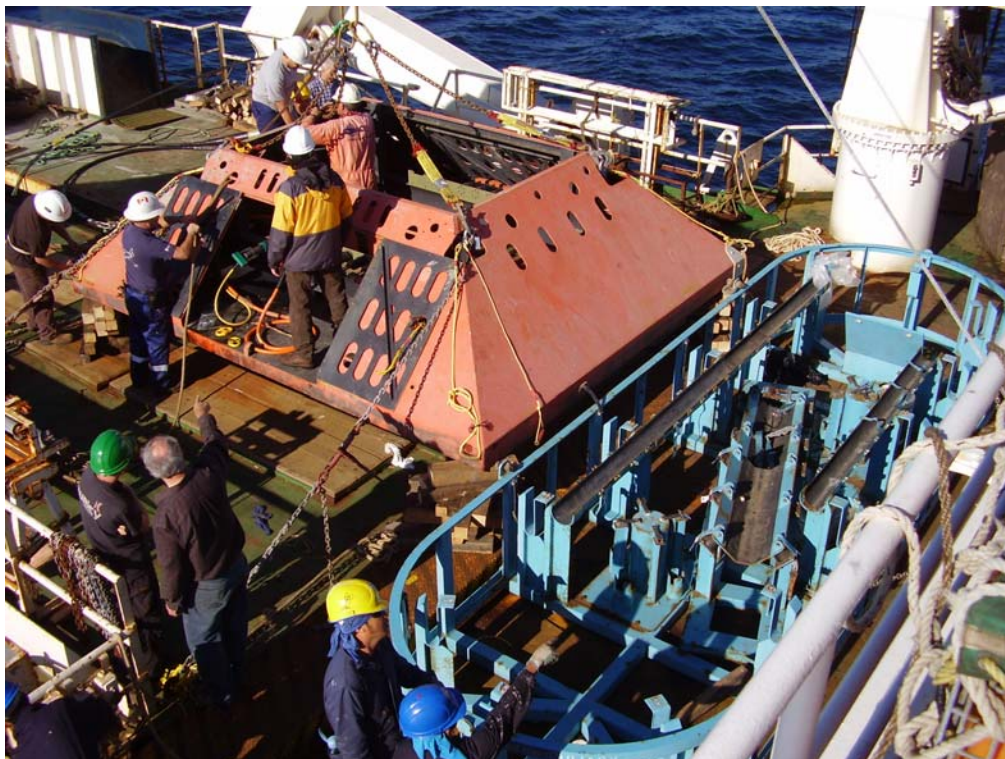
Fig. 4 - On-deck remedial operations

The recovered 1000 m of cable was found to be in acceptable condition with only some minor jute damage that appeared to be resulting from original plough burial. This was subsequently repaired. The splice operations were completed and the TRF readied for redeployment.

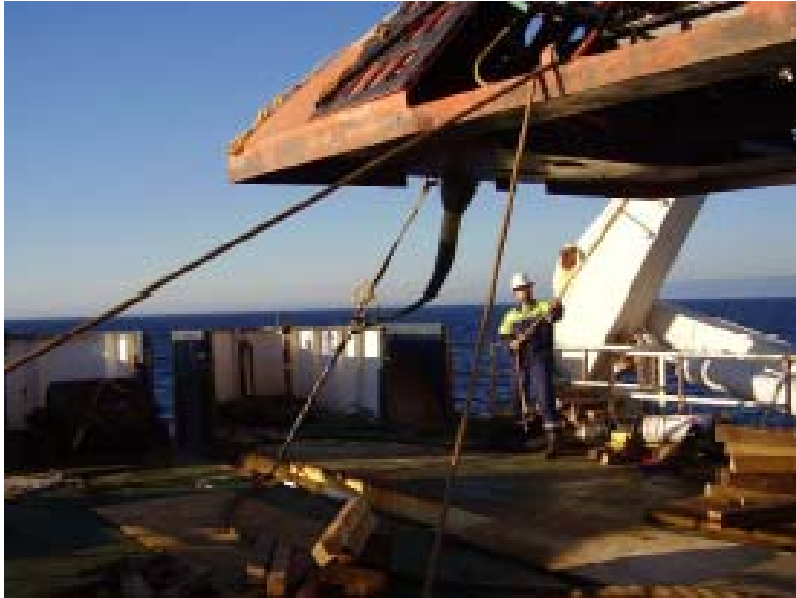
Fig. 5 – TRF being Outboarded

Redeployment was completed without incident and the TRF was replaced on the seabed within several meters of its original location.
