| MARS Problem Report | |
| <b>Subsystem:</b> DCS | <b>Module/CCA:</b> Cisco 3750 |
| <b>Description of the problem:</b> Damage to node-side Cisco 3750s. | |

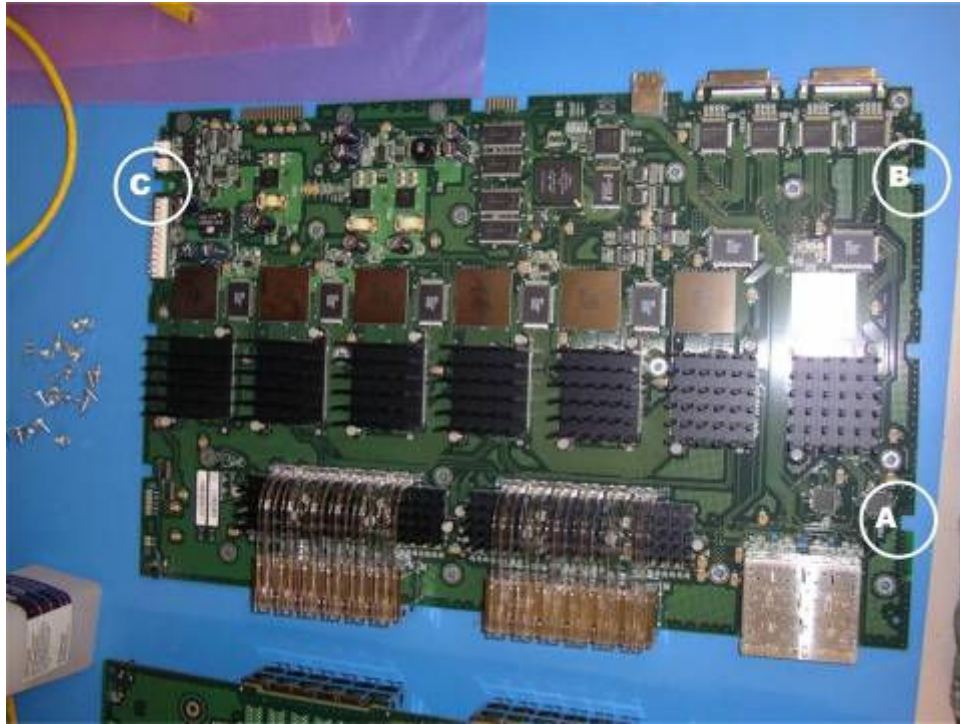
## Cisco 1

| MARS Problem Report | |
|---|---|
| Mounting screws used on one (or both?) of the node-side Cisco 3750 routers were too long – screws contacted and damaged edges of router mainboards. | |

| MARS Problem Report | |
|---|---|
| Affected routers moved to "engineering test" status, suitable for Fluorinert testing. Stabilized damage with RTV. | |

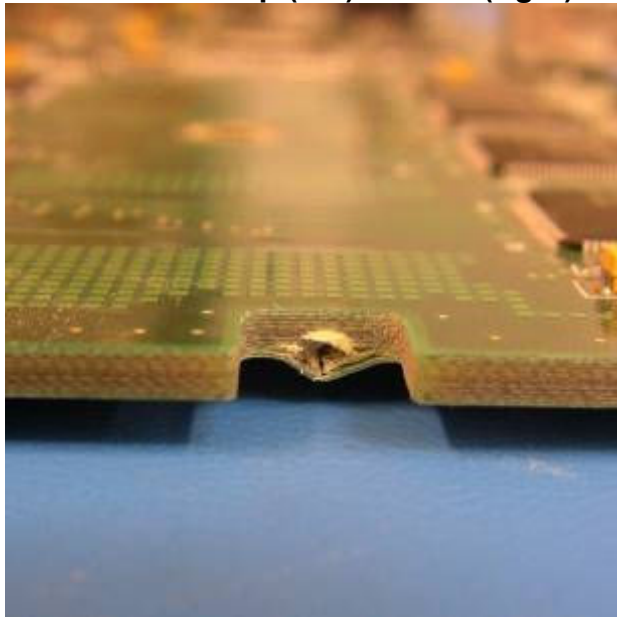
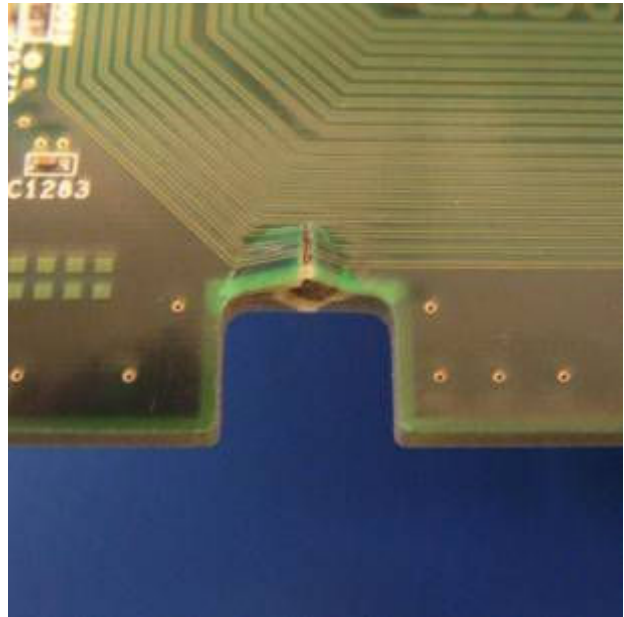
**Cisco 2 Site B top (left) bottom (right)**

| MARS Problem Report | |
|---|---|
| <p>Powered both Ciscos from stock AC power supplies (routers not yet configured for 12V operation. Both powered successfully. Routers appear to be properly configured for node-side operation as a stack with "Cisco 1" is the preferred master.</p> <p>Stack port 2 on Cisco 2 is non-functional (note damage in picture for Cisco 2 Site B, bottom).</p> <p>See attached photos</p> | |
