# Intel® StrongARM\* SA-1110 Microprocessor

Specification Update

*December 2001*

Order Number: 278259-023

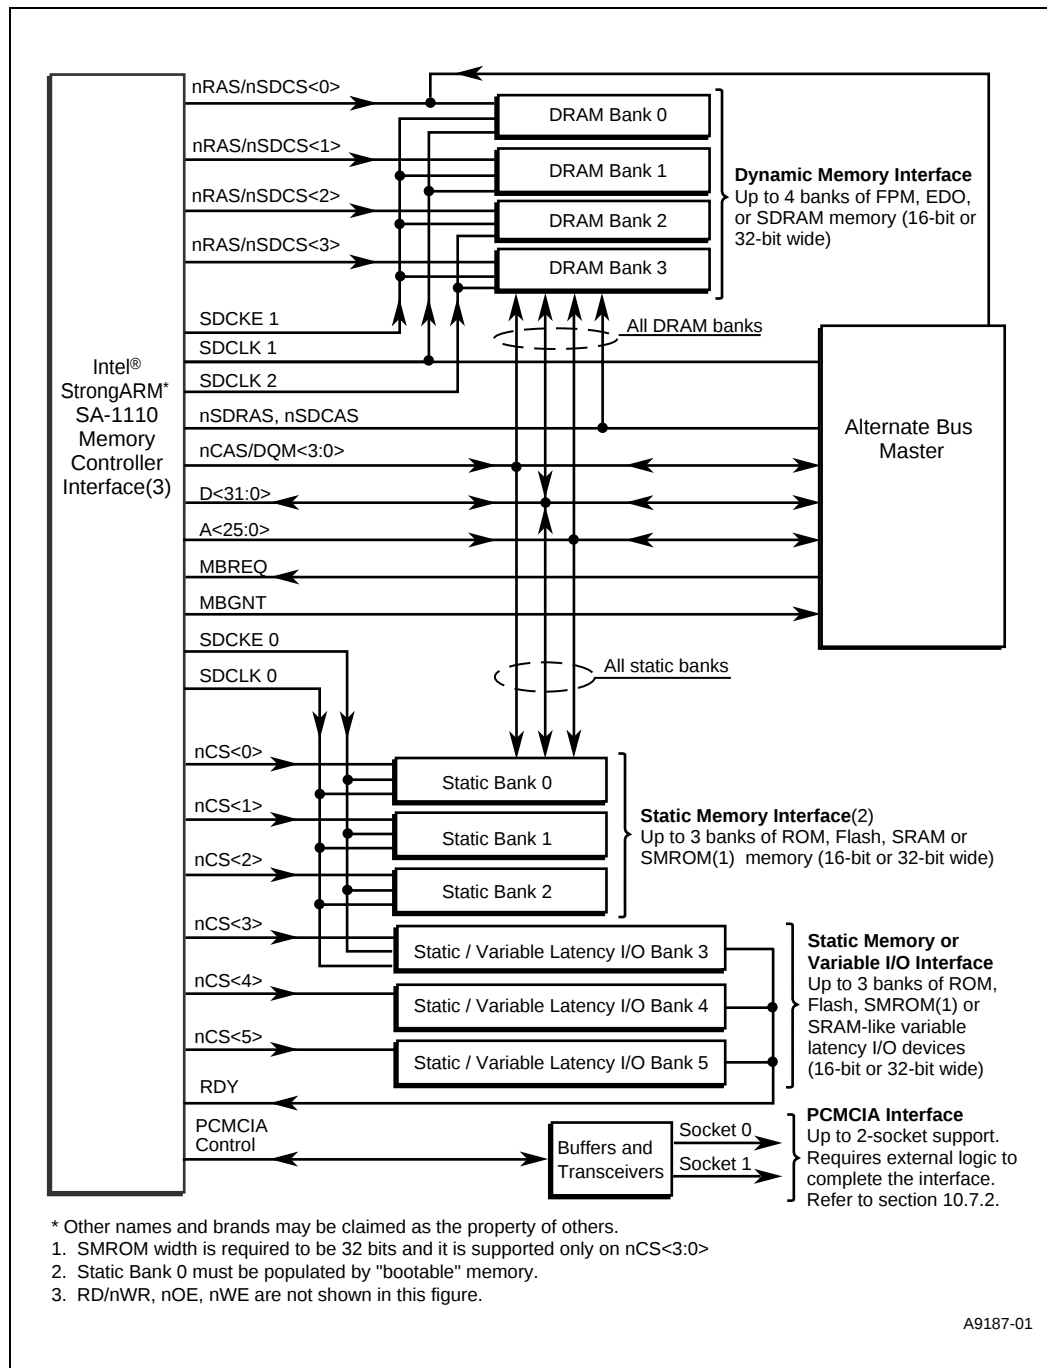
**Figure 10-1. General Memory Interface Configuration**

Changed Figure 10-1:
