## Active T89C51CC01 Errata List

80C51 MCUs

T89C51CC01UA  
T89C51CC01CA

Errata Sheet

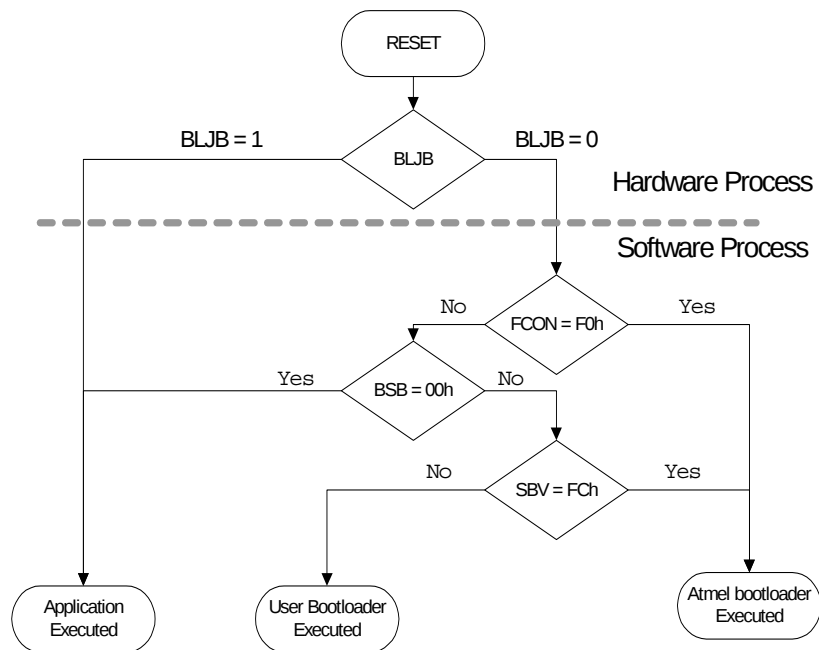
Version 1.2:

## 4. Boot Process Compatibility

There are some differences between Boot process of bootloader 1.2 and newer versions.

## Workaround

Use the fuse bit BLJB to start the application on both versions.
