**Works Order 8695**

**Bend Fatigue Test Report.**

**MBARI Umbilical.**

**Customer: SMD Hydrovision**

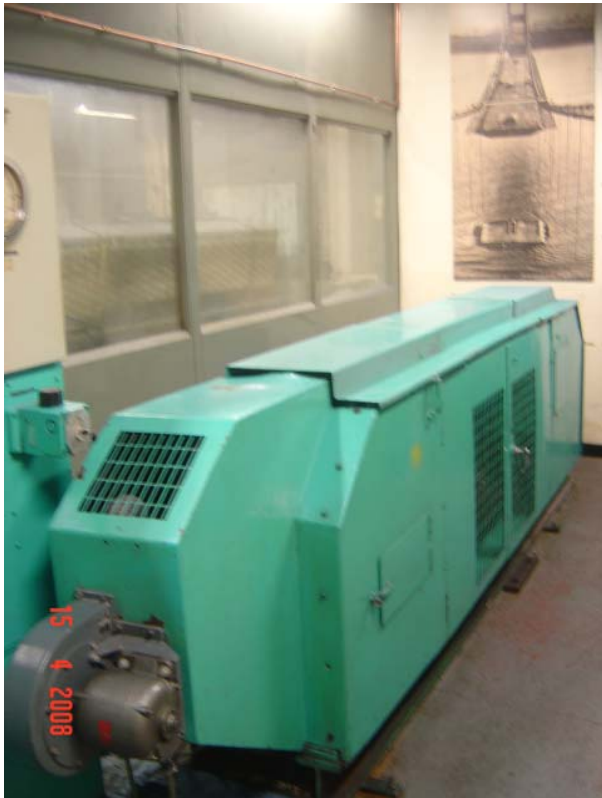
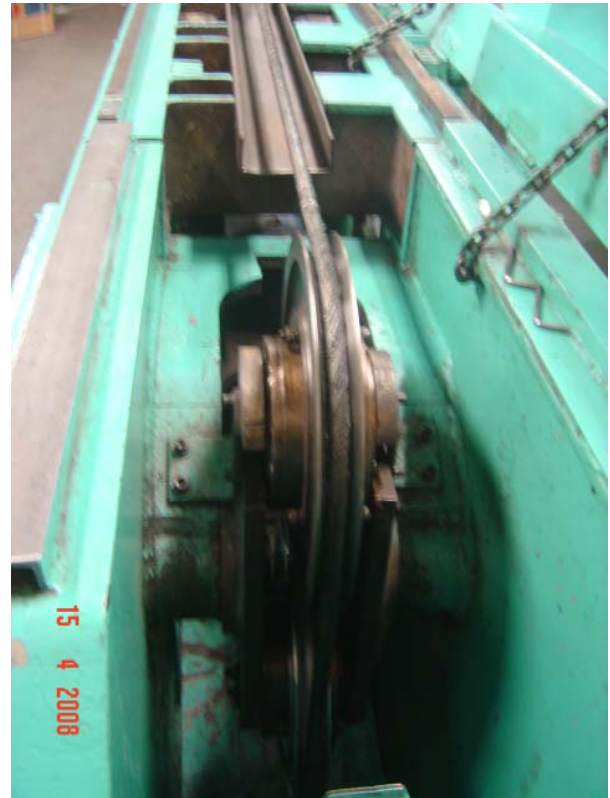
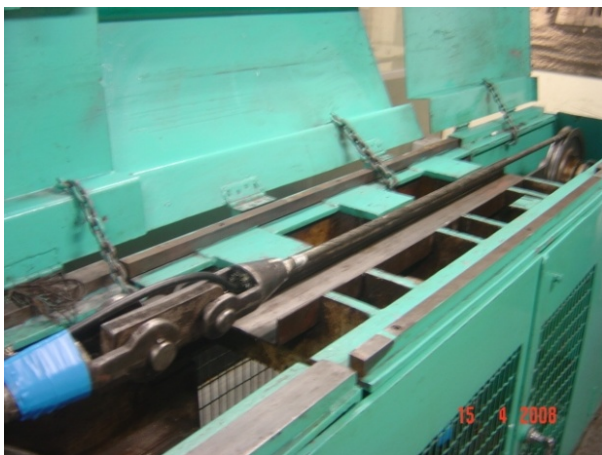
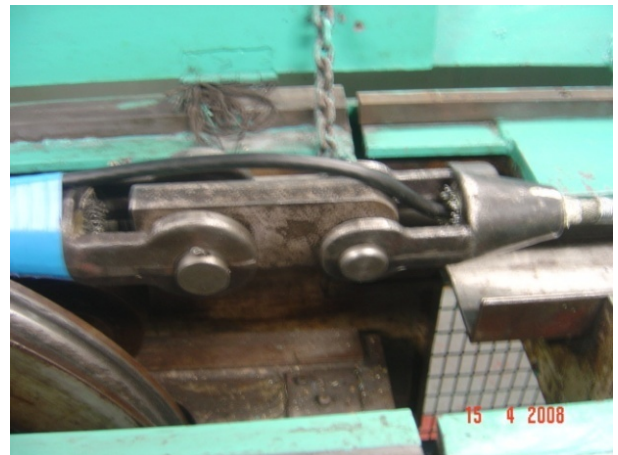
Some photographs of the test rig with the umbilical install into it are shown below:

The sheave wheel had a pitch circle diameter of 347.3mm and a root diameter of 330mm which was less than the diameter of the Global Marine sheave wheel which had a 450mm root diameter. Thus, in theory, the Bridon test should have been more onerous.

The groove in the sheave was  $17.3 + 7.5\%$  (18.6mm).

A load of 60kN (6.1T) was applied and it was cycled at approximately 9 cycles per min.

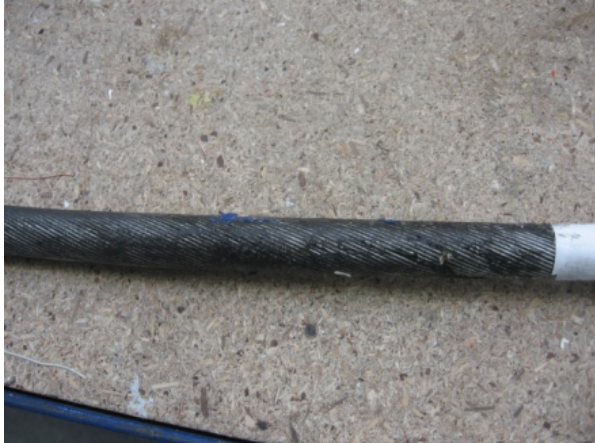
| | <p>Sample of the umbilical at the transition section that had been on and off sheave wheel (i.e. cycled) and that which had not.</p> |

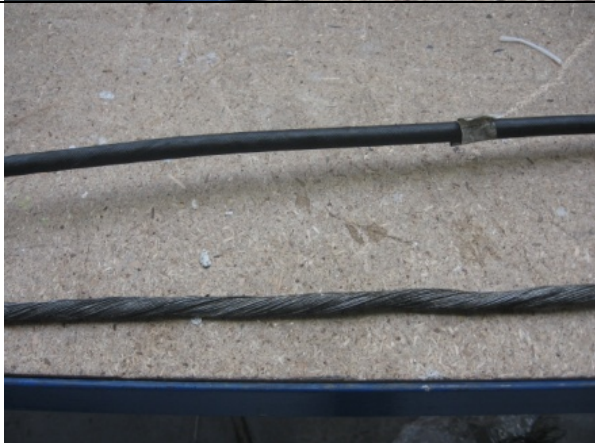
| | <p>Section of the umbilical with the armour removed.</p> |

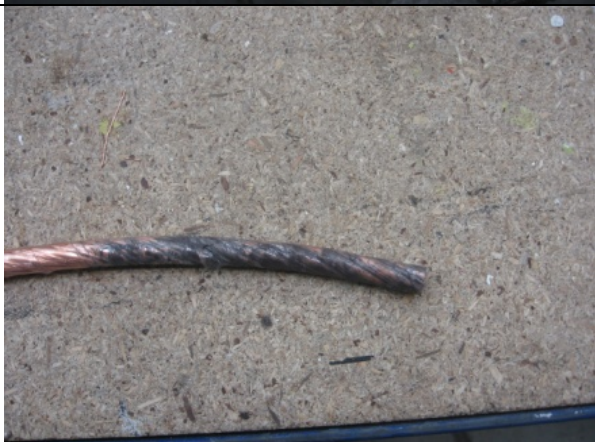
| | <p>Section of the umbilical with outer jacket removed. Discoloured portion is the area that had seen bending.</p> |

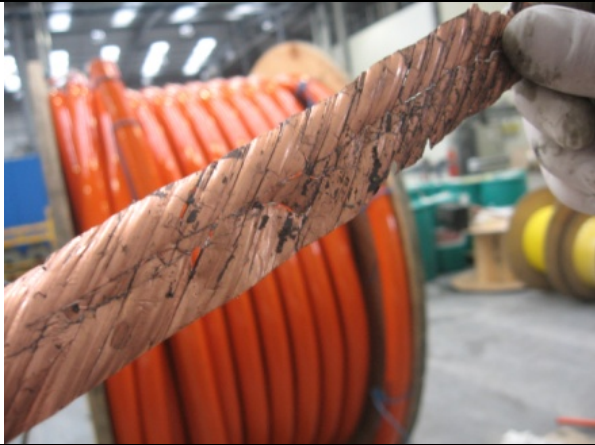
| | <p>Copper polyester tape removed from the umbilical. Signs of the tape cracking. This is typical on a cable that has undergone 5000 cycles.</p> |

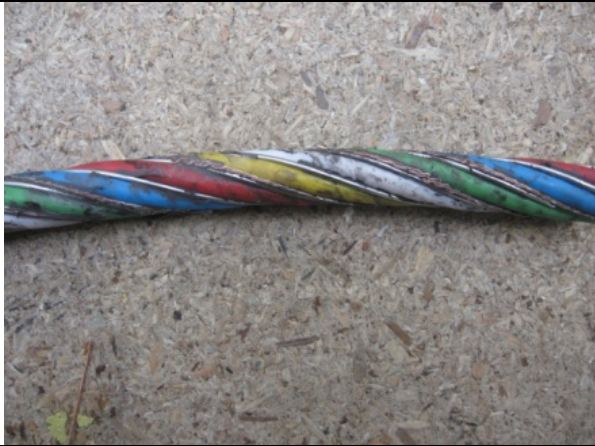
| | <p>View of the assembly. Shows the assembly in good order with no evidence of mechanical damage to the component parts.</p> |

Although there was clear evidence that the cable had undergone a 5000 cycle test there were no visual signs of any degradation to the component parts.

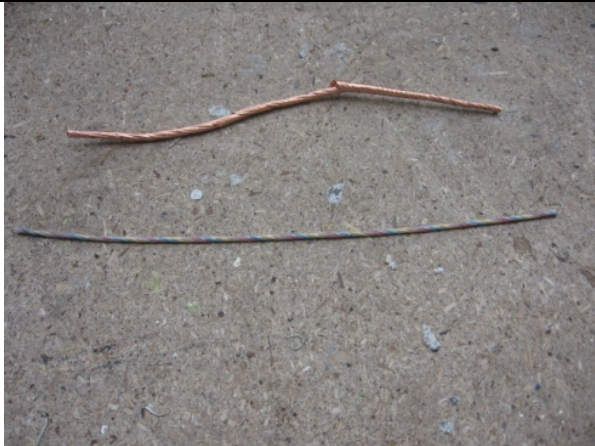
| | <p>View of the central quad. Again in good order with no signs of damage to the component parts</p> |
