## Inspection report

Program Number: 901006

BEDS Benthic Even Detector

BEDS#3 (10020895-AS1 SN003 12/2013, 10020895-AS2 SN003 11/26/2013)

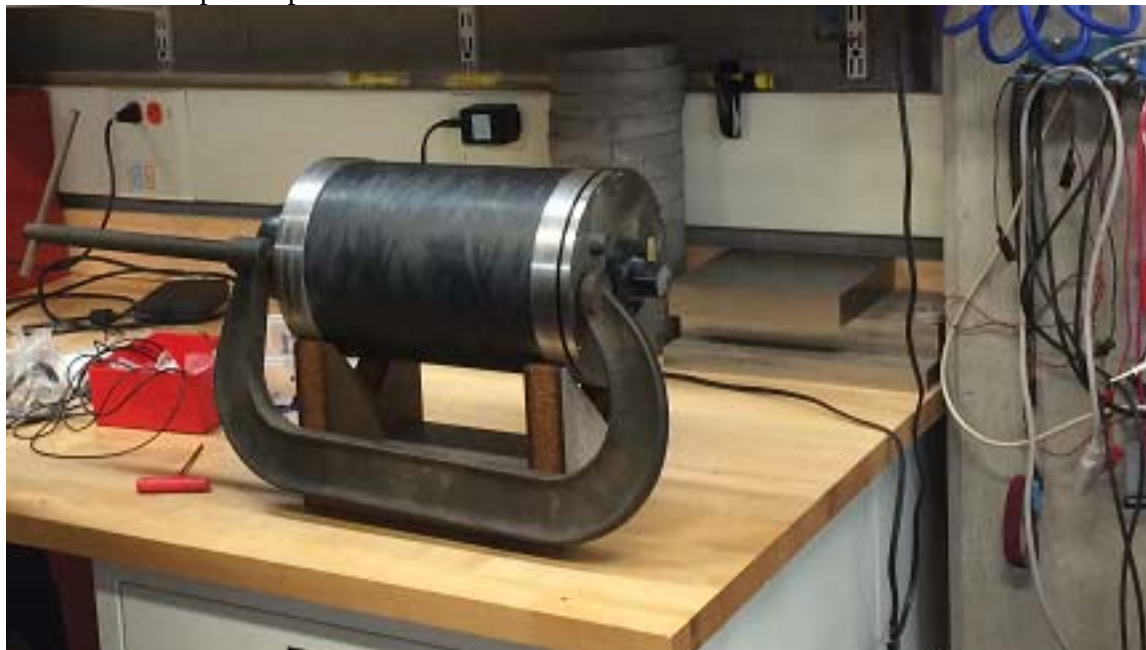
Housing does not have any signs of damage. Pressure slightly elevated, large clamps were used to hold housing's end plates until pressure release as a safety measure (no internal pressure read was performed immediately before opening). Subjectively, internal pressure was not more than 110% of atmospheric pressure.

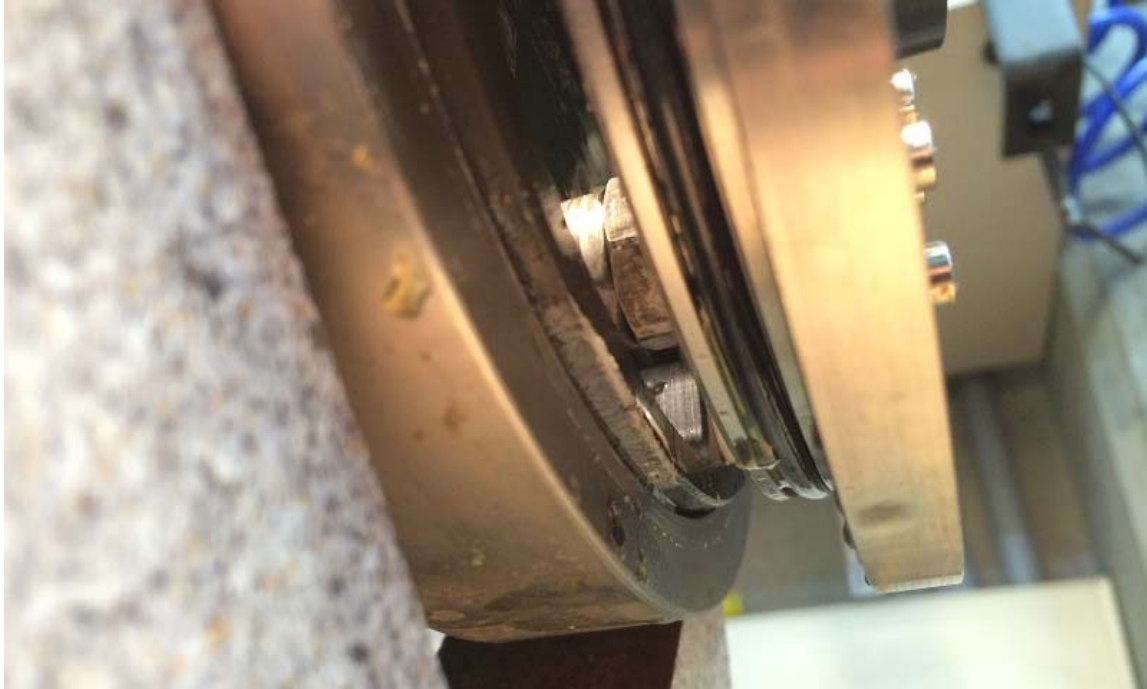
Once housing was open, presence of light-green liquid and strong chlorine smell became evident.

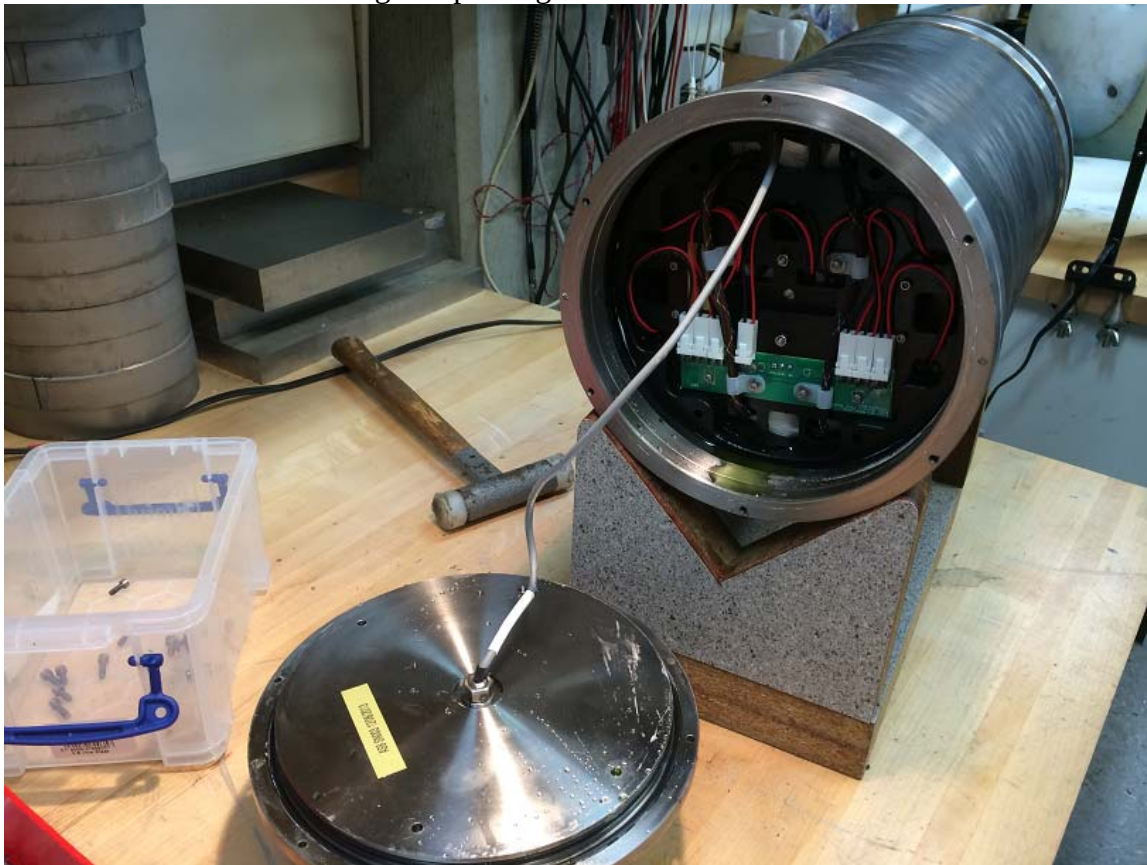
About 25-35mL of the light-green liquid was collected from the housing into polyethylene container. At this point battery failure and electrolyte leak became evident; MBARY Safety Dept had being notified; and the instrument with all the materials had being loaded on a plastic cart and moved out of the building to a parking lot.

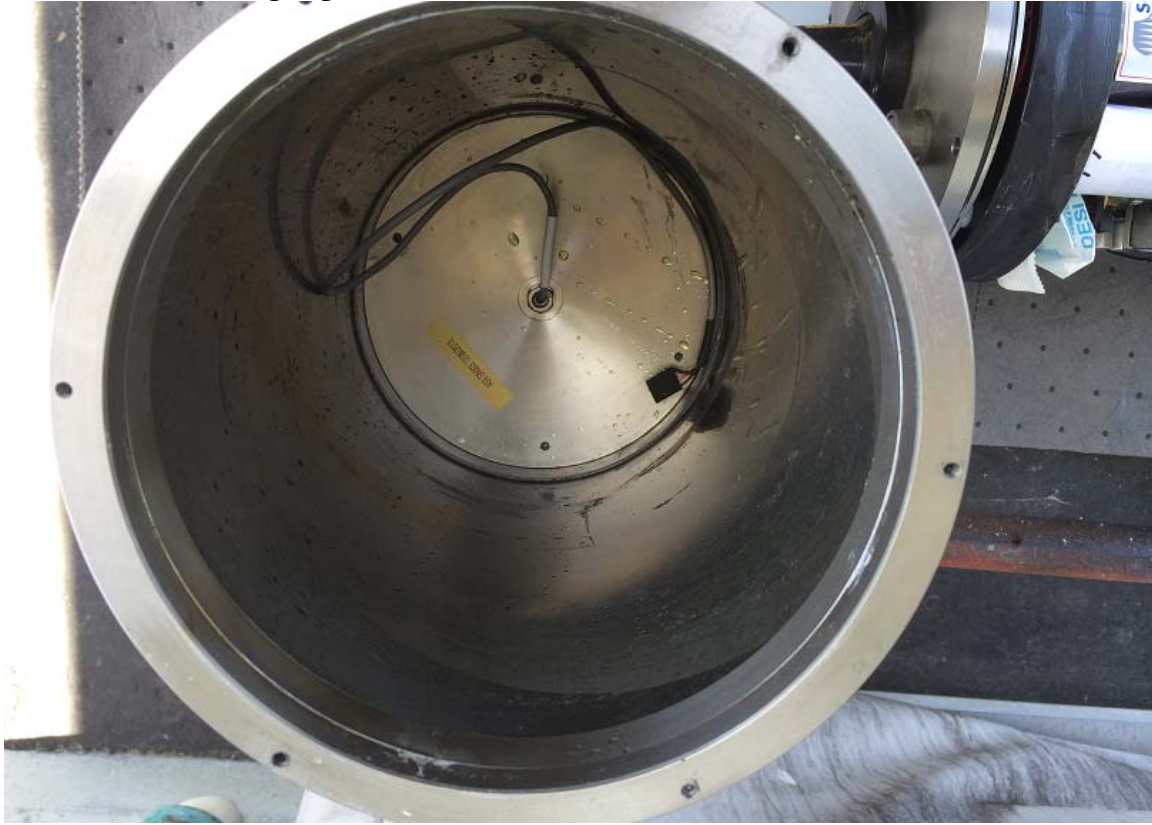
Housing does not have any signs of mechanical damage. Inside surface of the housing contaminated with light-green fluid.

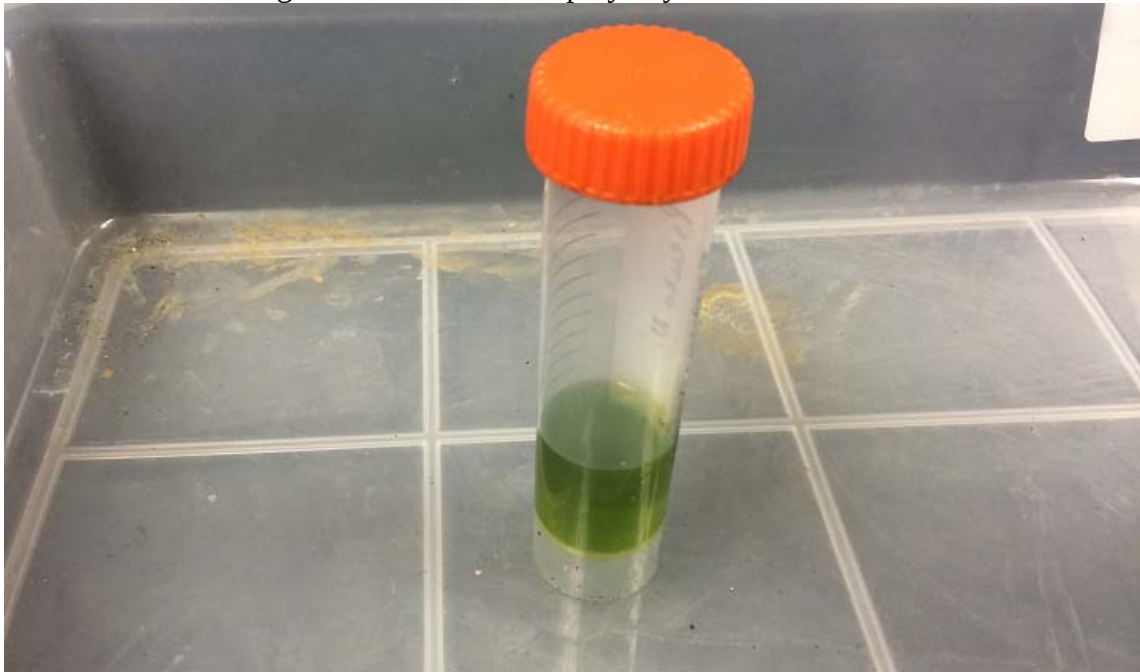
About 25-35mL of the light-green liquid was collected from the housing into polyethylene container and then transferred to a vile. About half was spilled on a plastic cart while working outside of the building when wind overturn polyethylene container.

1. Check if collected light-green liquid contains sea water, to rule out leaking pressure housing.
  - a. Compare optical absorption spectra of collected liquid to pure CSC93 series electrolyte?
  - b. Compare refractive index of collected liquid to pure CSC93 series electrolyte?

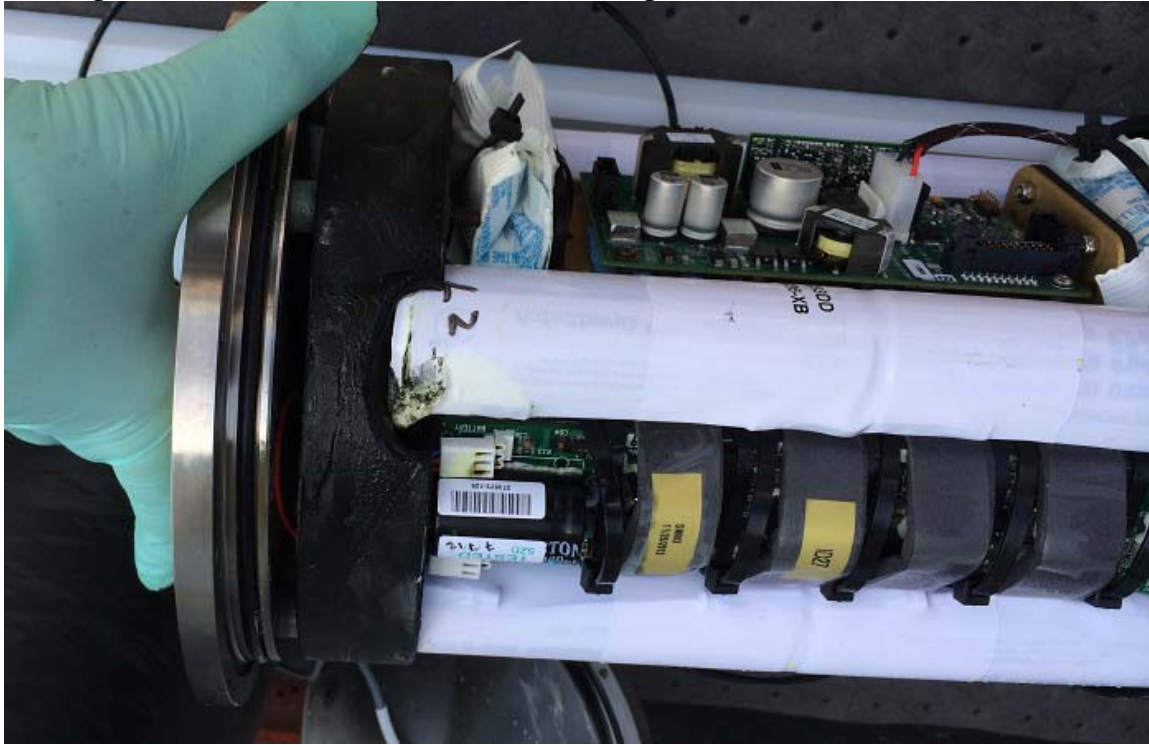
Left Black Delrin endplate holding battery sticks found missing about 1x3 cm section adjacent to Battery Stick marked L2 (means: stick “2”, oriented to the left end plate, assembly AS3-LEFT). Missing section is later found inside of the housing.

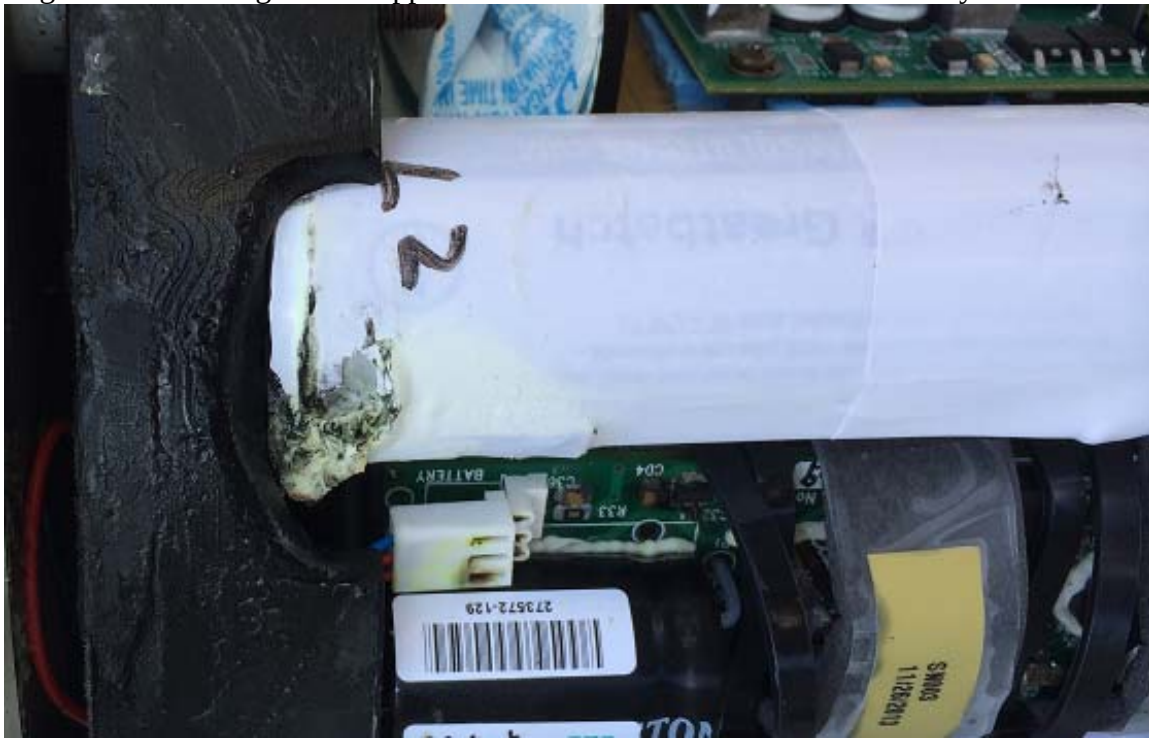
Edges of the missing section appeared “rounded” as if melted or chemically etched.

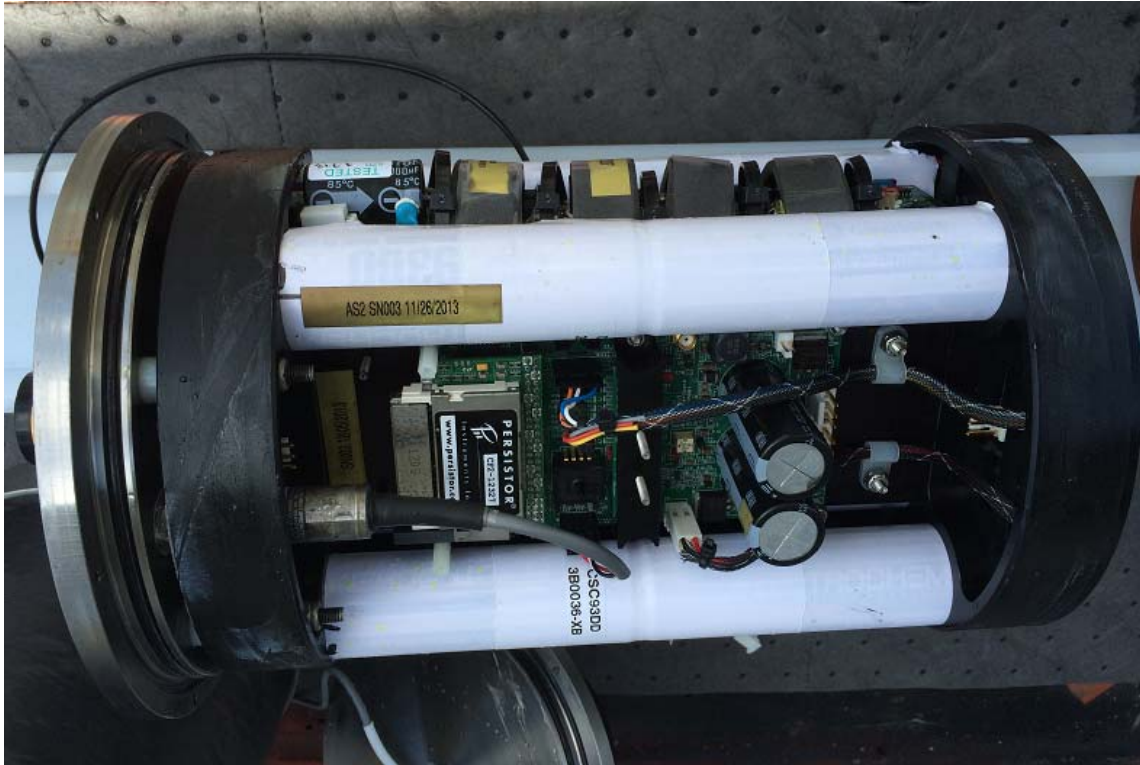
Internals of 10020895-AS2 assembly look undisturbed aside of presence of light-green fluid on some surfaces, and some discoloration of metals: pressure sensor housing, solder on PCB boards and so on:

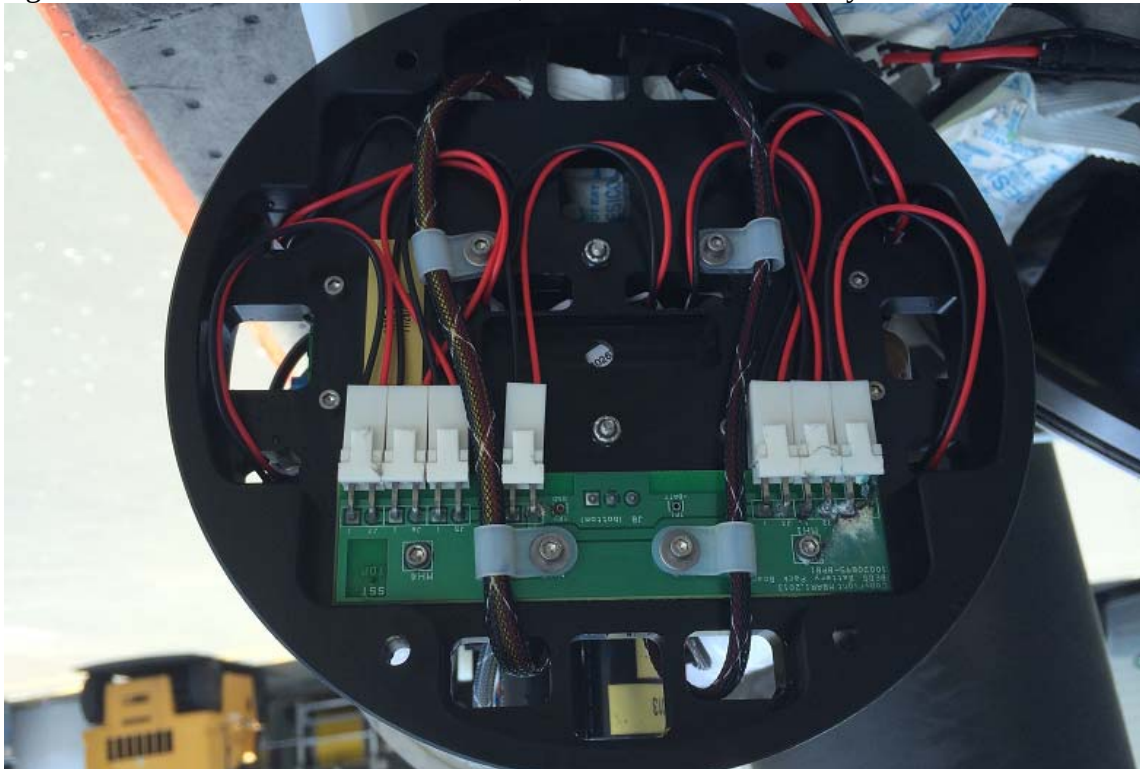
Battery pack board (10020895-BPB1) mounted on right end plate (10020895-AS3-RIGHT) has signs of corrosion near connectors J1-J2, but later tested to be fully functional

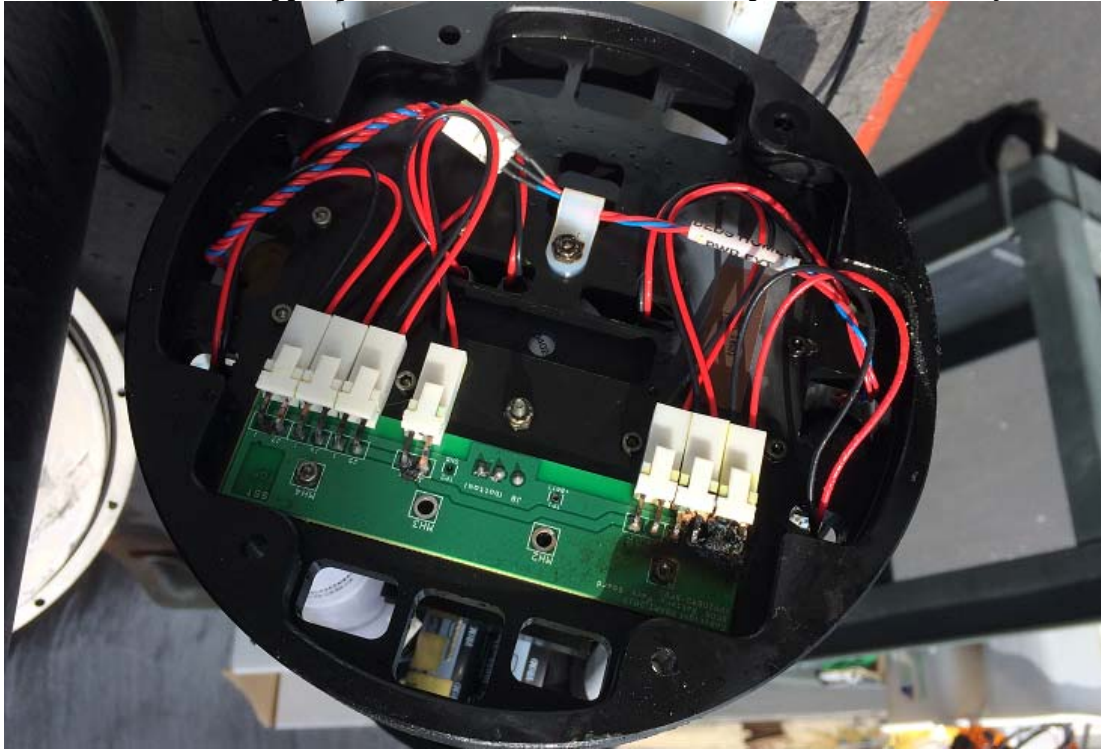
Battery pack board (10020895-BPB1) mounted on LEFT end plate (10020895-AS3-LEFT) is corroded near connectors J1-J2 with black-green deposits covering connectors pins; and later tested NOT to be functional. Damage to the board include dissolved traces between pins J1.1 and J2.2, and J1.1 and copper pour net name "+ BATT" on Top and BOTTOM layers.

- a. Battery cell SN 7331 located in a Slot L2 of the LEFT half-pack
  - b. Possibly, presence of seawater inside of the housing.
2. Battery pack:
  - a. LEFT half-pack failed due to corrosion of copper traces on Battery Pack Board

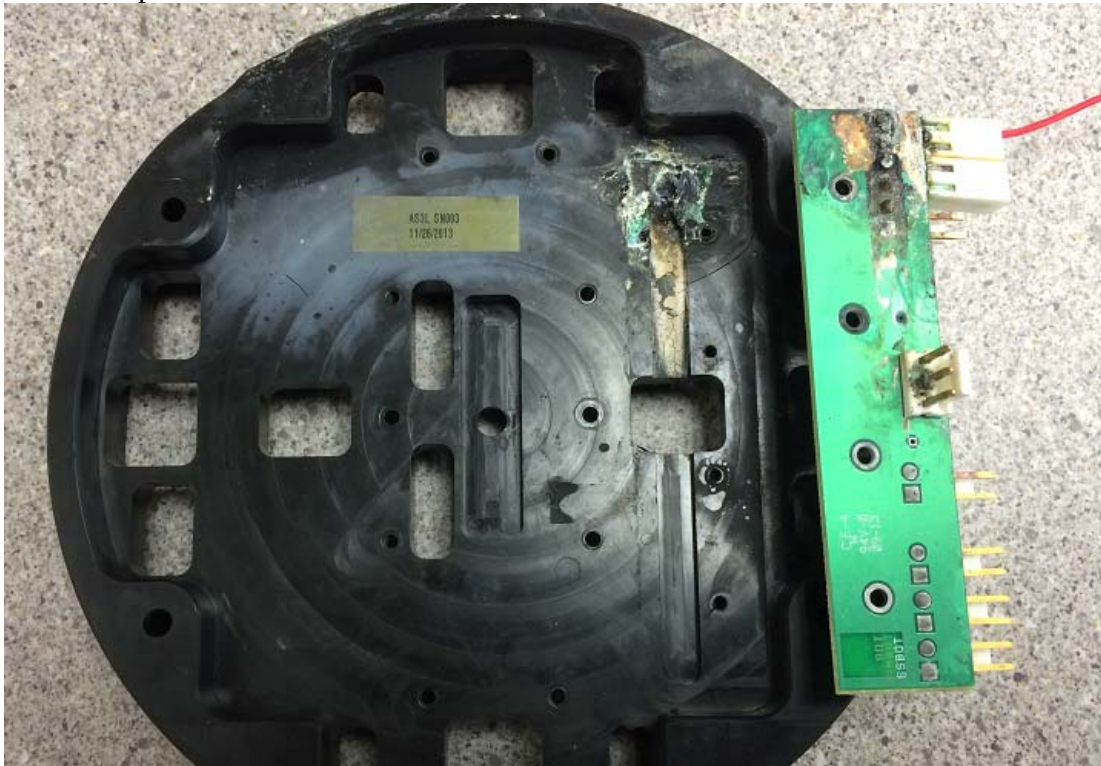
Black Delrin under the LEFT battery pack board is corroded with approximately 15x5x1mm mass missing, with discoloration and pitting in surrounding areas as if the electrolyte was trapped inside the channel under the PCB board enabling galvanic corrosion between energized connector pins.

- i. Channel milled in a Black Delrin endplate under Battery Pack Board negatively affected reliability allowing liquid to be trapped under the board and electrochemical corrosion to occur.

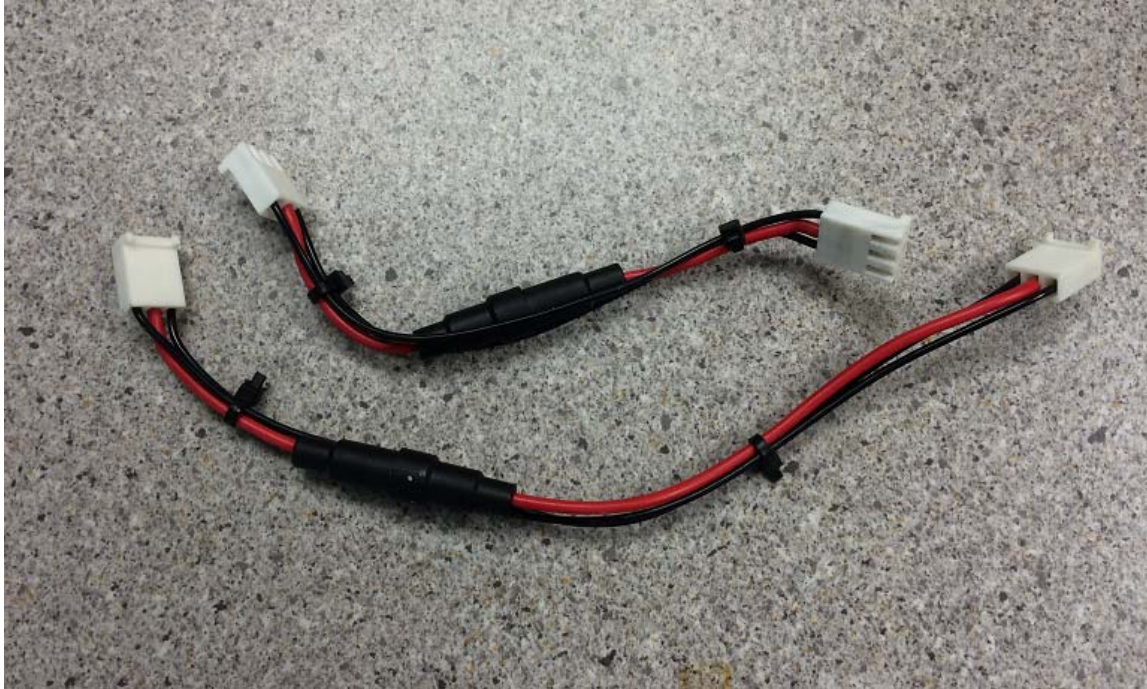
Fused Power Harnesses delivering power from each Battery Pack Board to Mother Board are intact and later tested to be functional.

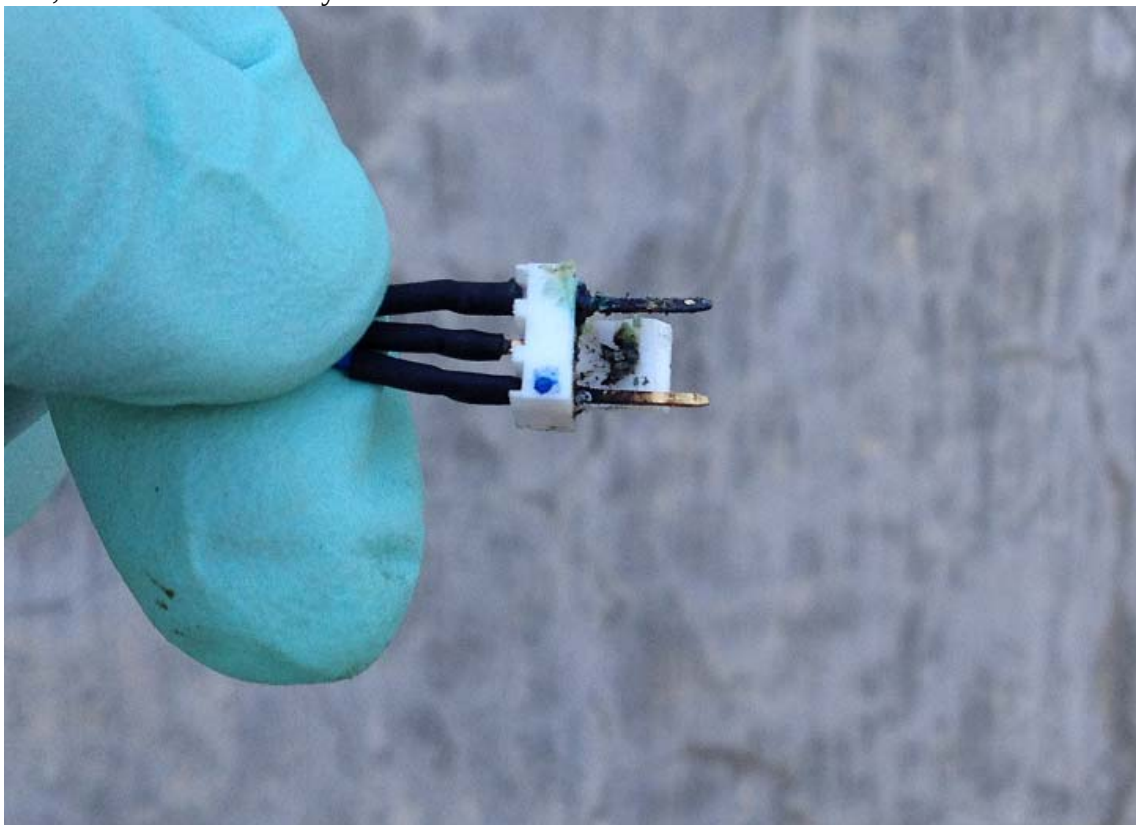
Connector pins in Homer power harness are damaged but since central pin is redundant positive line, Homer is most likely functional

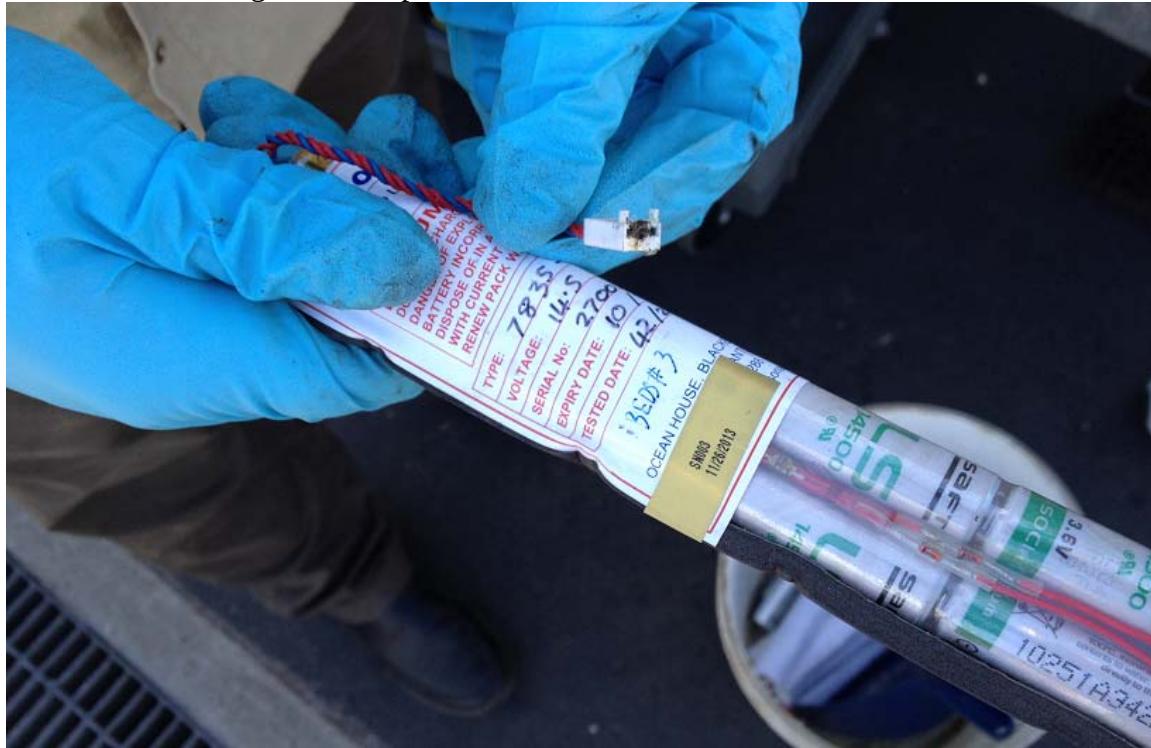
Other side of damaged Homer power harness connector

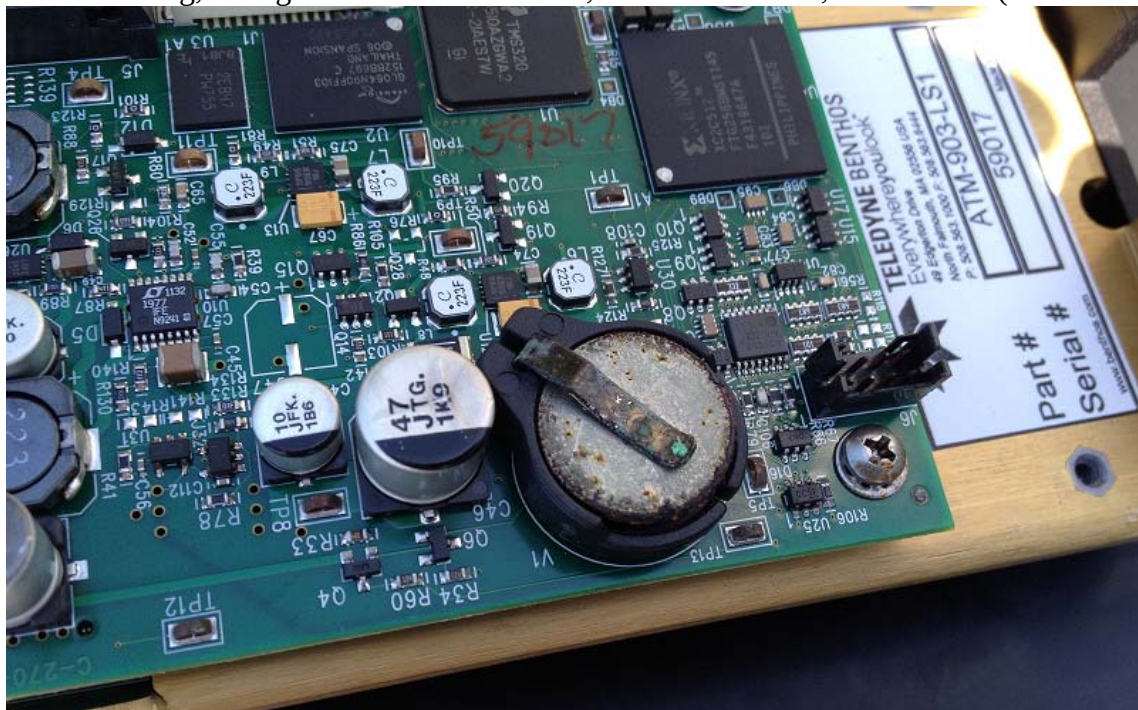
Coin cell on acoustic board stack has some surface corrosion/ discoloration. Cell removed for board cleaning, voltage measured at 2.997 V , model CVR1632; 3V nominal (= functional).

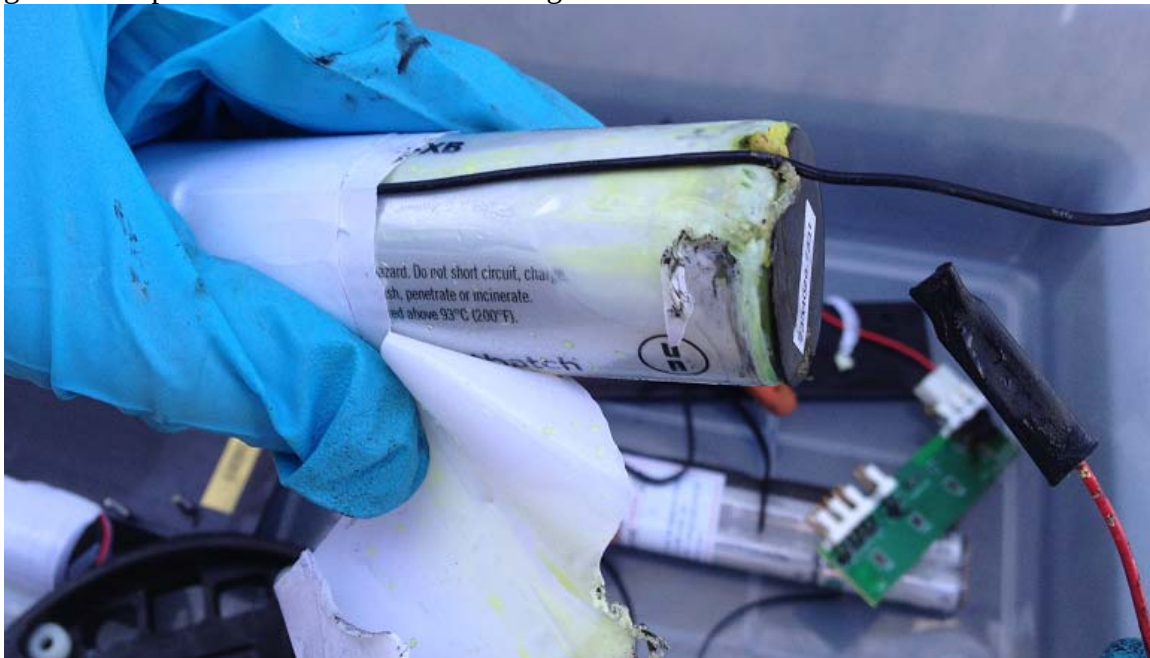
Affected “battery stick” from Slot L2, SN 7331, heat shrinking material partially removed; light-green fluid present under the heat shrinking material

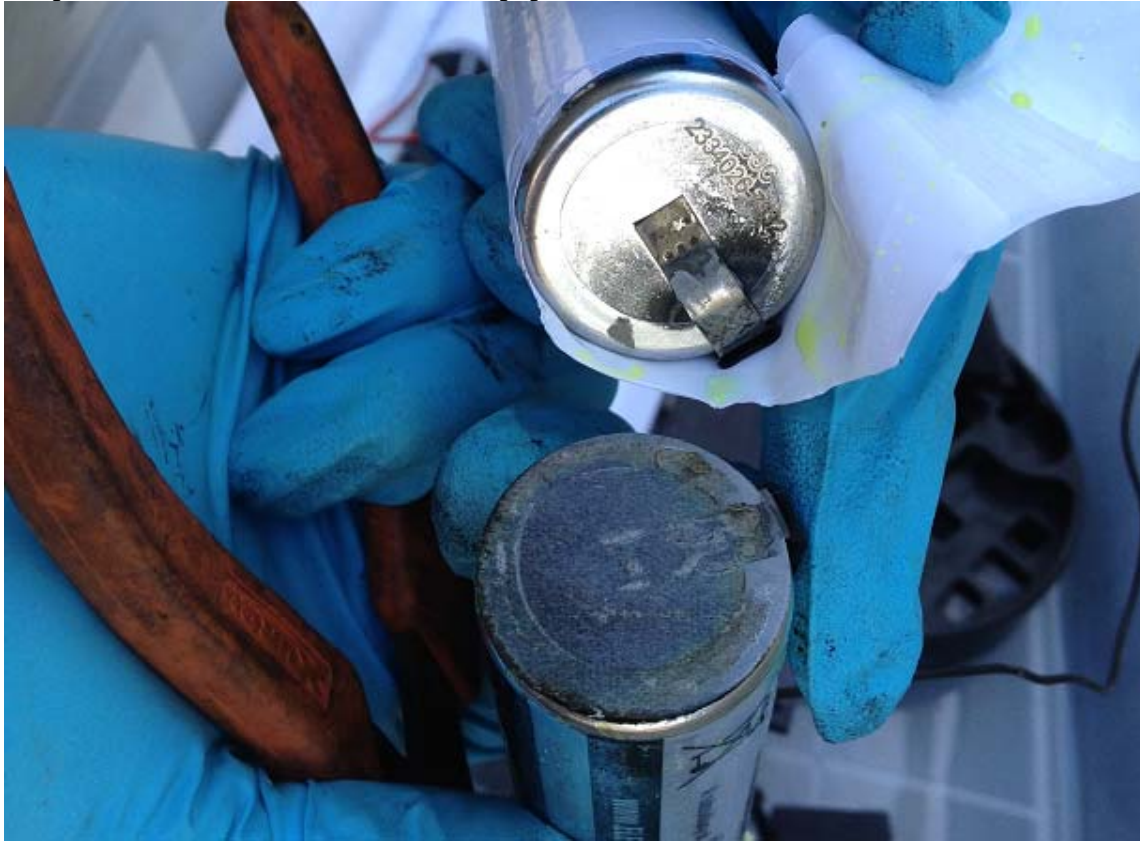
Light-green fluid present under the heat shrinking material to the middle of “battery stick” but not present of the other side of middle paper disk dividers

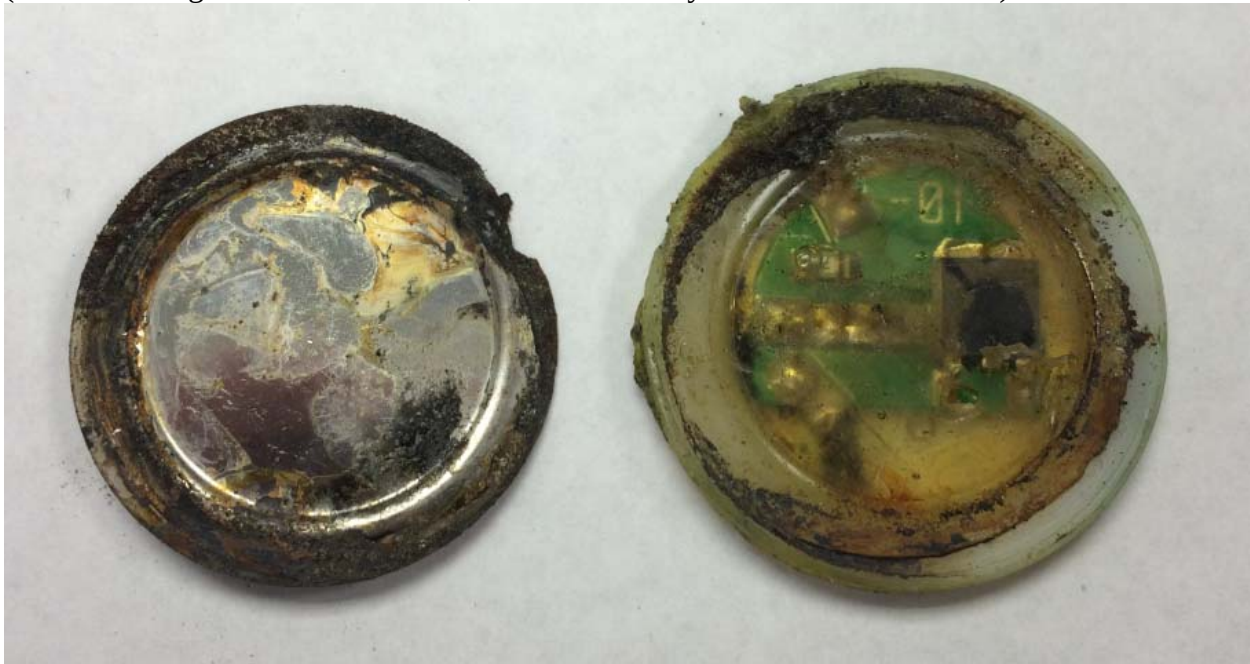
Plastic cap with protection elements of cell CSC93DD part# 3B0036-XB, batch 2334026, SN 7331. Fuse is blown (resistance measured at 51kOhm), reverse protective diode is functional (forward voltage measure at 0.133V; reverse 2.98V by Protek 506 multimeter)

- b. RIGHT half-pack retained full functionality and continued supplying power to Mother Board.
3. Battery cell failure (SN 7331):
  - a. Protective fuse is blown presumably due to corrosion and electrical short circuit on Battery Pack Board.

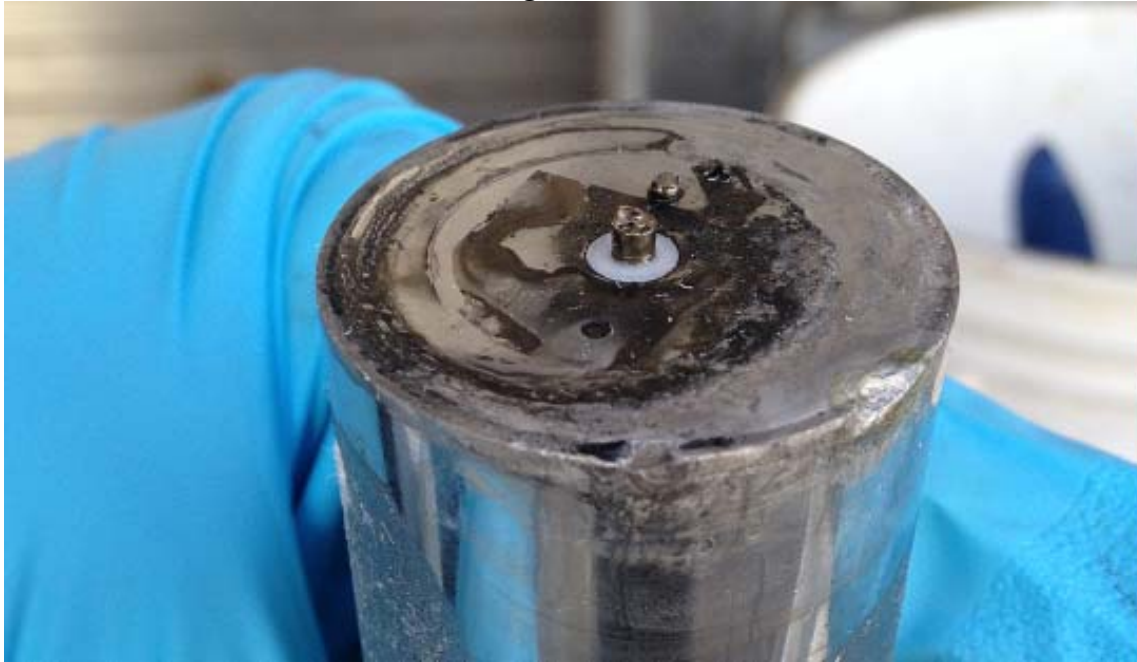
Cell SN 7331; plastic cap and labels removed; 2 “cavities” are visible on the edge of pressure vessel; “left one” about 2x3 mm; and “right one” about 2x5mm

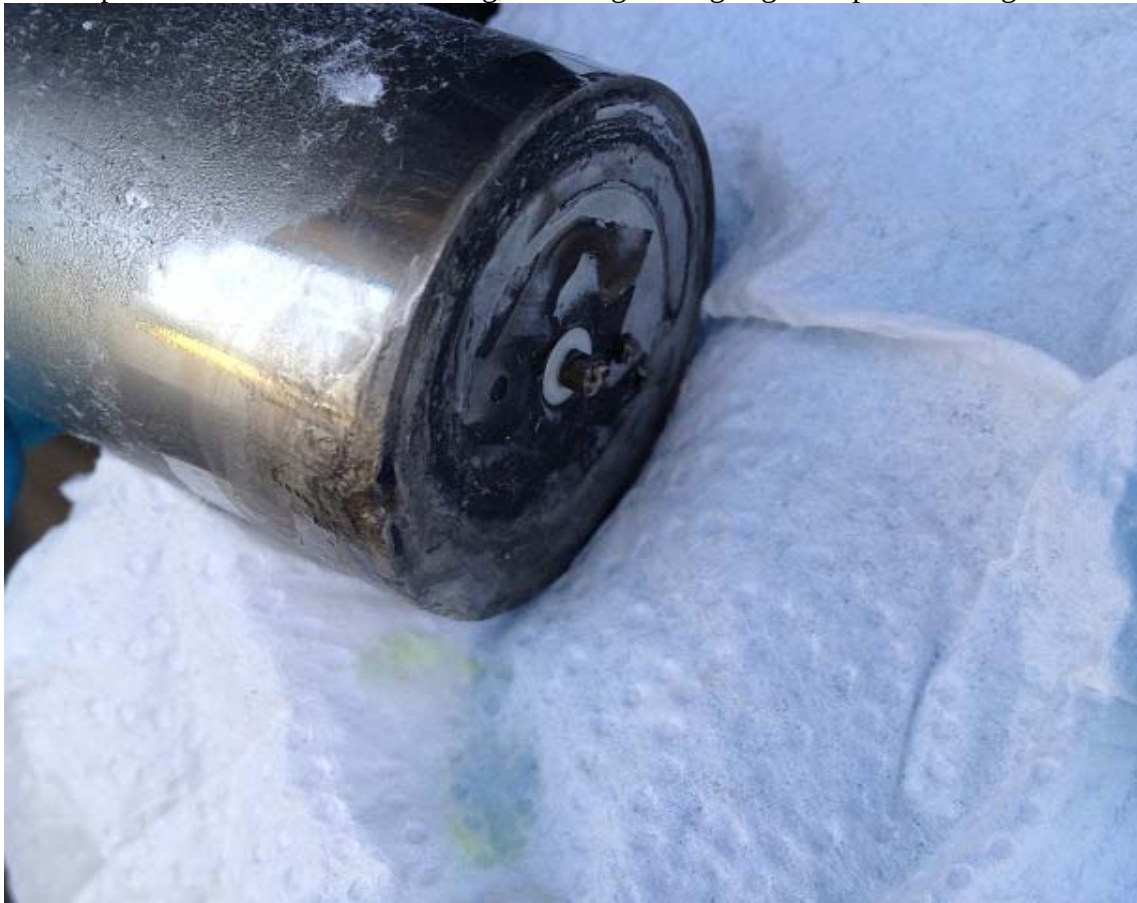
Those 2 cavities proven to be leaking electrolyte which was confirmed by holding a cell against a tissue upside-down with some shaking; resulting in 2 light-green spots forming on a tissue

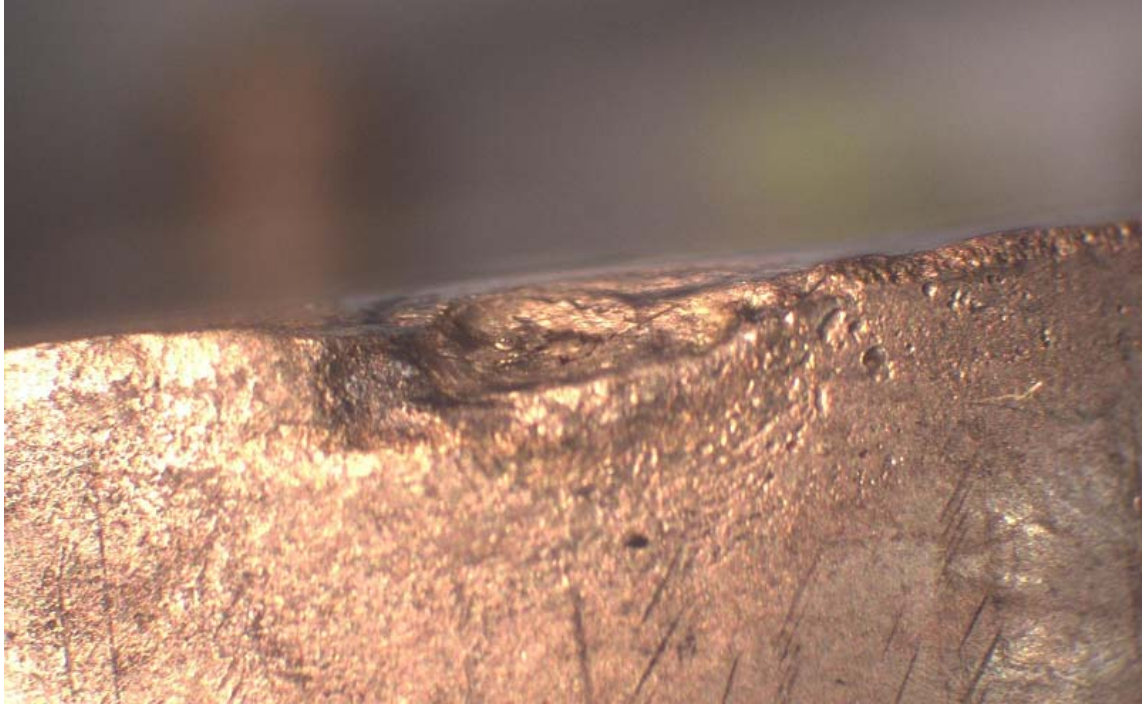
“Right cavity” under microscope. There is a small opening in the middle of the cavity where bubbles of the gas and light-green electrolyte coming out are visible which prevents accurate measurement of a size of the opening.

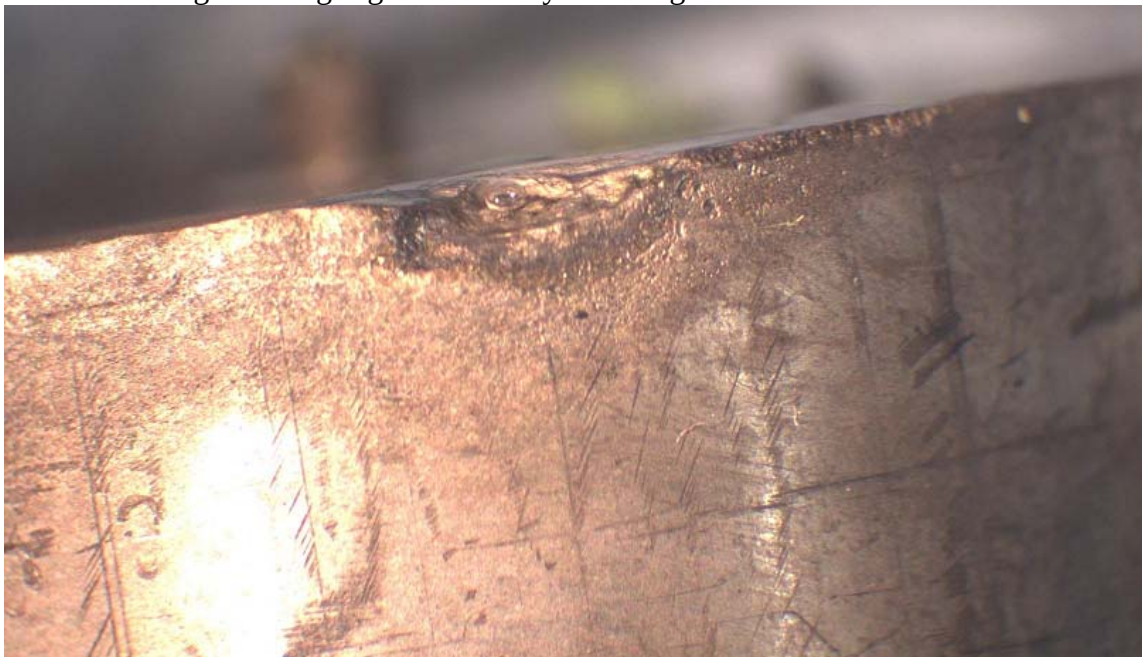
“Left cavity” under microscope. There is a small opening in the middle of the cavity where bubbles of the gas and light-green electrolyte coming out are visible

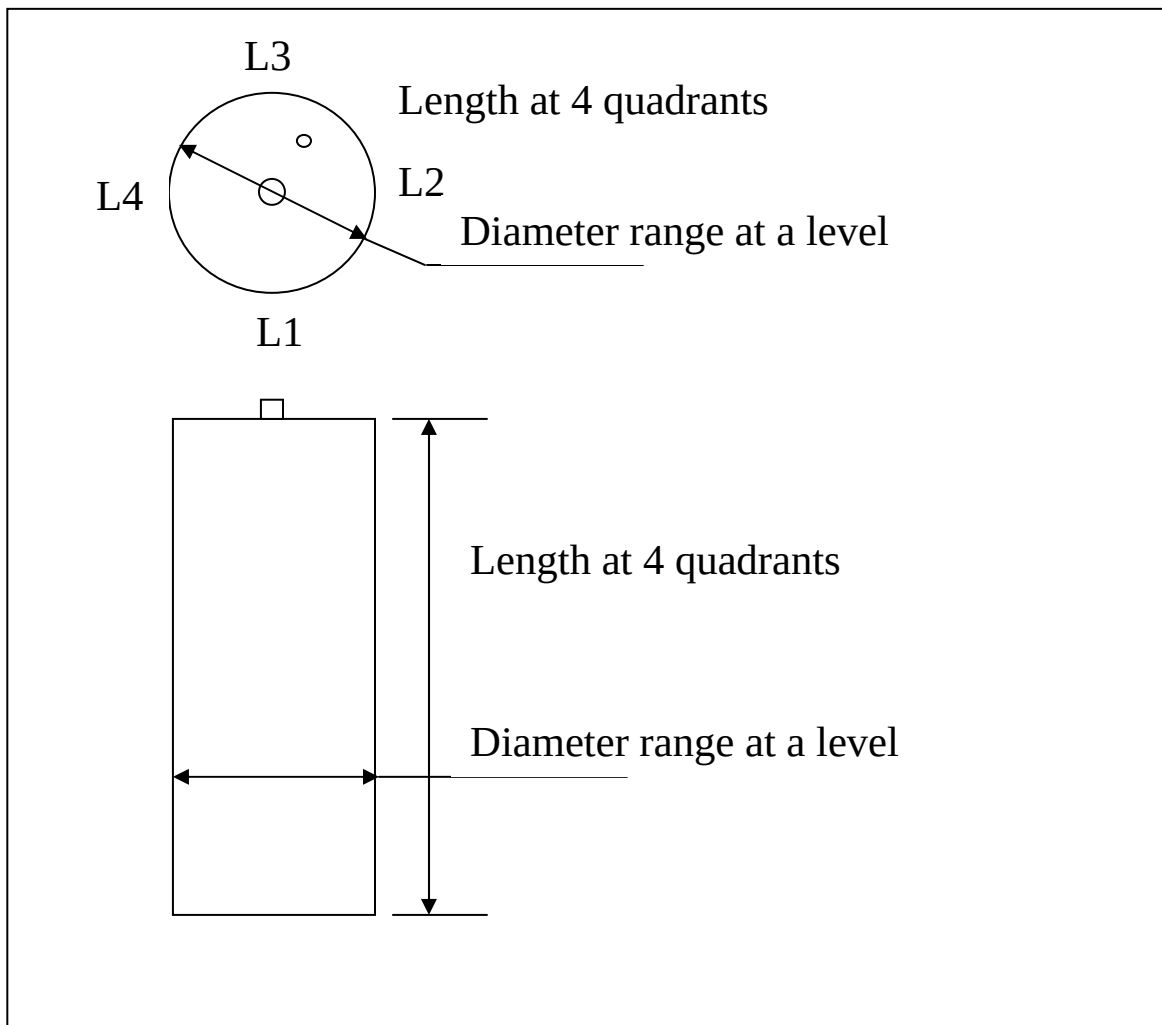
Geometry of the Cell SN 7331 pressure vessel, with protective plastic cap and labels removed to bare metal, measured by 6" digital Mitutoyo calipers. Please refer to the diagram below.

- b. No change in pressure vessel geometry
    - i. Reason for a cell failure with subsequent electrolyte leak is unknown.
  - c. No signs of thermal damage or thermal run-away (by condition of heat shrinking material and polymer labels).
