# i2MAP Dome Failures

Two variations of the dome seat were tested, design #1 with a flat seat and design #2 with a flat seat with some compliance from a machined groove.

Assembled by mrc 2/17/2016

Rev. B 26FEB16

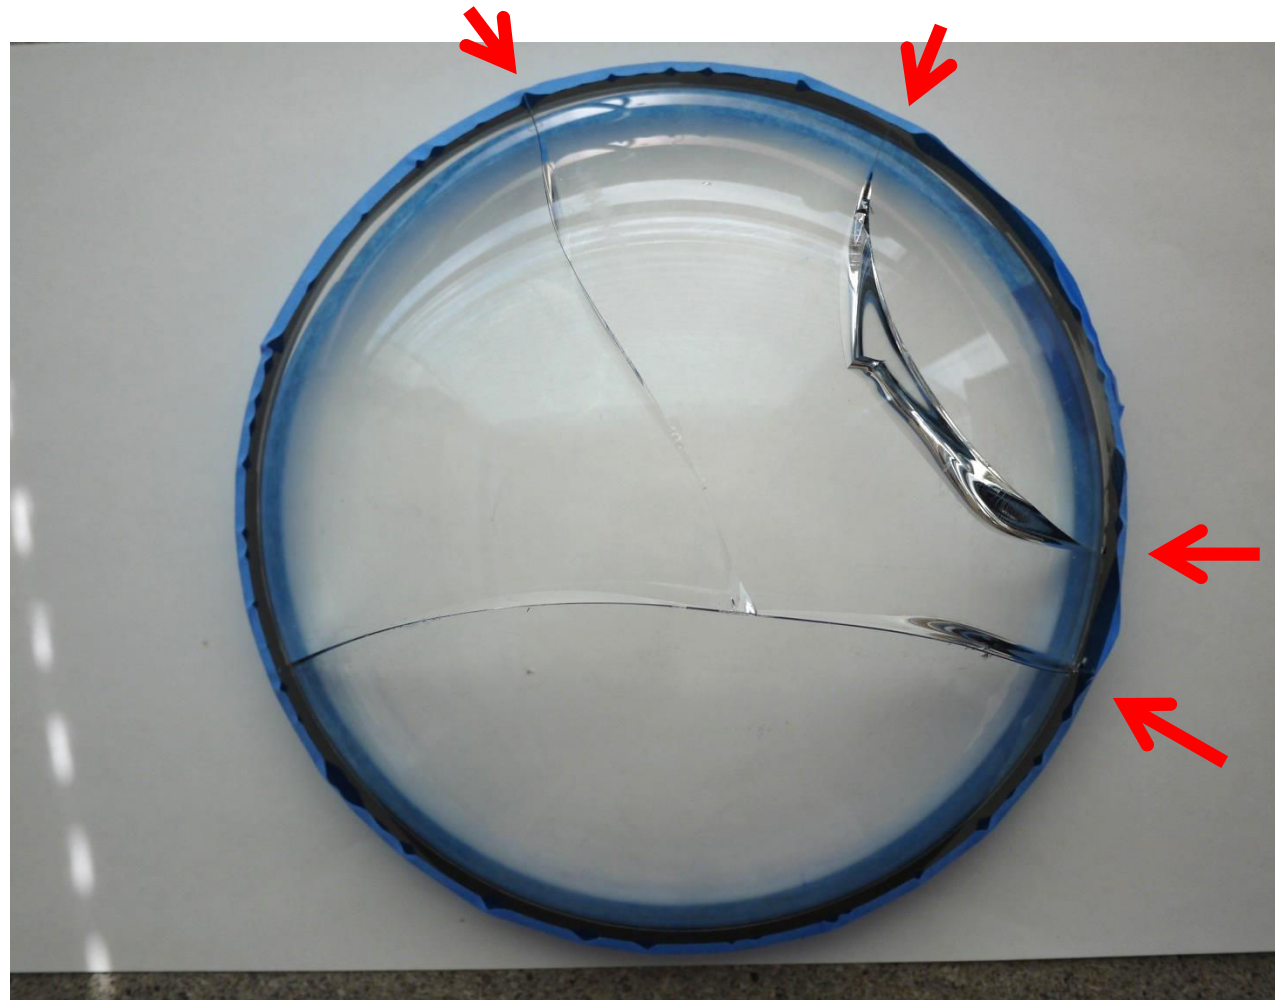
Initial  
failure  
points?

# Description of Dome #1 Cracks

- #1 Appears to show slow crack growth through a mirror section to 27mm then a distinct boundary which probably is a transition to rapid failure.
- #2 Also shows a mirror section of 27mm and a boundary.
- #3 Also shows a mirror section of 25mm and a boundary.
- #4 Also shows a mirror section of 24mm and a boundary.
- #5 Show no boundary and no lead-in mirror region implying that the failure along this crack occurred all at once.

The conclusion drawn from this is that the dome slowly cracked under continuous stress at locations #1-4 until the cracks reached about 25mm and then the dome rapidly failed at all locations.

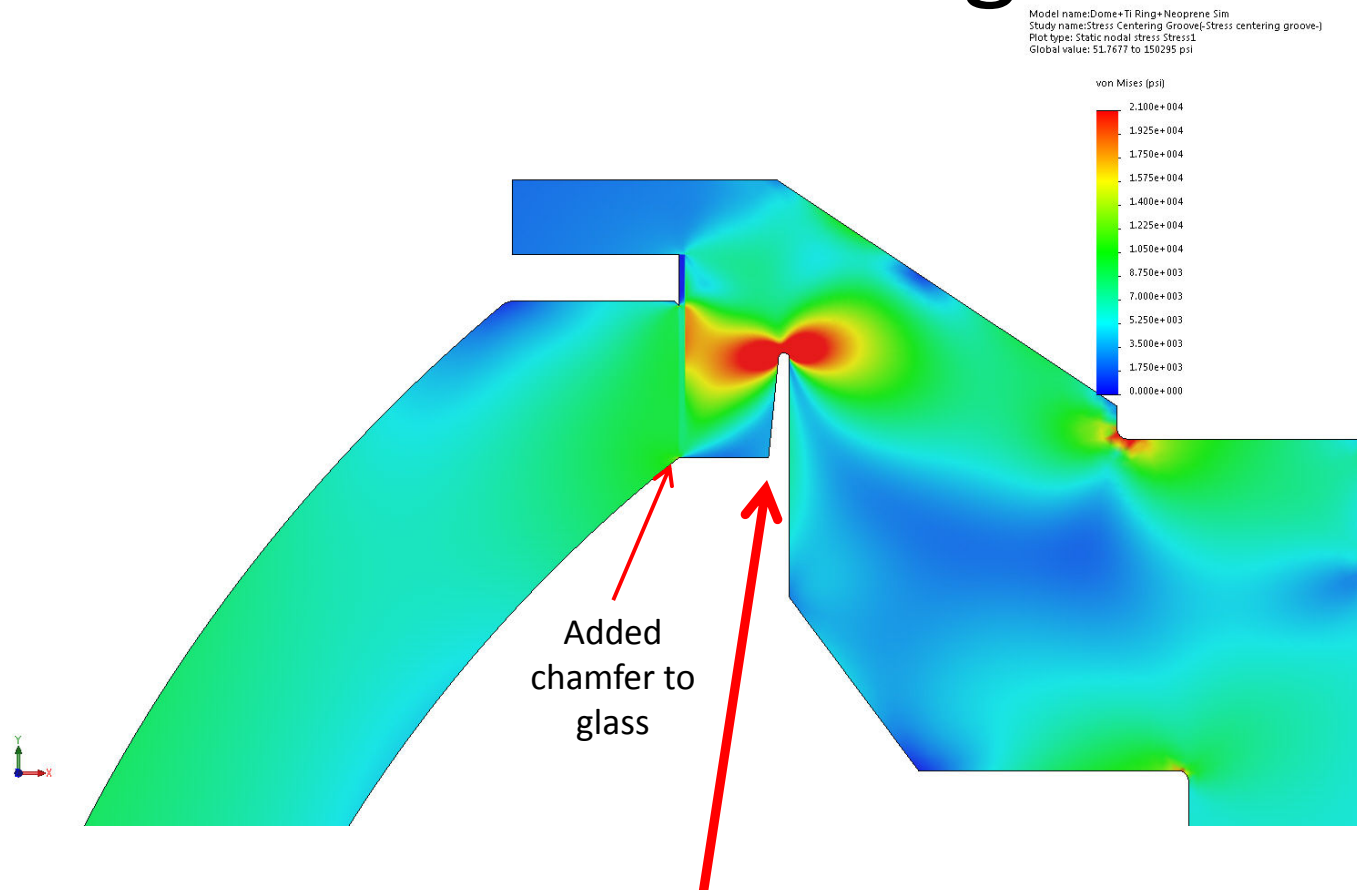
# Dome Seat Design #2

Same design as #1 except for; addition of groove below the seat to allow slight flexure of dome seat under hydrostatic pressure, Kapton ring thickness under dome seat was increased from 0.005 to 0.020 thickness, the seat areas was optically polished, and a small polished chamfer was added to the dome inside radius (outside radius already had a ground chamfer).

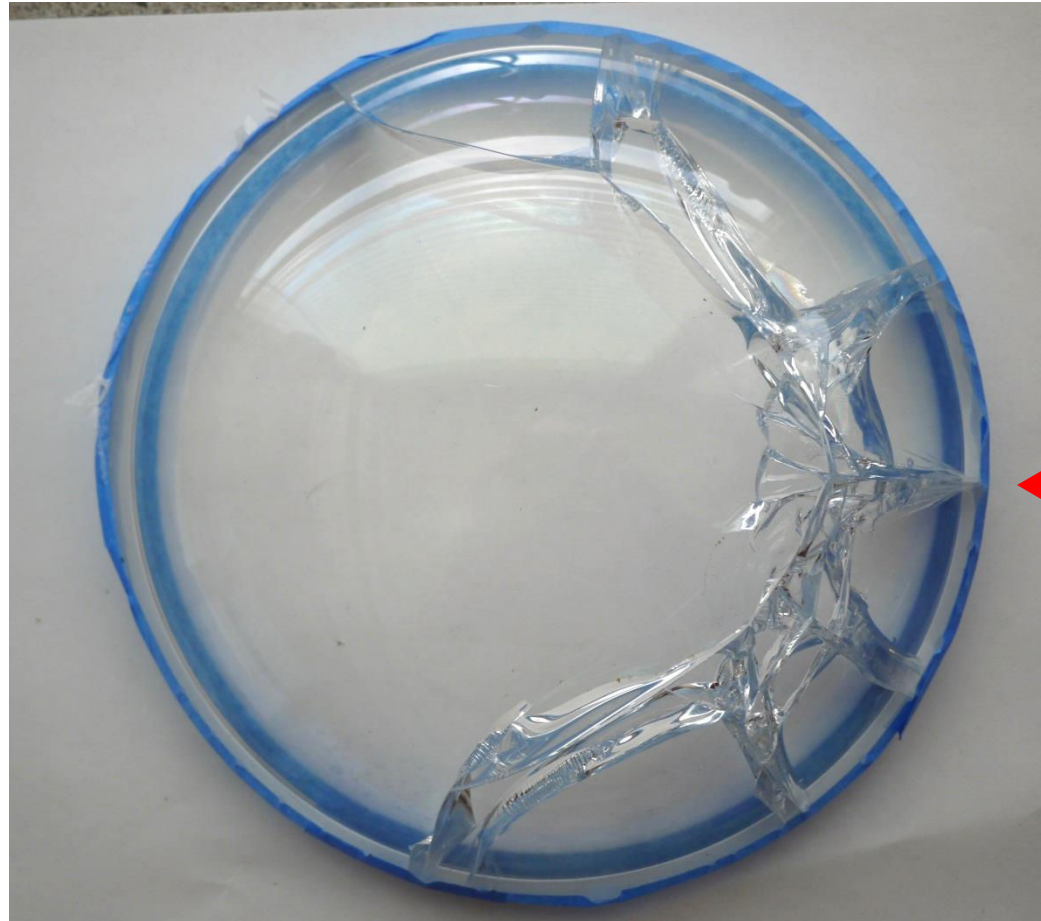
Initial  
failure  
point?

The conclusion is that the initial cracking was at location #4, precisely at the outer edge of the dome seat. The crack only grew to 3mm before the entire dome failed, implying that the glass along the failures was highly stressed. This is supported by the radiating cracks from this location. All of the other cracks are more chaotic. Only crack #6 bears any indications that it might have originated along the outer dome edge. The fact that there is little evidence of slow crack growth and that the failure occurred at much lower pressures than dome #1 leads to the conclusion that the dome in design #2 is much more highly stressed.

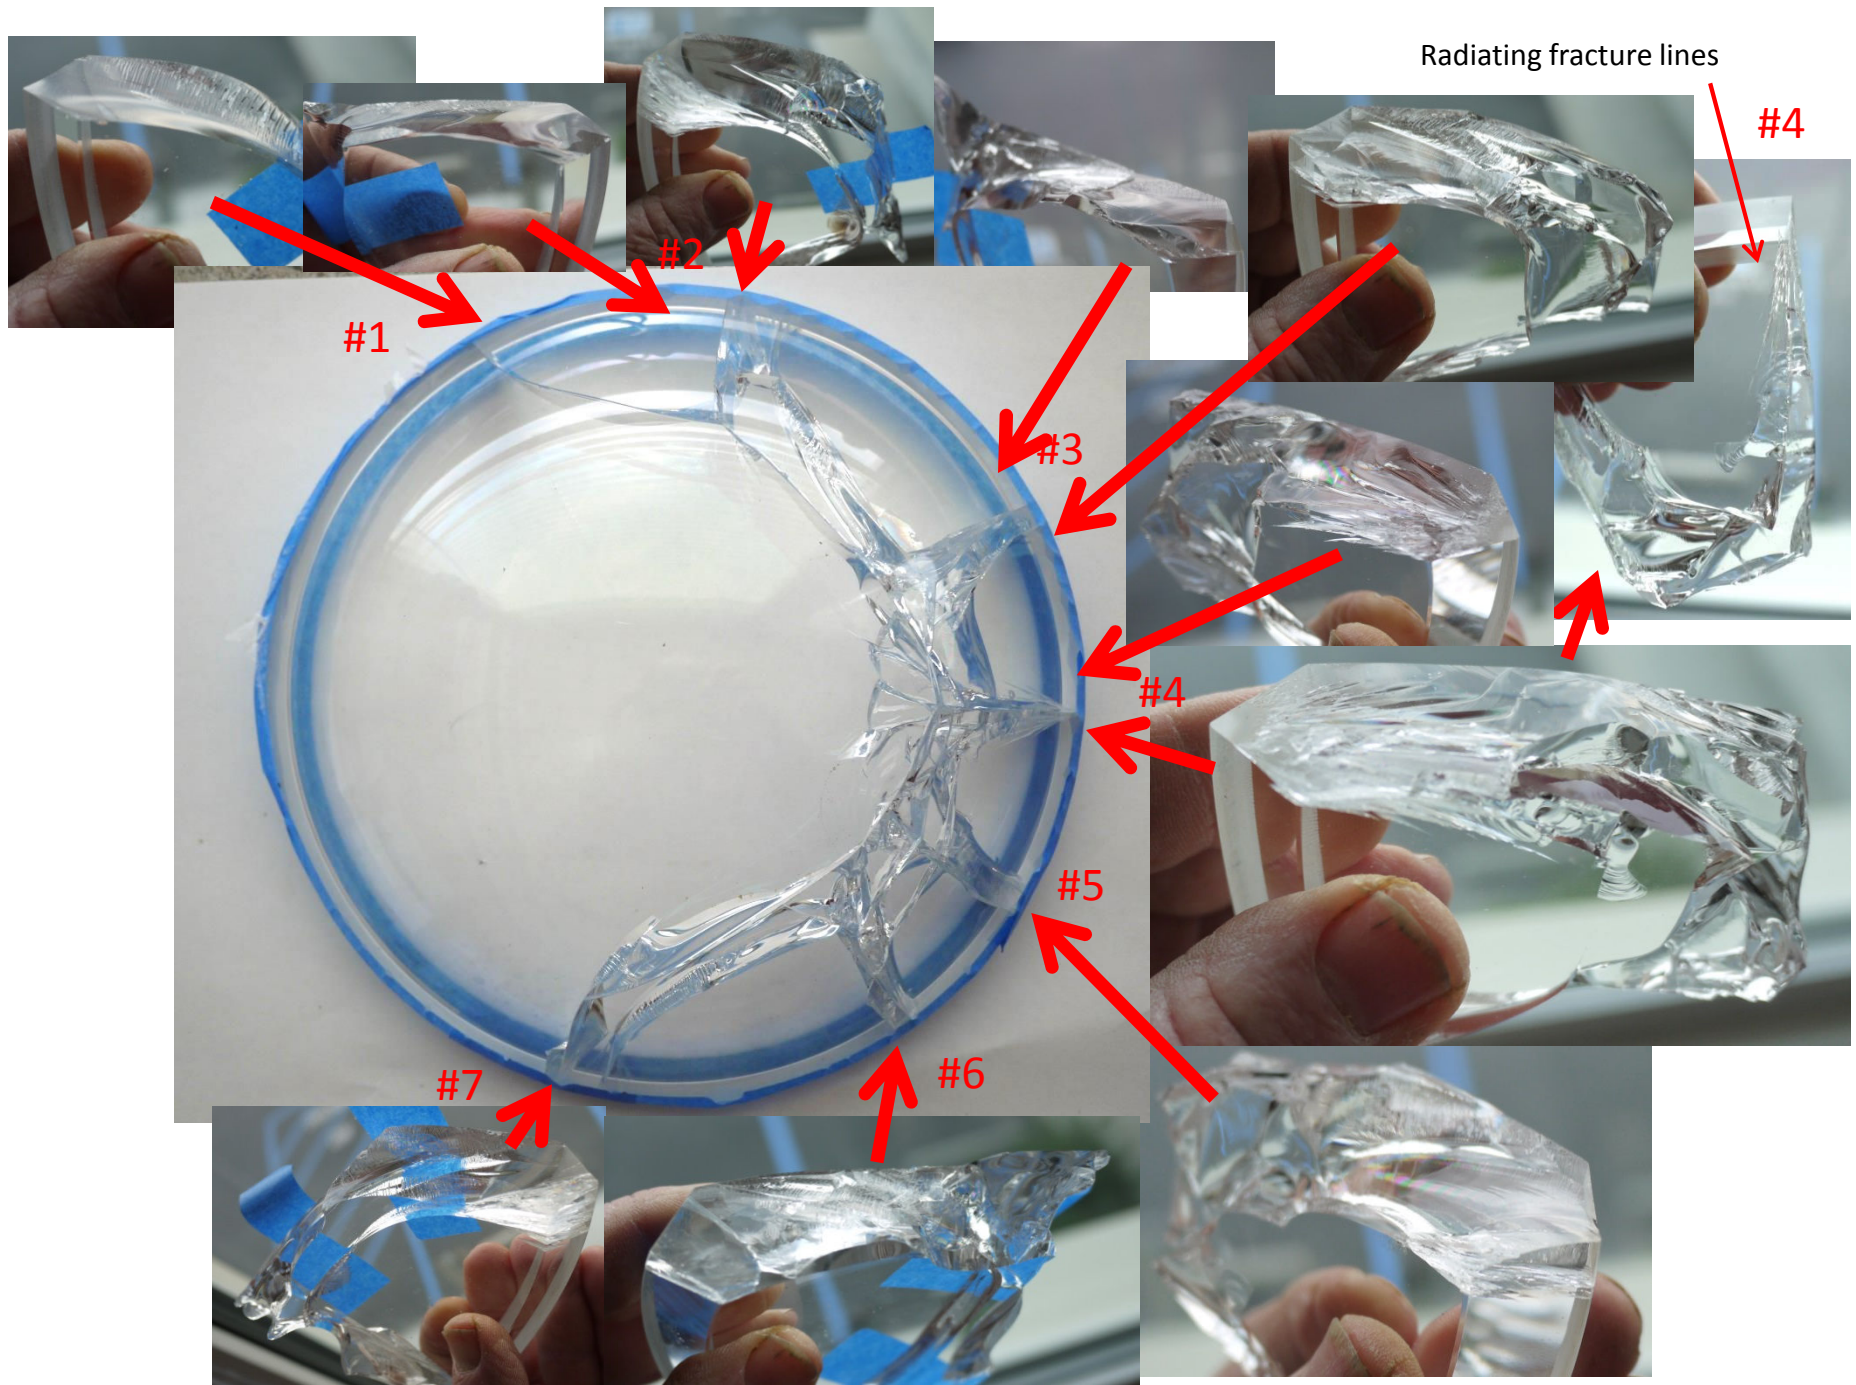
- Note that a surface defect was observed on the outer rim of the dome before pressure test. It was a small ~ 1mm chip in the outer ground chamfer. It was marked with a (now faint) black magic marker line. One of the radius cracks did occur at this location.

- #1 Appears to indicate a failure along the inside radius of the dome that simultaneously expanded to the dome edge and seat. It did not originate at the rim or seat area.

- #2 Appears similar to #1.
- #3 Also appears similar to #1 although slightly more chaotic. The last place to fail was at the dome inner seat chamfer.
- #3 The other split on #3 also appears similar to #1 although, again, slightly more chaotic. It appears that the crack radiated from the center inner radius of the dome toward the seat area.

- #5 Again is similar to #1 and the failure appears to have first occurred on the inner radius and radiated out to the dome edge and seat area.
- #6 Is fairly chaotic but appears to possibly have originated in the inner edge and outer edge dome seat area, but probably during the complete dome failure. No evidence of slow crack growth.

- #7 Appears to have originated on the dome inner edge and migrated out to the dome edge and seat area.

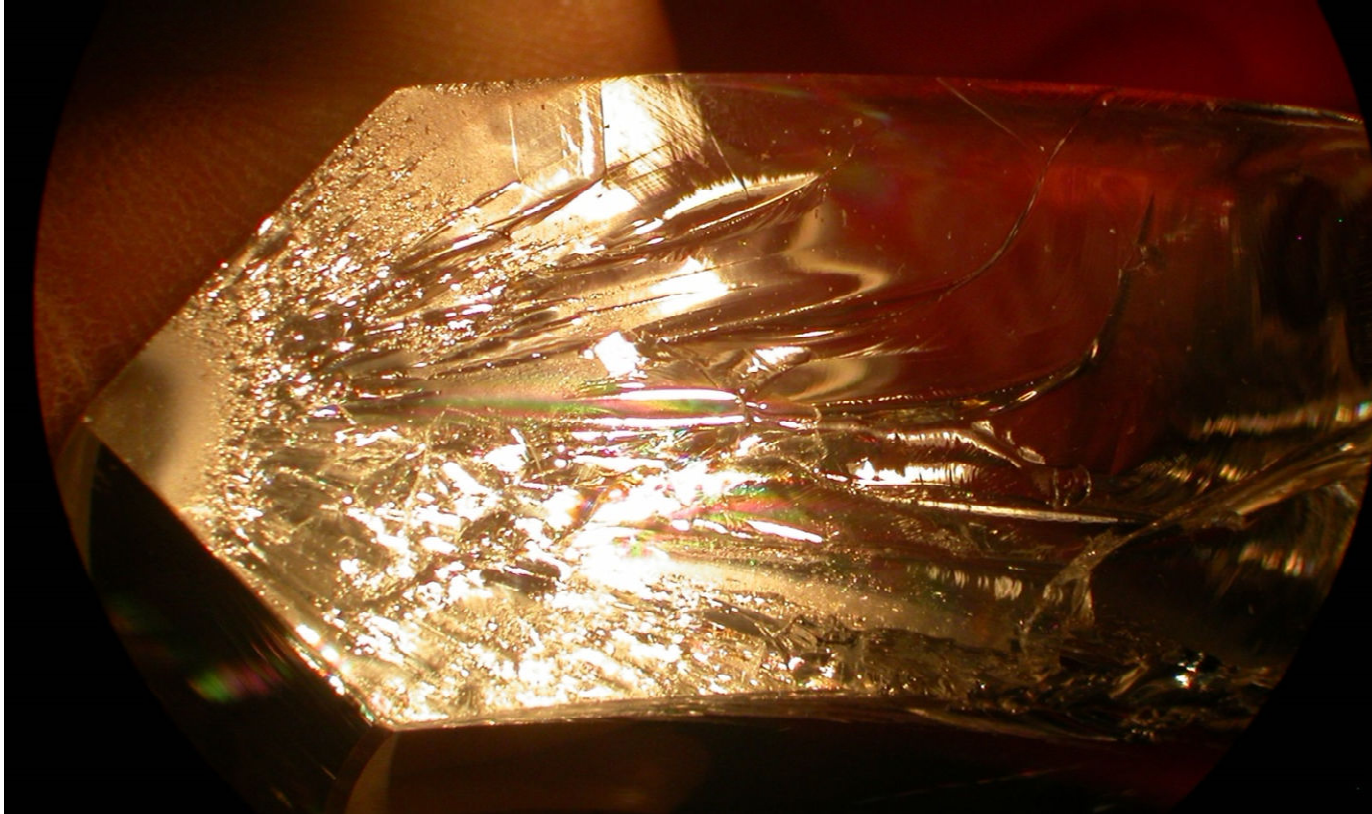
Close-up of fracture #4

- #4 Appears to slowly start precisely at the junction of the seat and the outer radius of the glass dome. The crack grew to 3mm in a “mirror” region, then extended rapidly into a mist and hackle region up into the dome. Radiating cracks indicate the glass was highly stressed around the area of failure and that the failure was rapid once the crack developed beyond 3mm. This crack may have been the initial failure point.
