# Serious incident investigation aviation

- Place Genus All Nippon Airways Co., Ltd. exports (Flight
- Type Formula 692)
- Registration Boeing 787-8 type formula
- symbol JA804A
- Date and time January 16, 2013 (Wed) Around 8:26  
of occurrence Sky near Takamatsu Airport An altitude of  
Site of approximately 32,000 ft  
occurrence

February 5, 2013

Transportation Safety  
Board

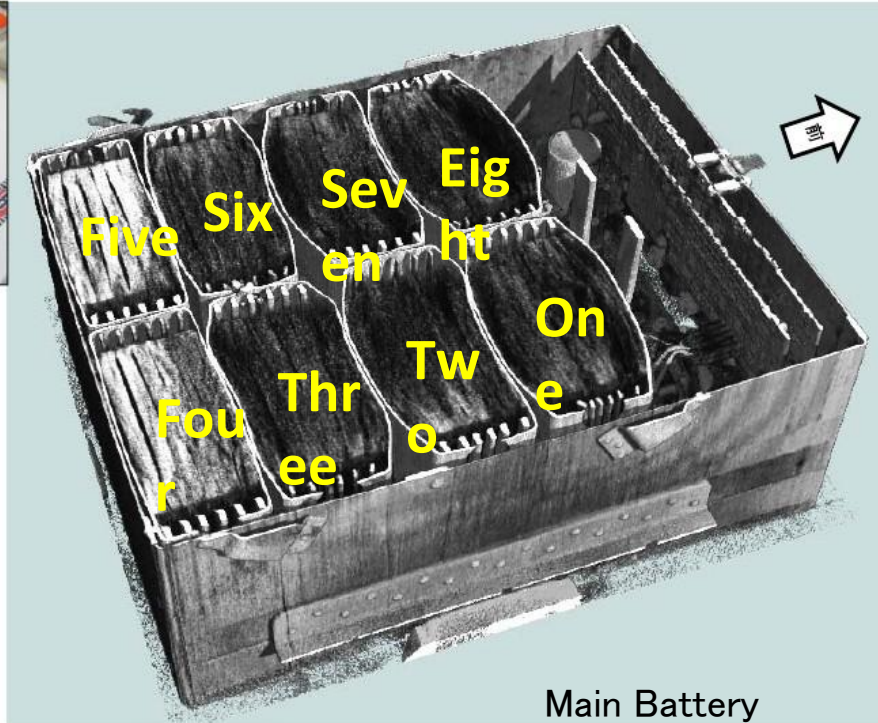
Main Battery

CT scans into 3D images taken by JAXA

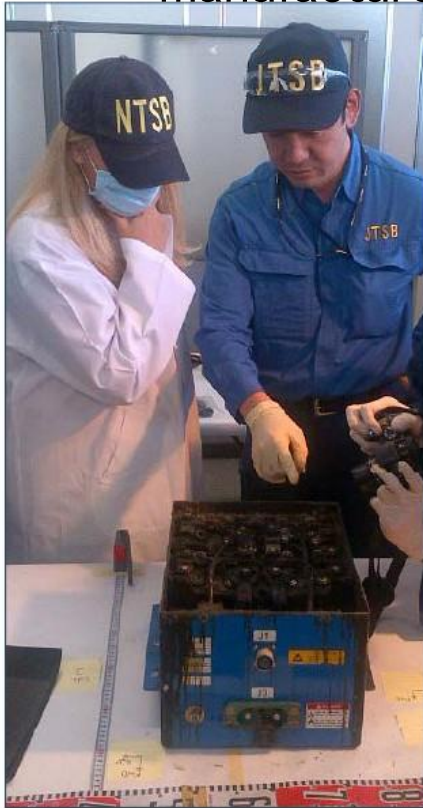
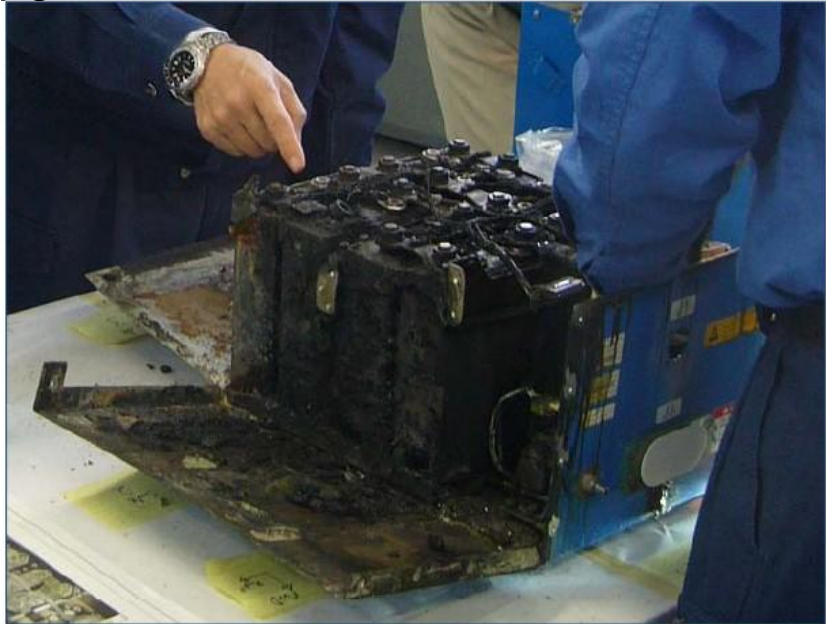
Main Battery

## 5. Degradation of the battery in the manufacturer's

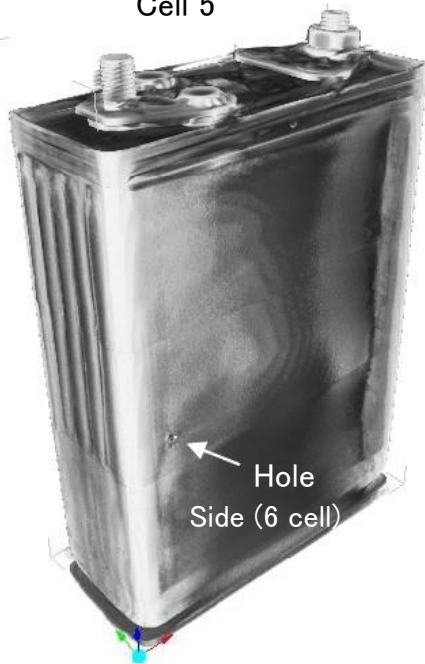
Cell 5

CT scan taken  
Into a 3D image

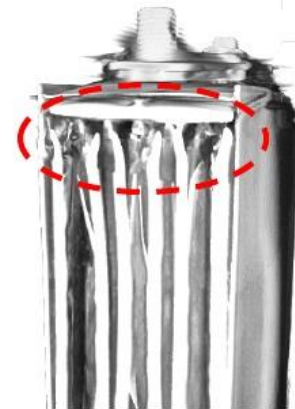
Cell 6

The positive  
electrode  
Internal wiring is  
Meltdown

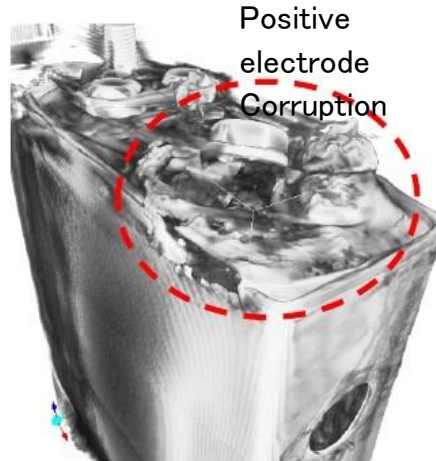
Cell 3

Positive  
electrode  
Corrosion

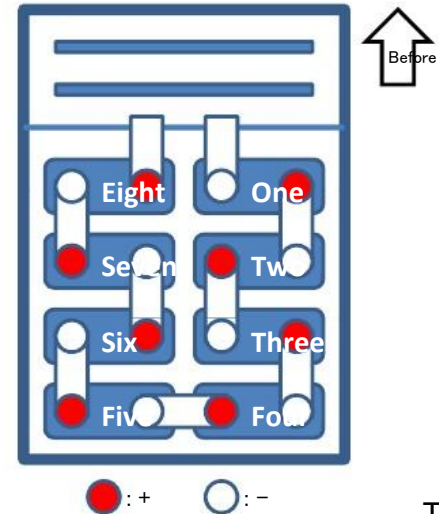
- Damage seen all eight cells.  
3 cell and 6 cell damage particularly large
- Thermal damage is seen in all cells
- Seen thermal runaway
- The positive electrode of the cell 3  
Damage damage is large size
- Except for cell 4 and cell 5  
Six positive electrode of the cell  
Observed in the internal fusing

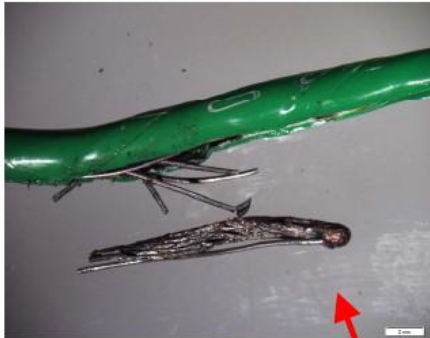
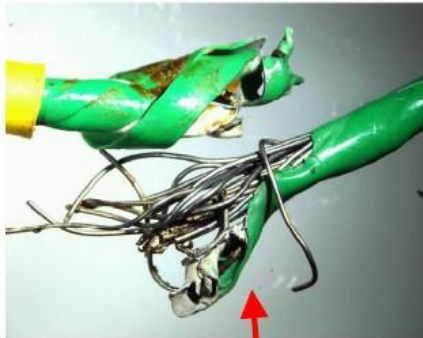
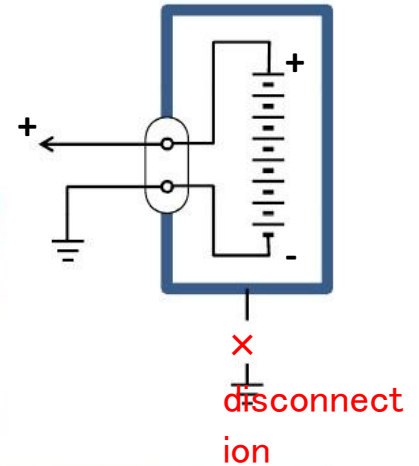
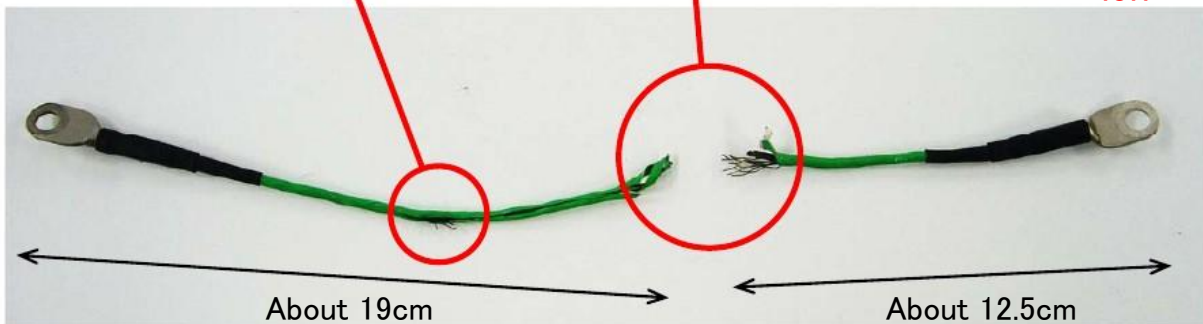
Ground wire of the enclosure battery is disconnected.

■ Continue the investigation of the  
disconnection of the grounding wire enclosure
