## MSP430F541x/543x Device Erratasheet

### 1 Current Version

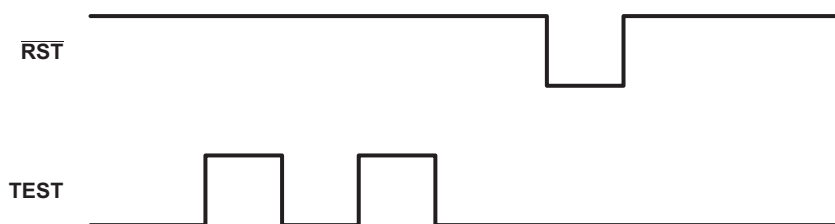
To exit the BSL one of the following methods must be used.

- A Power cycle
- or
- Toggle the TEST pin twice when  $\overline{RST}$  is high, and then pull  $\overline{RST}$  low.

**NOTE:** This sequence is not subject to timing constraints and the appropriate level transitions are sufficient to trigger an exit from BSL mode.
