## **Deep PIV Fiber Optic Assembly Report**

**Project: 901809.00 DeepPIV/ Deep Sea Bioinspiration**

**Author: Denis Klimov (EE) (sectioning), with input from Aaron Schnittger (MT); (potting; pressure testing).**

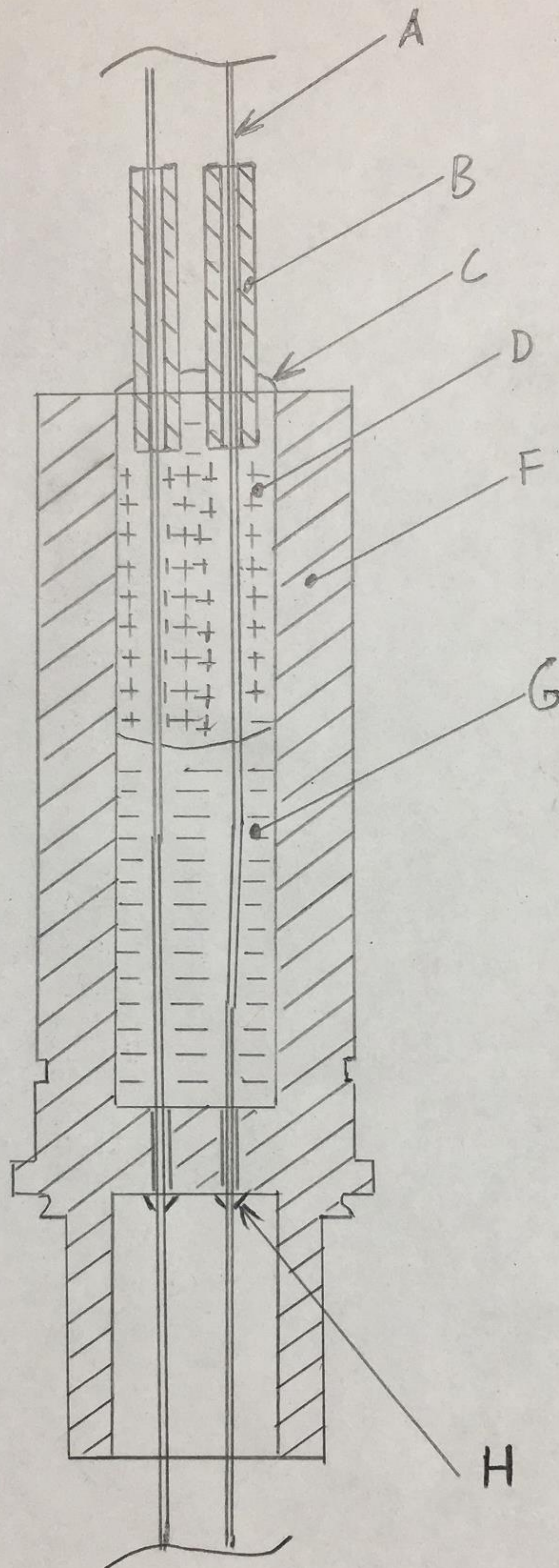
**Fig 1: Schematic diagram of Fiber Optic Penetrator potting assembly**

**A: Optical fibers, cleaned with acetone (x2)**

**B: Strain tubing 1.25", abraded, cleaned with acetone, potted length 0.25" (2x)**

**C, D: Soft (rubbery) potting compound (Devcon Flexane 80 Liquid 15800)**

**F: Stainless Steel Penetrator (drawing FIBER OPTIC CABLE PLUG; P-1002444-18), acid etched, acetone cleaned**

**G, H: Hard two part epoxy-Loctite E-60NC**

- Final configuration was devised with two-part fills and strain relieve tubing, with two assembly successfully tested under pressure. Concept configuration is shown on (**Fig 1**) and assembly procedure described in report **[9]**

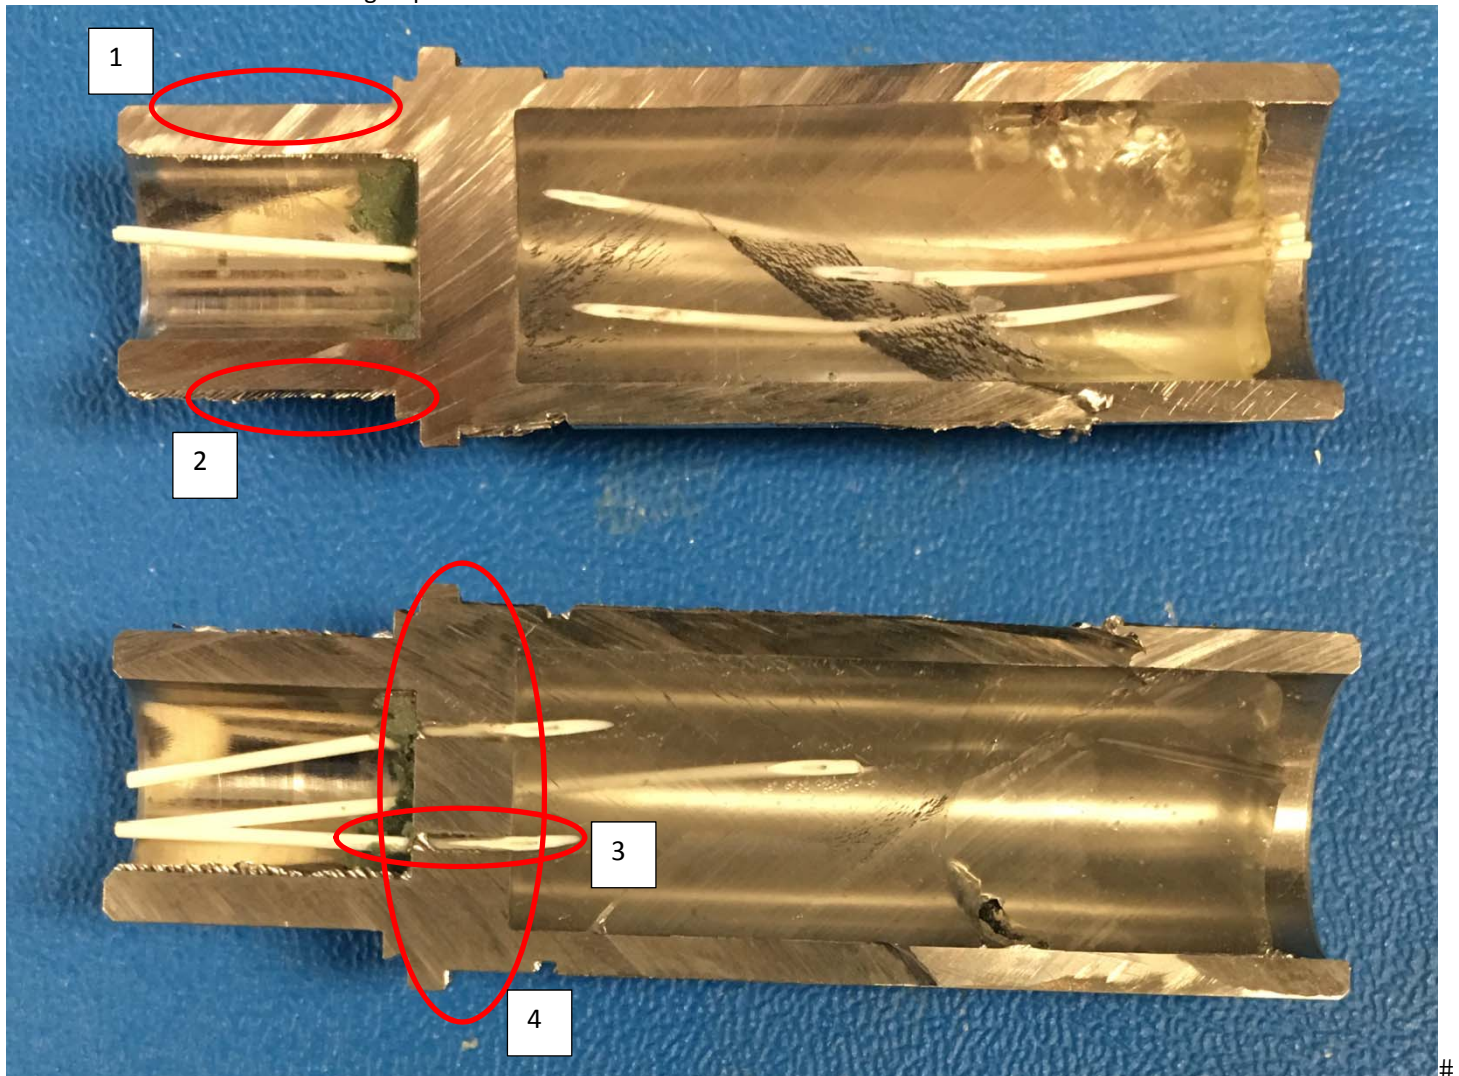
Fig 1. (Sample 1). **Did not leak** under pressure. Note the difference in presence/ absence of burrs on the edge depending on the blade transition from air to steel or steel to air (Illustration circles 1,2). Bottom of the penetrator has thick base designed to withstand the water pressure up to ~ 1000 meters (Illustration circle 4). Base has 4 small (0.040"-0.062") holes designed for passing individual fibers (Illustration circle 3).#

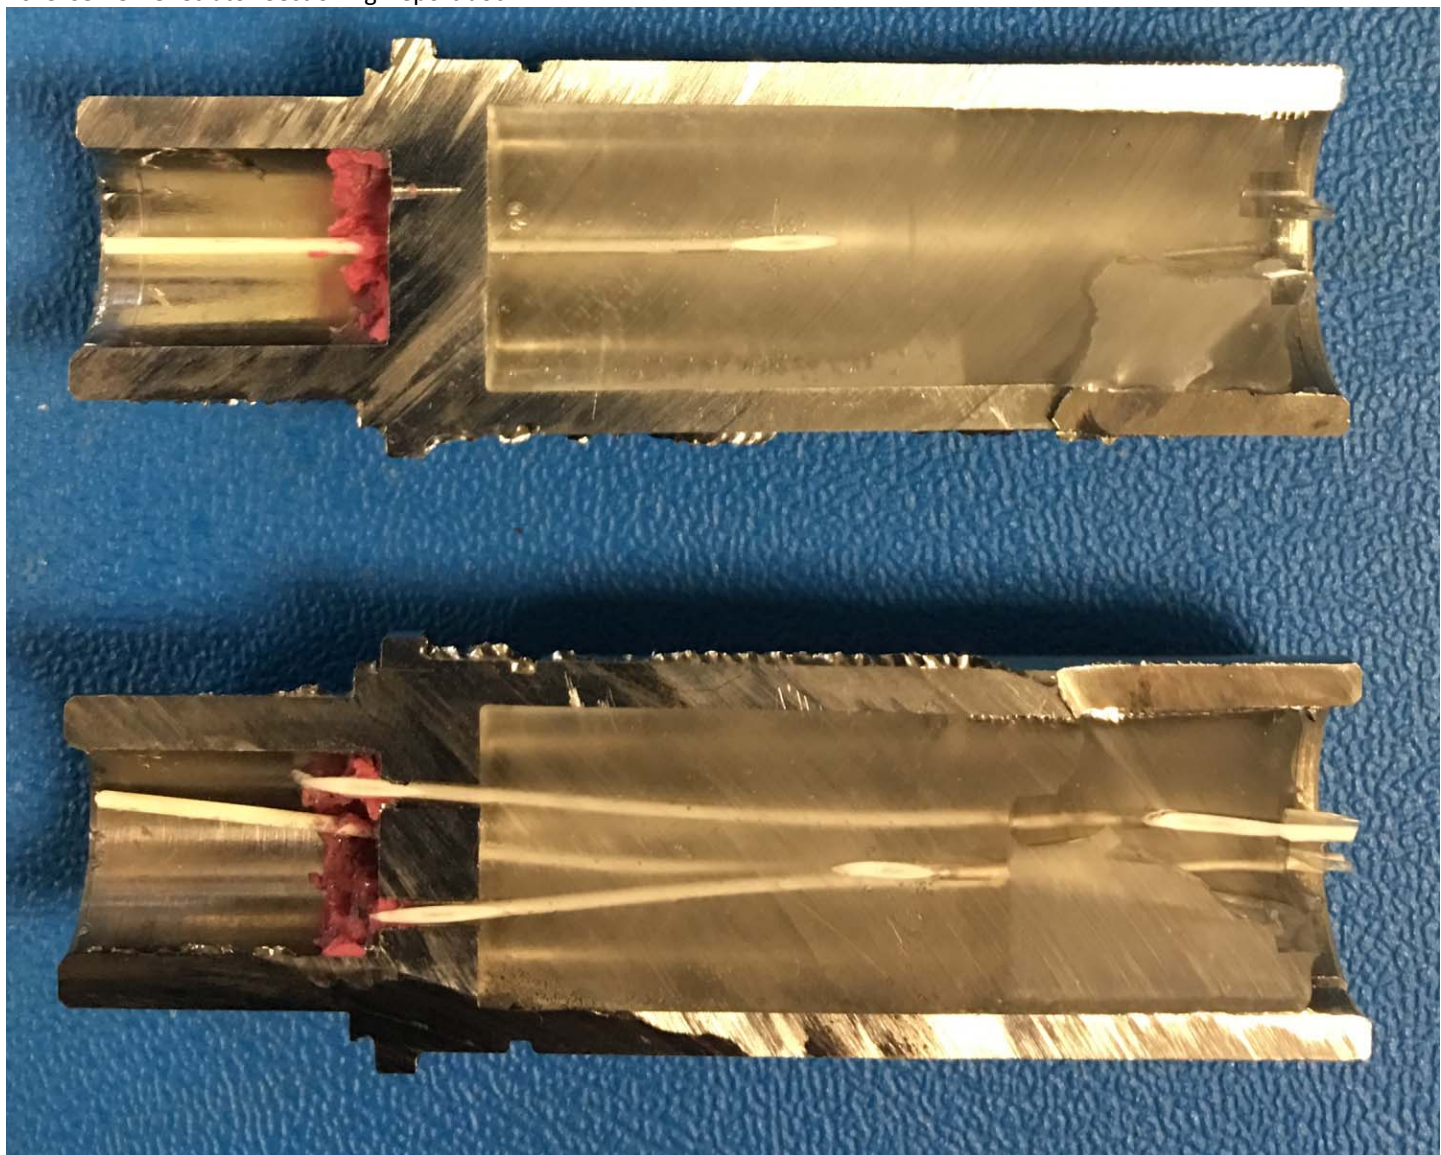
Fig 2. (Sample 2). Developed leak under pressure. #

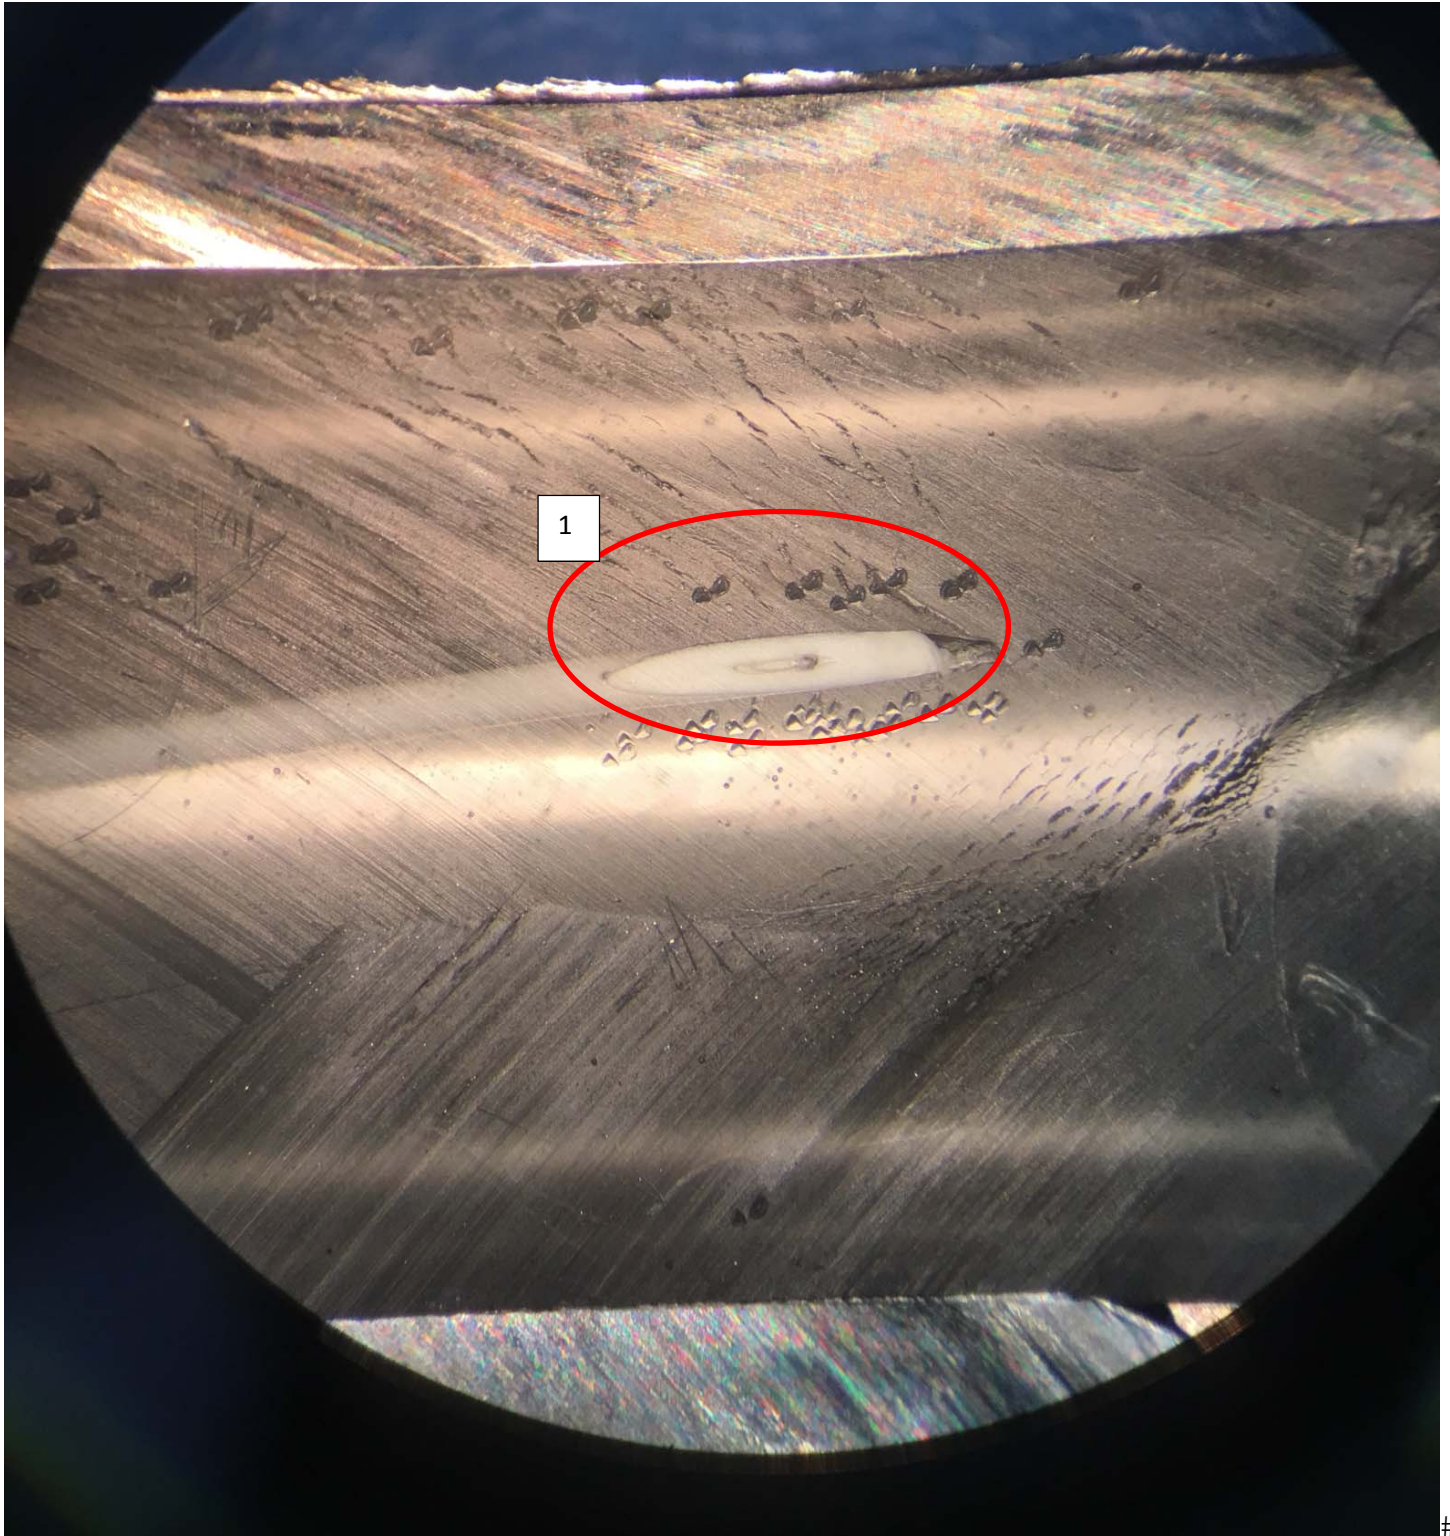
Fig 3. (Sample 1). No perceived gap between epoxy and optical fiber. Fiber can be pulled out by force, but some level of adhesion is present. No signs of liquids in the gap(s). (Illustration circle 1)#

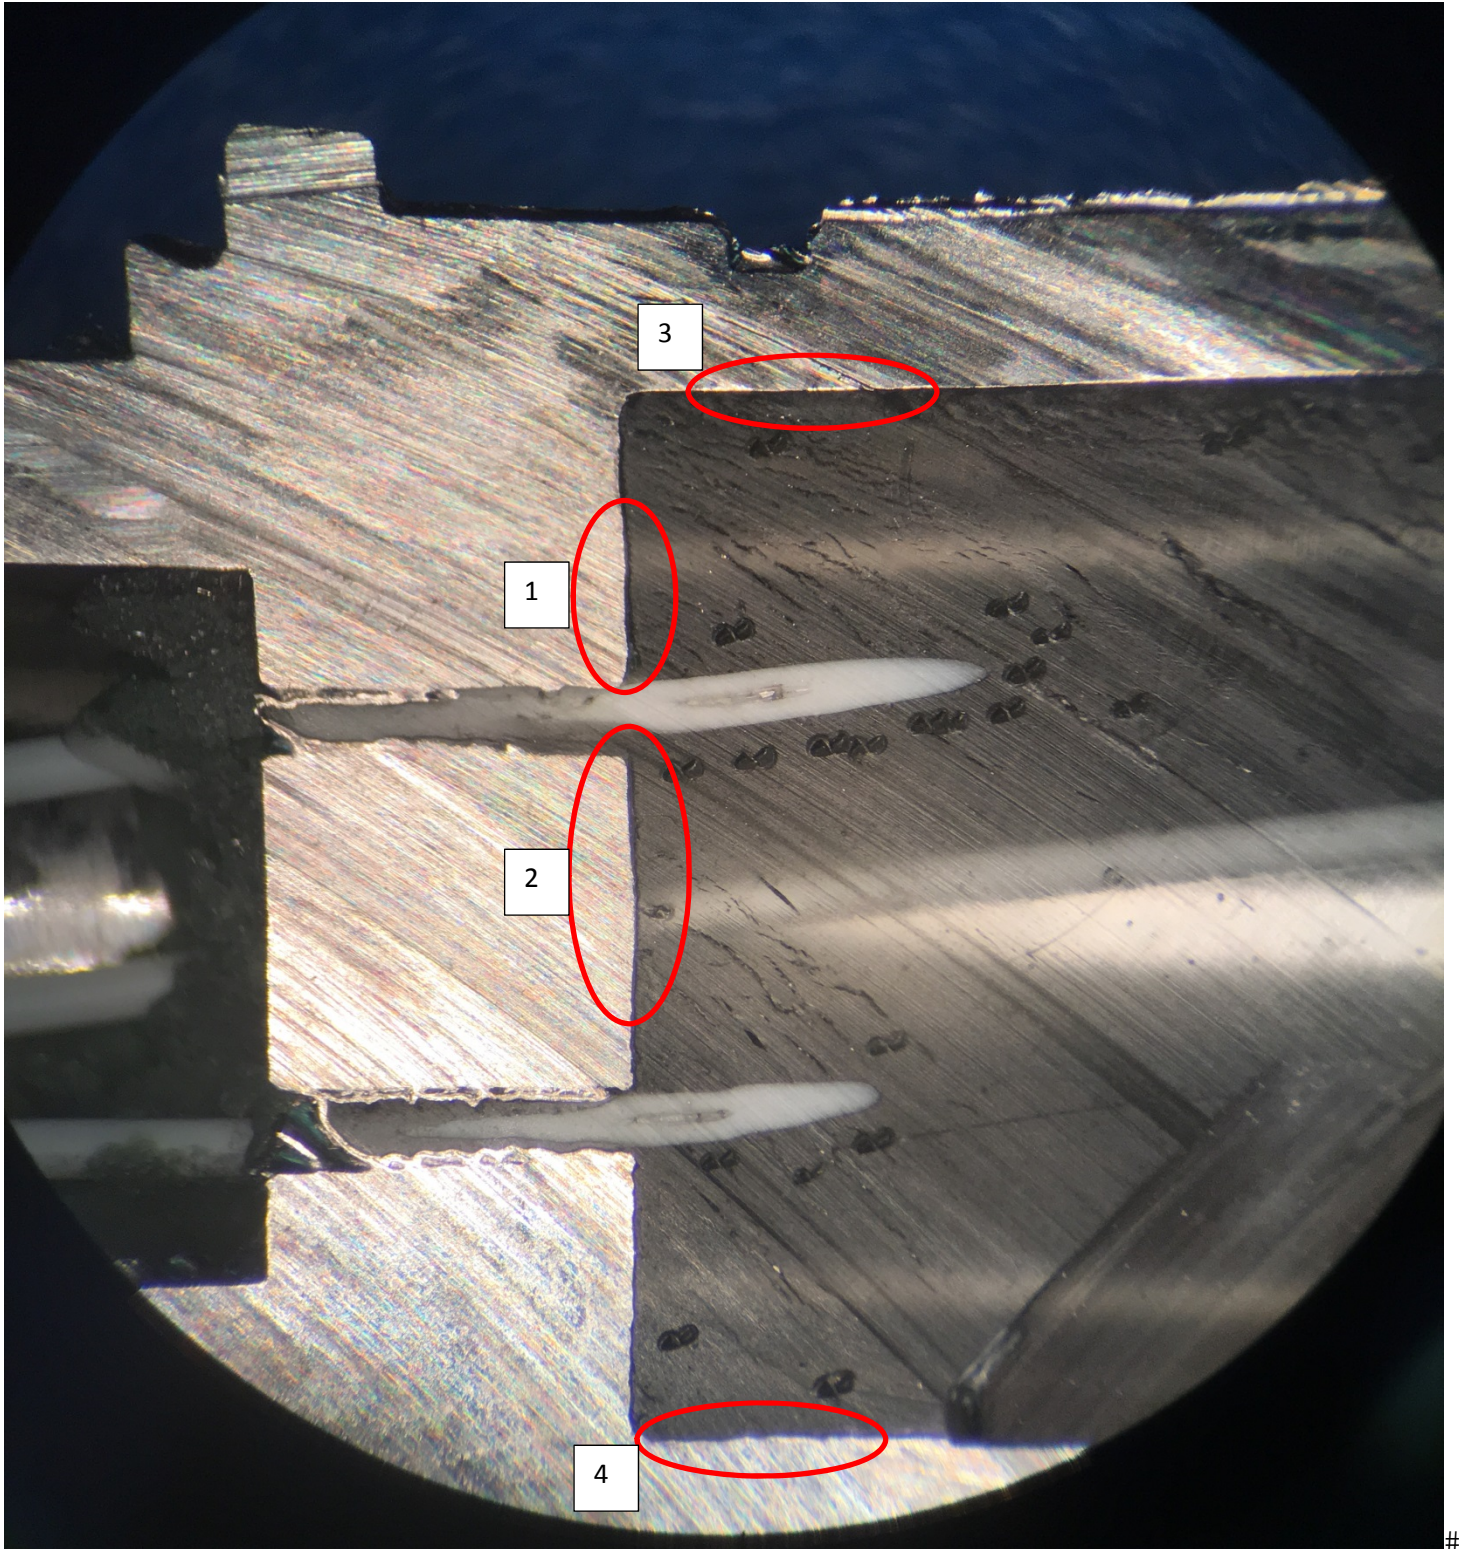
Fig 4. (Sample 1). There seems to be gap visible between the epoxy and the penetrator tube thru most of potting perimeter (illustration circles 1, 2). It is not clear if the gap is an artefact of cutting process or was it present before cutting. The argument against artefact is that the gap looks the same on top and bottom part of the picture irrespectively of blade transition from epoxy to steel or steel to epoxy (Illustration circles 3, 4) as compared to transition from steel to air and air to steel visible on Fig 1.

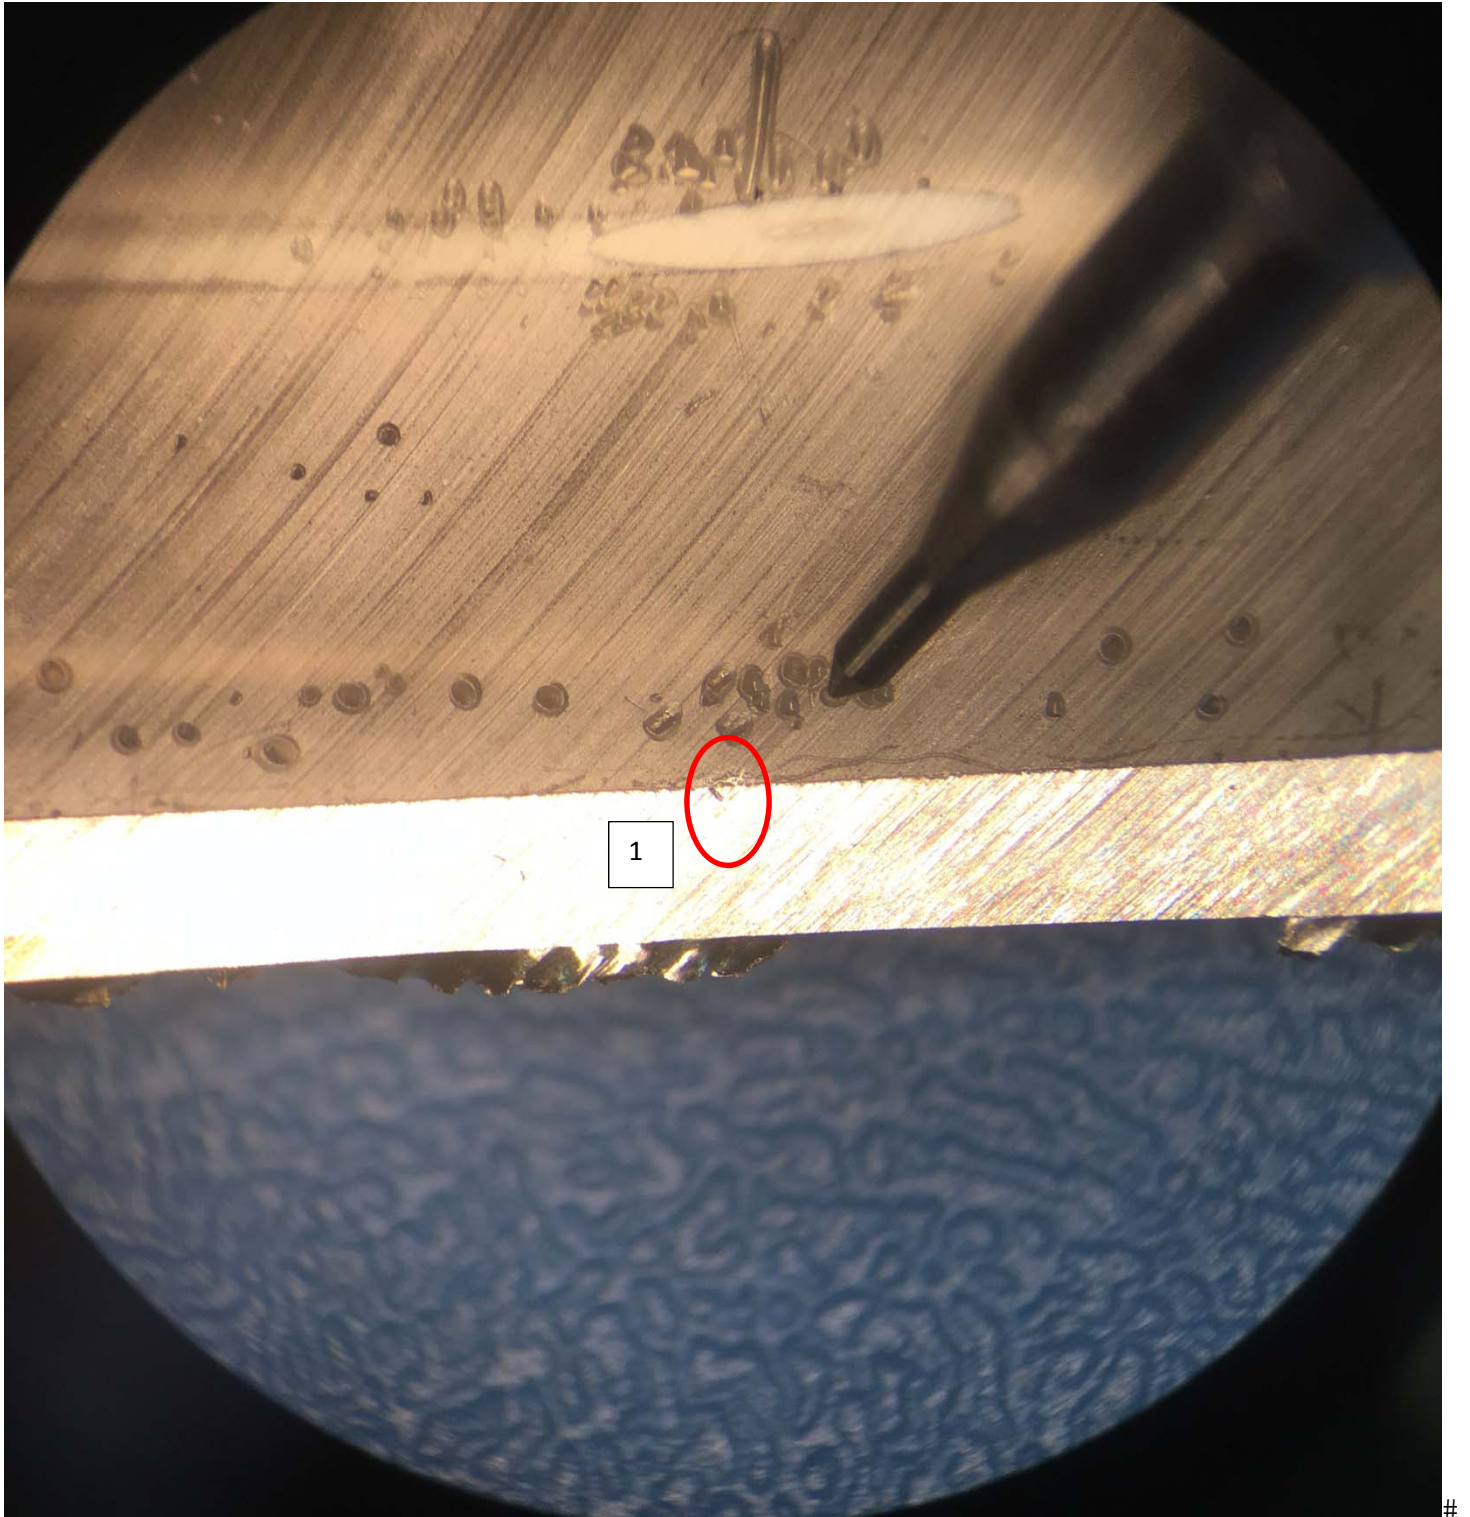
Fig 5. (Sample 2). There seems to be liquid present between the epoxy and the penetrator tube. When pressed with probing tool, micro droplets of liquid come out of the gap (Illustration circle 1)#

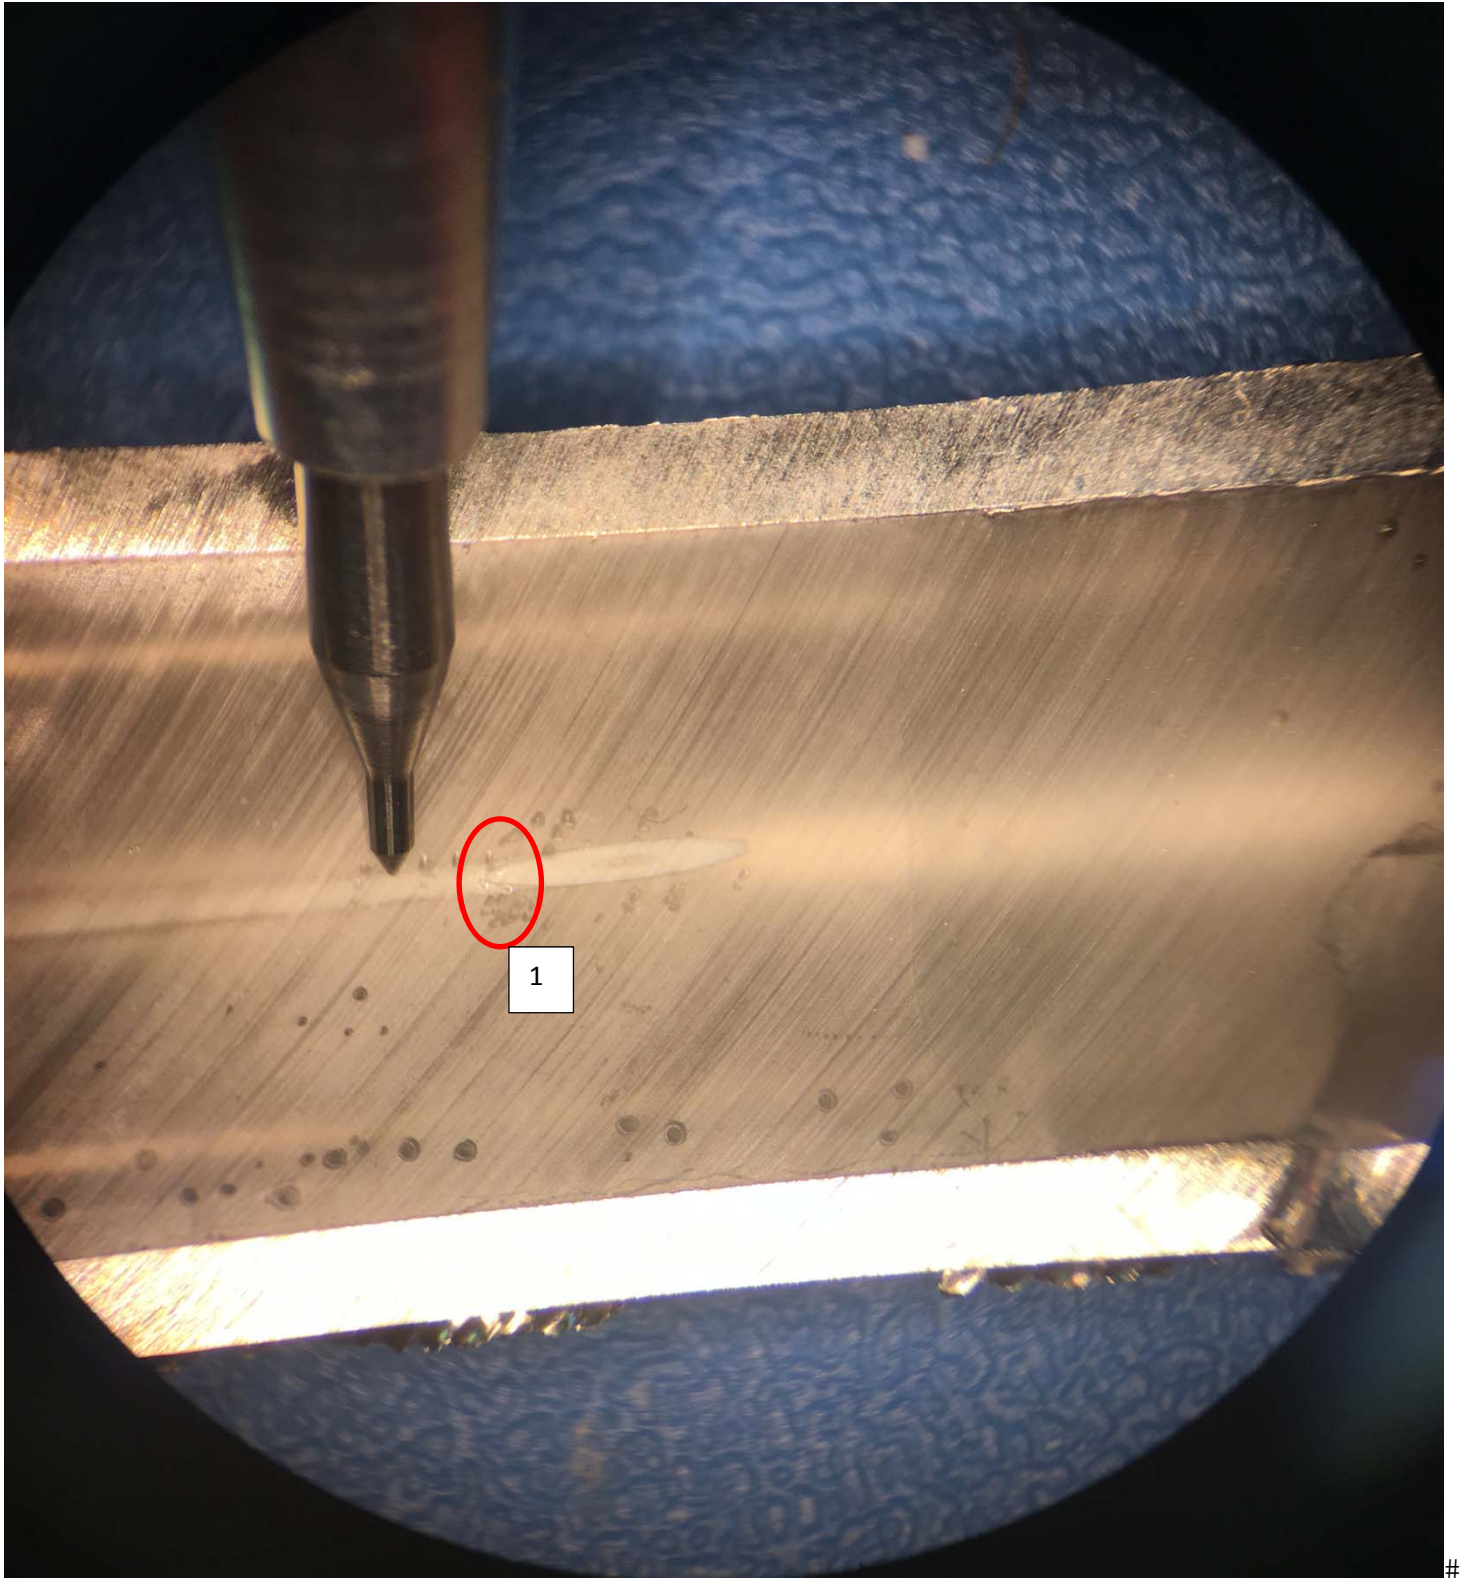
Fig 6. (Sample 2). There seems to be liquid present between the epoxy and the optical fiber. When pressed with probing tool, micro droplets of liquid come out of the gap (Illustration circle 1)#

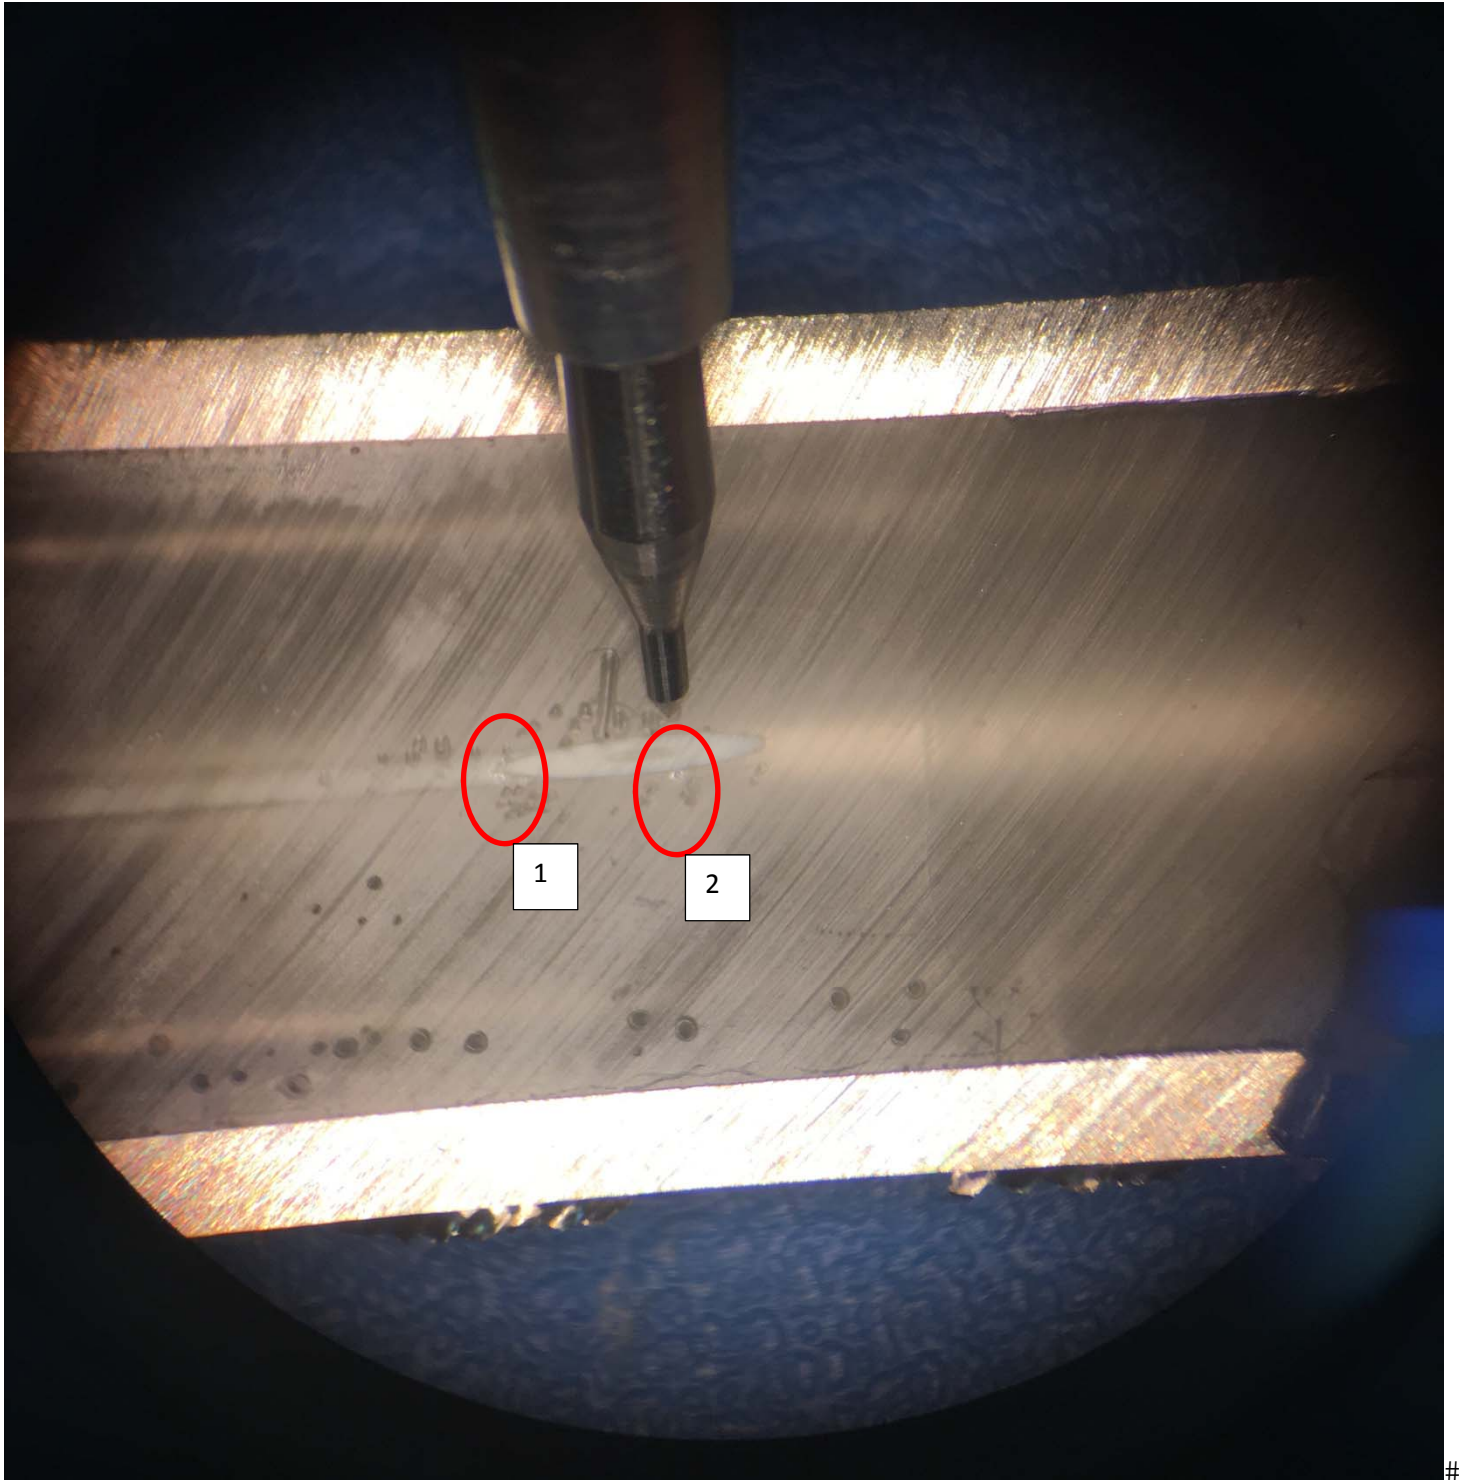
Fig 7. (Sample 2). There seems to be liquid present between the epoxy and the optical fiber. When pressed with probing tool near other side of fiber section; micro droplets of liquid come out of the gap near that spot as well (Illustration circles 1, 2)#

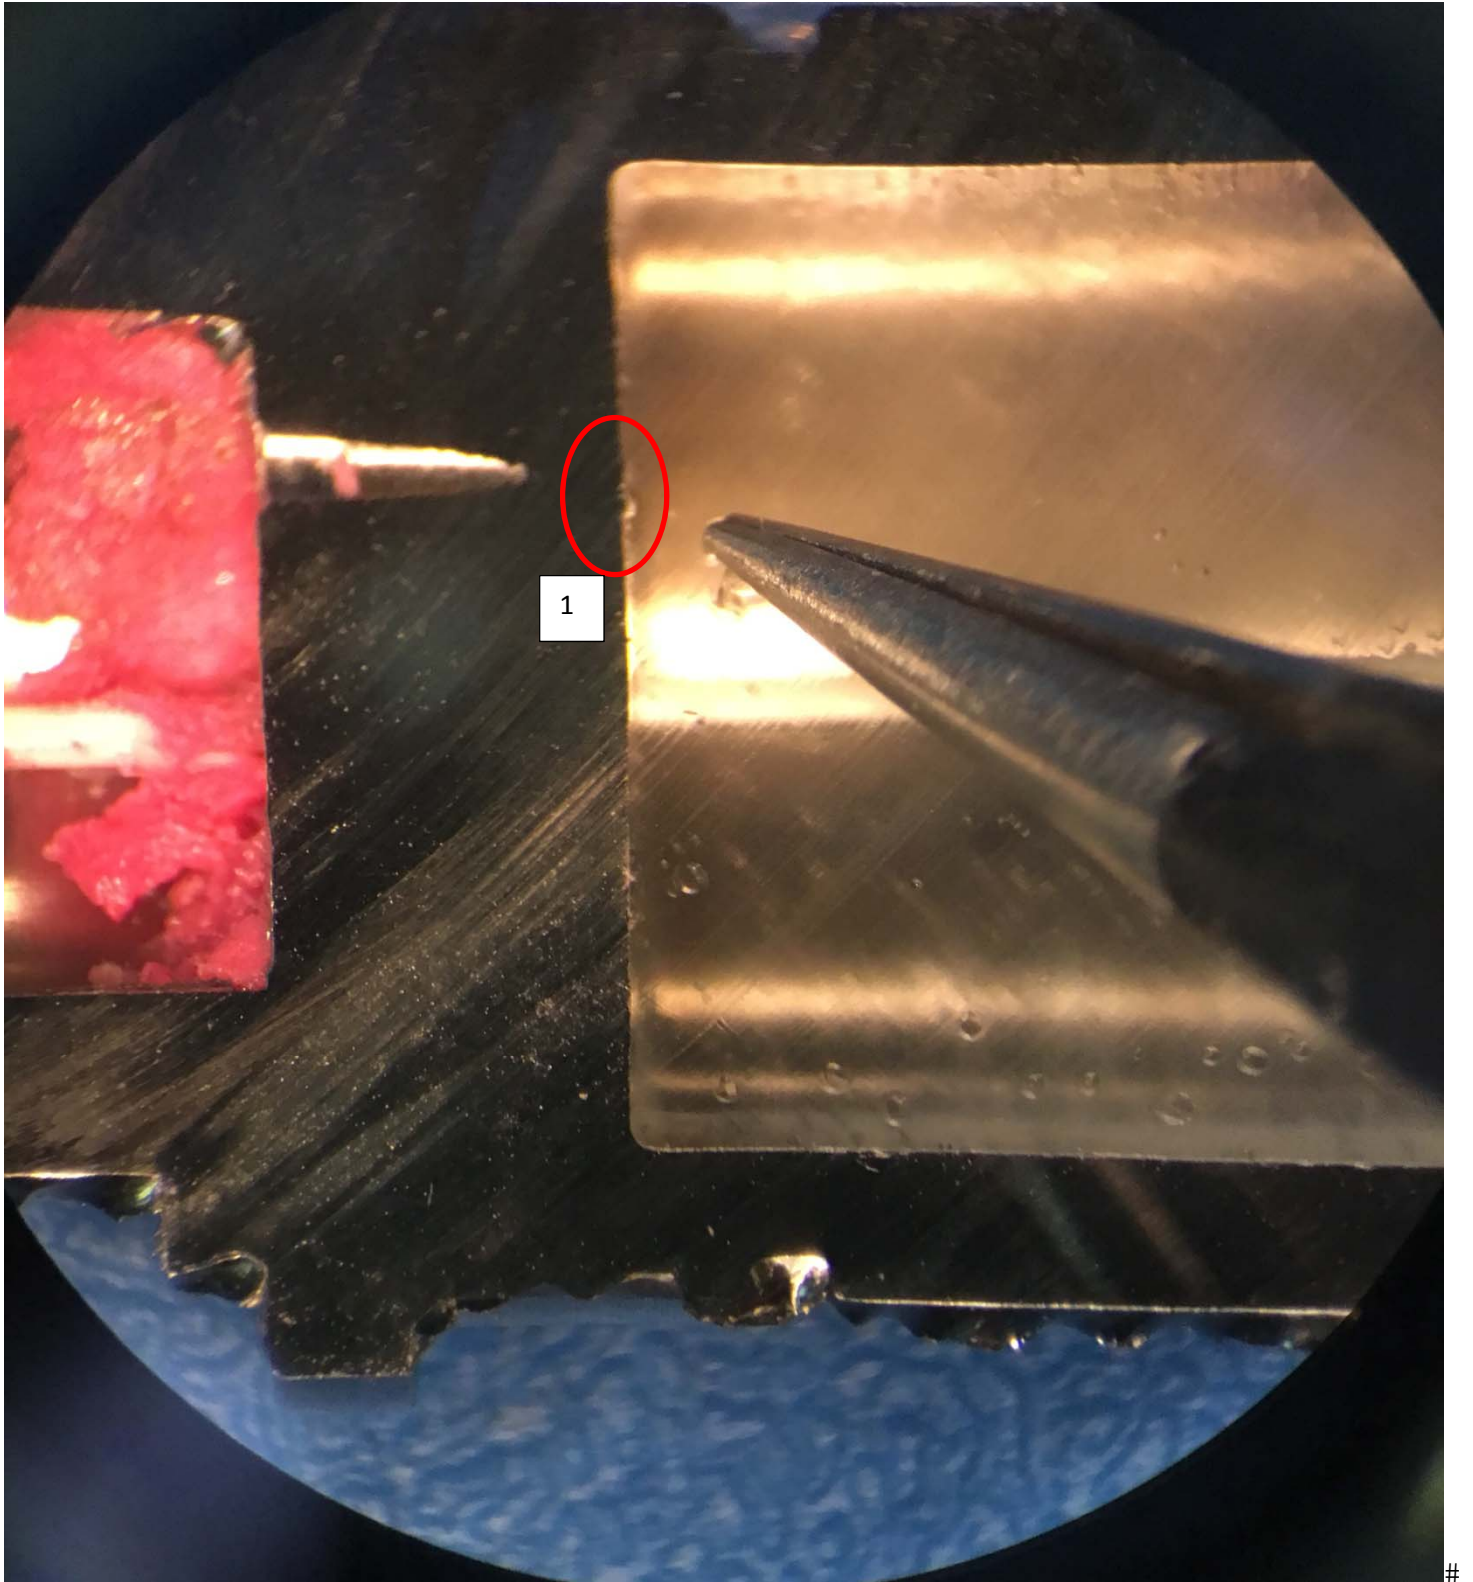
Fig 8. (Sample 2). Similar to Fig 6, 7; when pressing with probing tool near the edge on the bottom of the potting pocket, micro droplets of liquid come out of the gap (Illustration circle 1). Visibility of the droplet is not so great in this picture; but it is visually apparent when viewing under stereo microscope

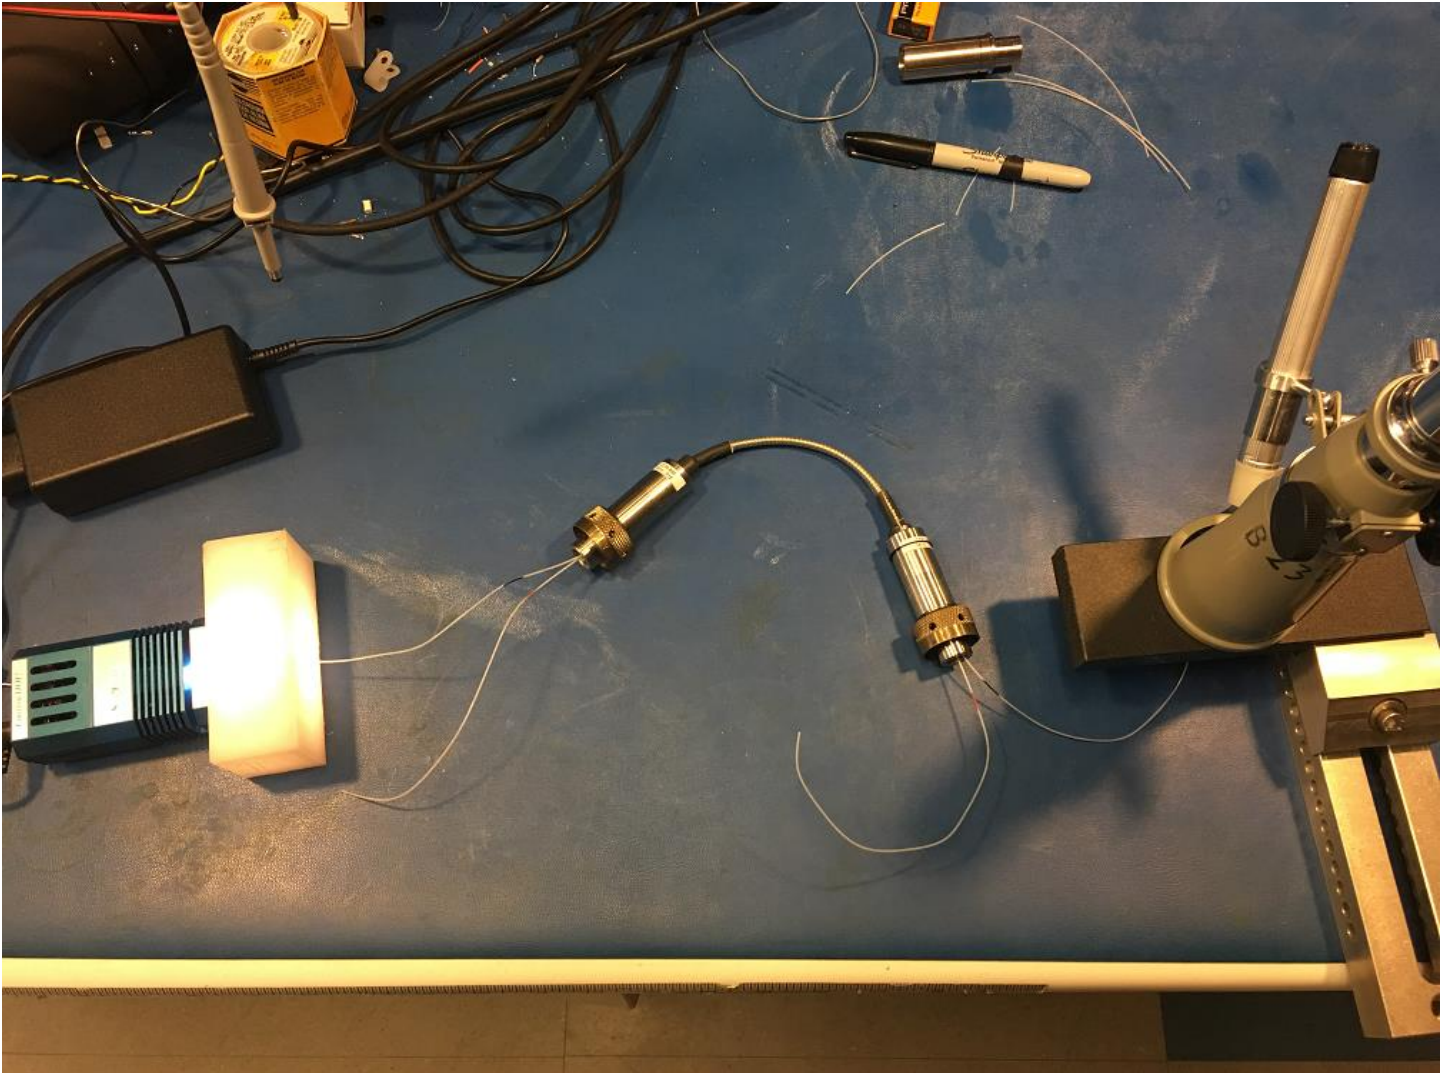
- Check light transmission on 2 fibers – done 4/15/2019 (Klimov)
    - Black fiber was transmitting; while **red did not transmit** (Fig 10, 11)
    - Red fiber was subsequently trimmed with 1" steps and inspected after each trimming; but even after trimming both sides to 1" long length (sections which were never folded); the fiber does not transmit, suggesting **internal damage to one fiber** (Fig 12)

**Fig 10. Testing optical transmission after pressure testing. Fiber marked 'black' is transmitting; fiber marked 'red' is not (4/15/2019)**

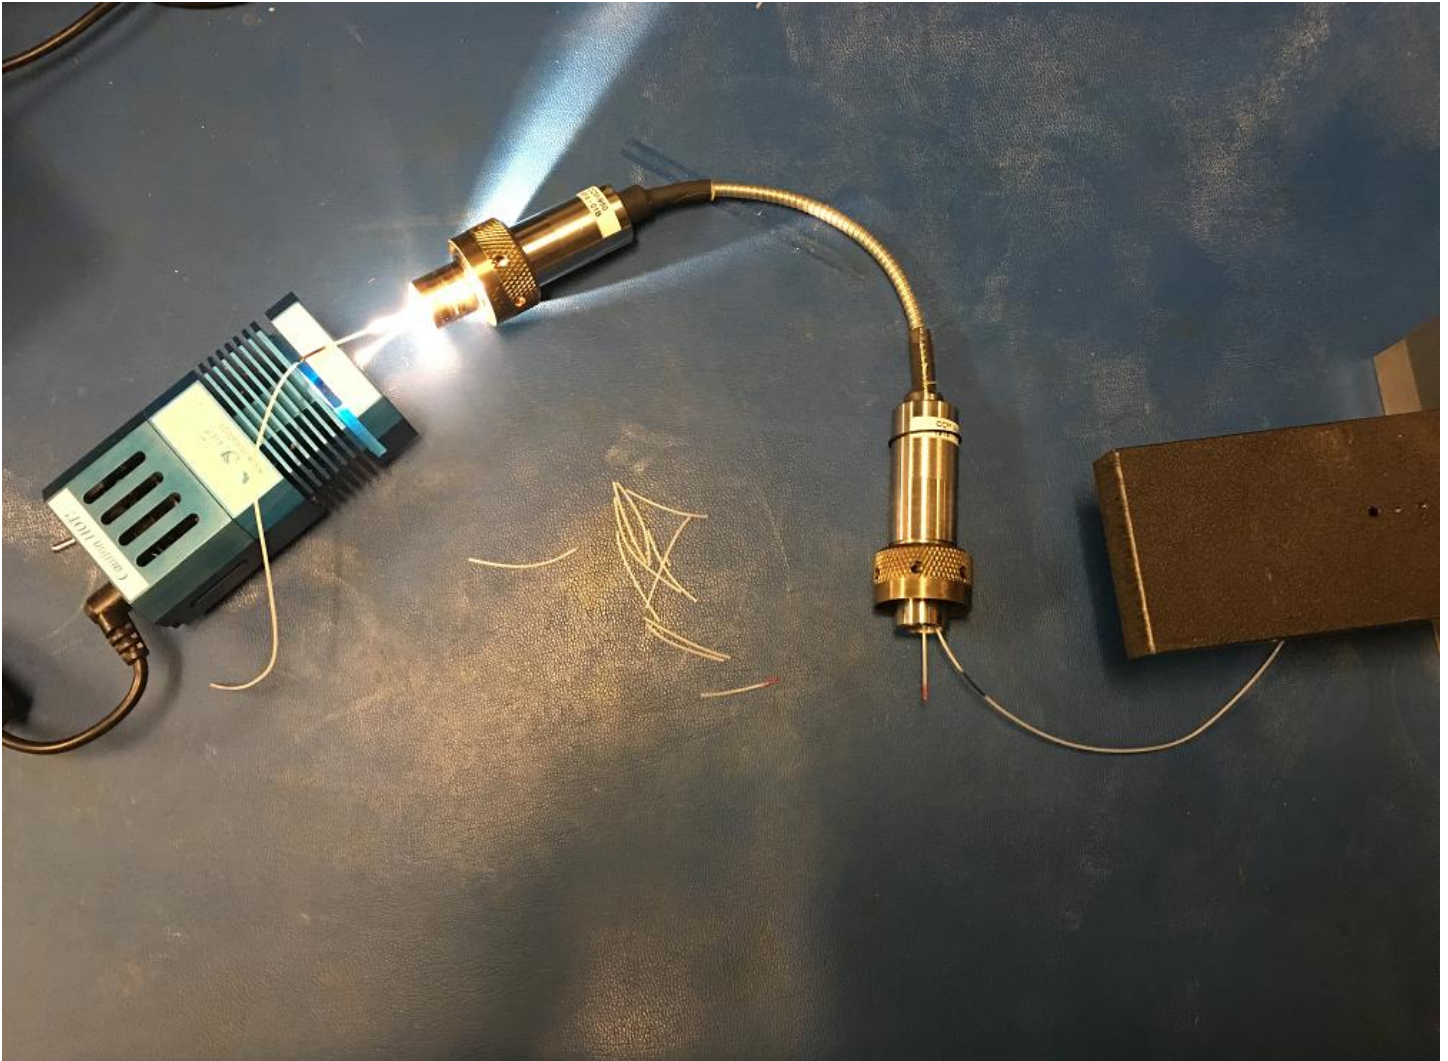
**Fig 12. Testing optical transmission after pressure testing. Fiber marked "red" is sequentially cut by 1" at the time alternating on both sides. Even after 1" (straight section) left on both sides, red fiber is not transmitting; suggesting internal damage to the fiber (4/15/2019)**
