## **Deep PIV Fiber Optic Assembly Report**

**Project: 901809.00 DeepPIV/ Deep Sea Bioinspiration**

**Author: Denis Klimov (EE) (sectioning), with input from Aaron Schnittger (MT); (potting; pressure testing).**

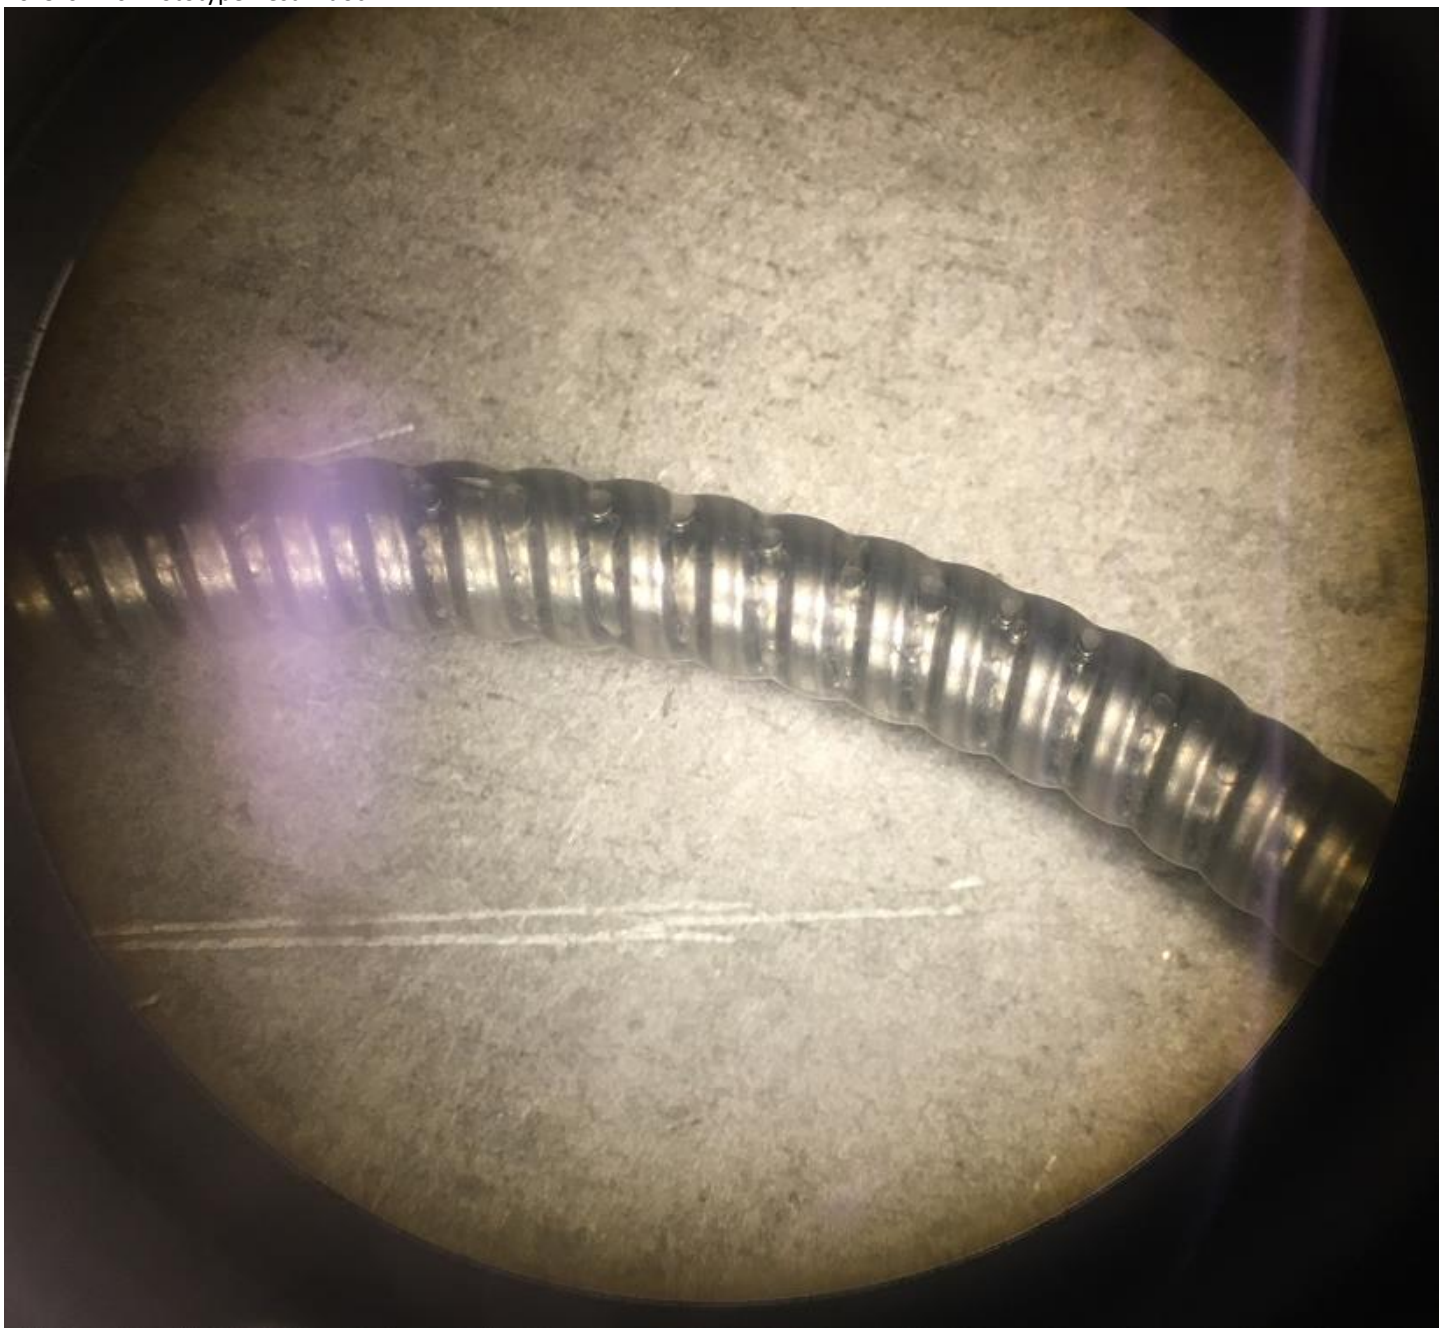
- The **spiral steel jacket is flooded** as observed thru clear heat shrink jacket (Fig 13, 14).

**Fig 13. After pressure testing. Spiral jacket under heat shrinking tubing is flooded; air bubbles are visible (4/15/2019)**

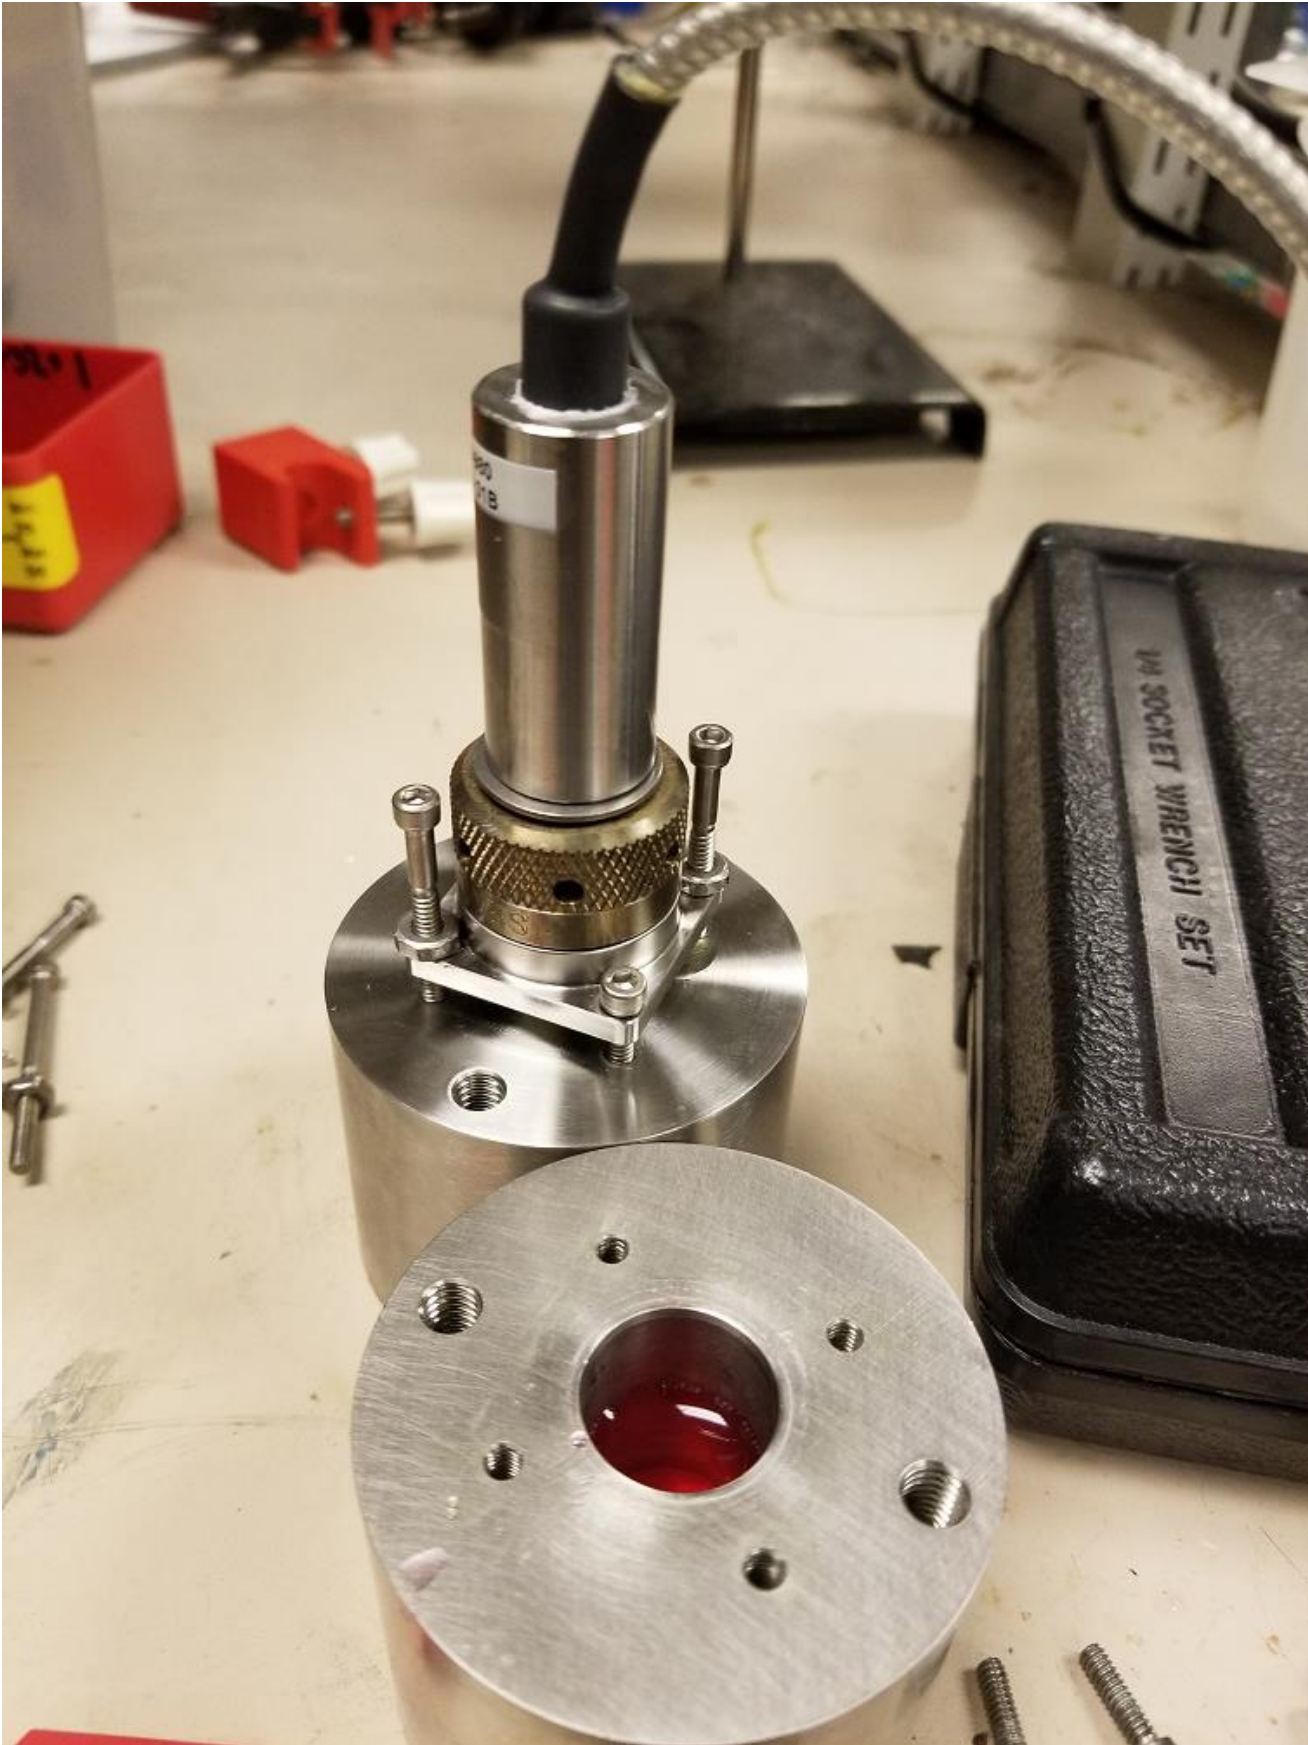
- Remove 2 connectors and check for presence of water in the dry volume – done 4/15/2019 (Schnittger)
    - **Both dry volumes were found flooded** (Fig 15)

- Pressure was observed in the "dry" volumes on both sides; suggesting that **water intrusion occurred thru some sort of 'soft' interface capable on acting like a valve**; and not thru opening or a gap which would allow pressure release.

**Fig 15. Assembly opened after pressure testing. Mixture of water with liquid-detecting dye is visible (4/15/2019, photo by Schnittger)**

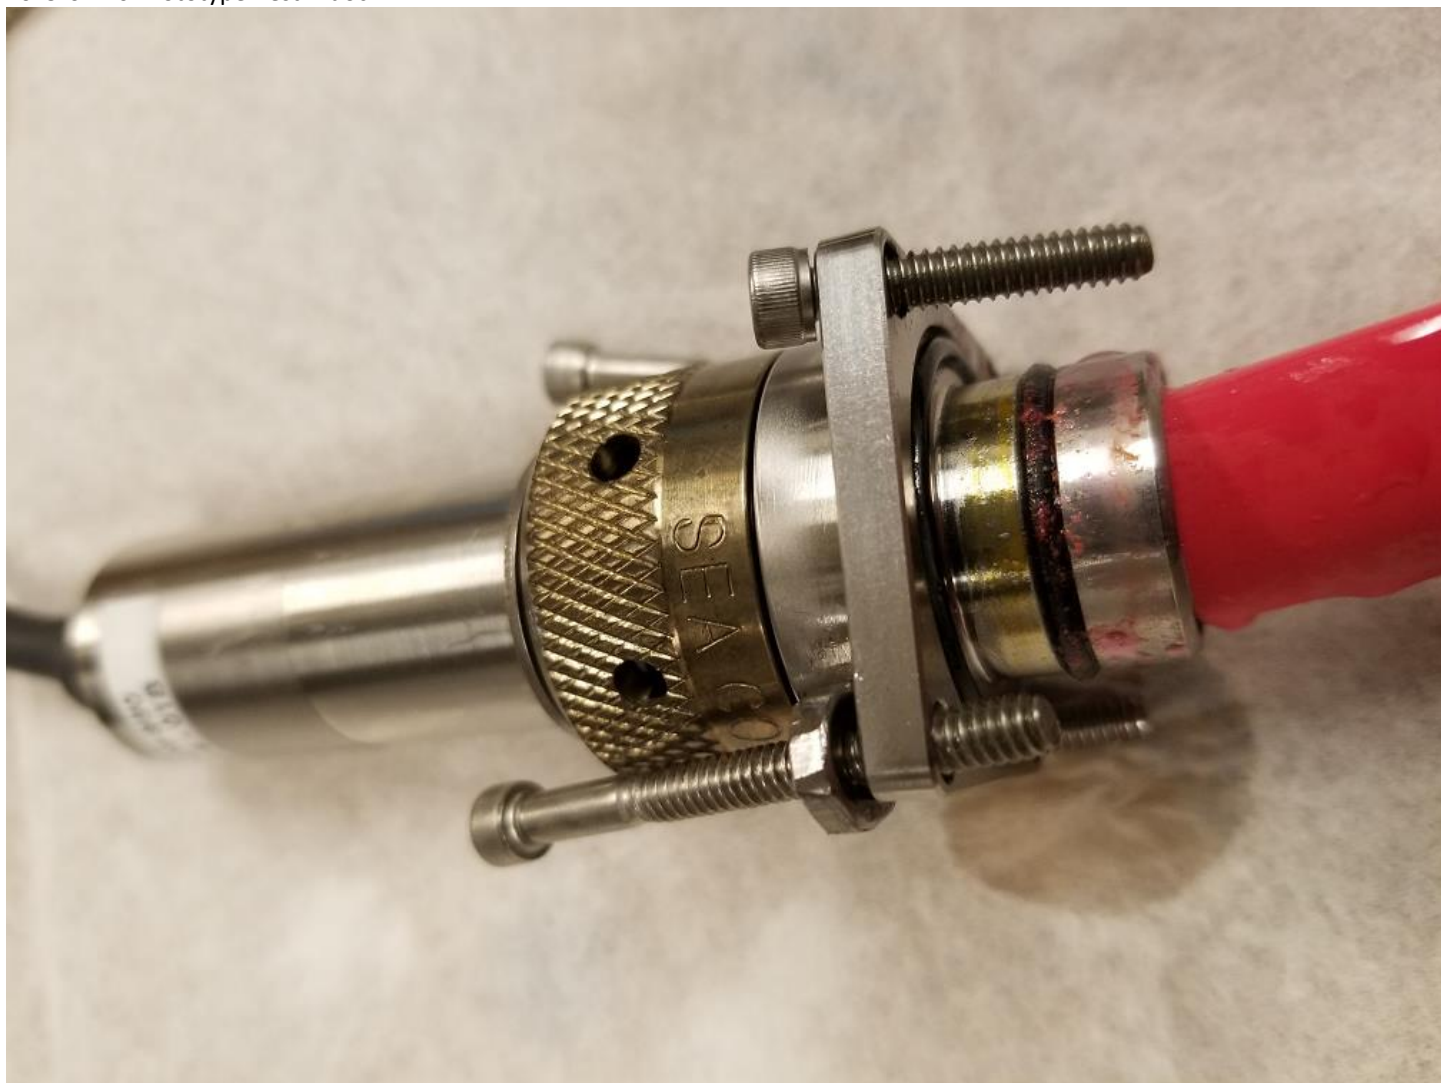
- Water intrusion was most likely thru penetrators **and not by O-rings**, since moisture-detecting dye did not detected water between O-rings (Fig 16, 17)

**Fig 16. Assembly opened after pressure testing. Pressure relieve mechanism (4/15/2019, photo by Schnittger)**

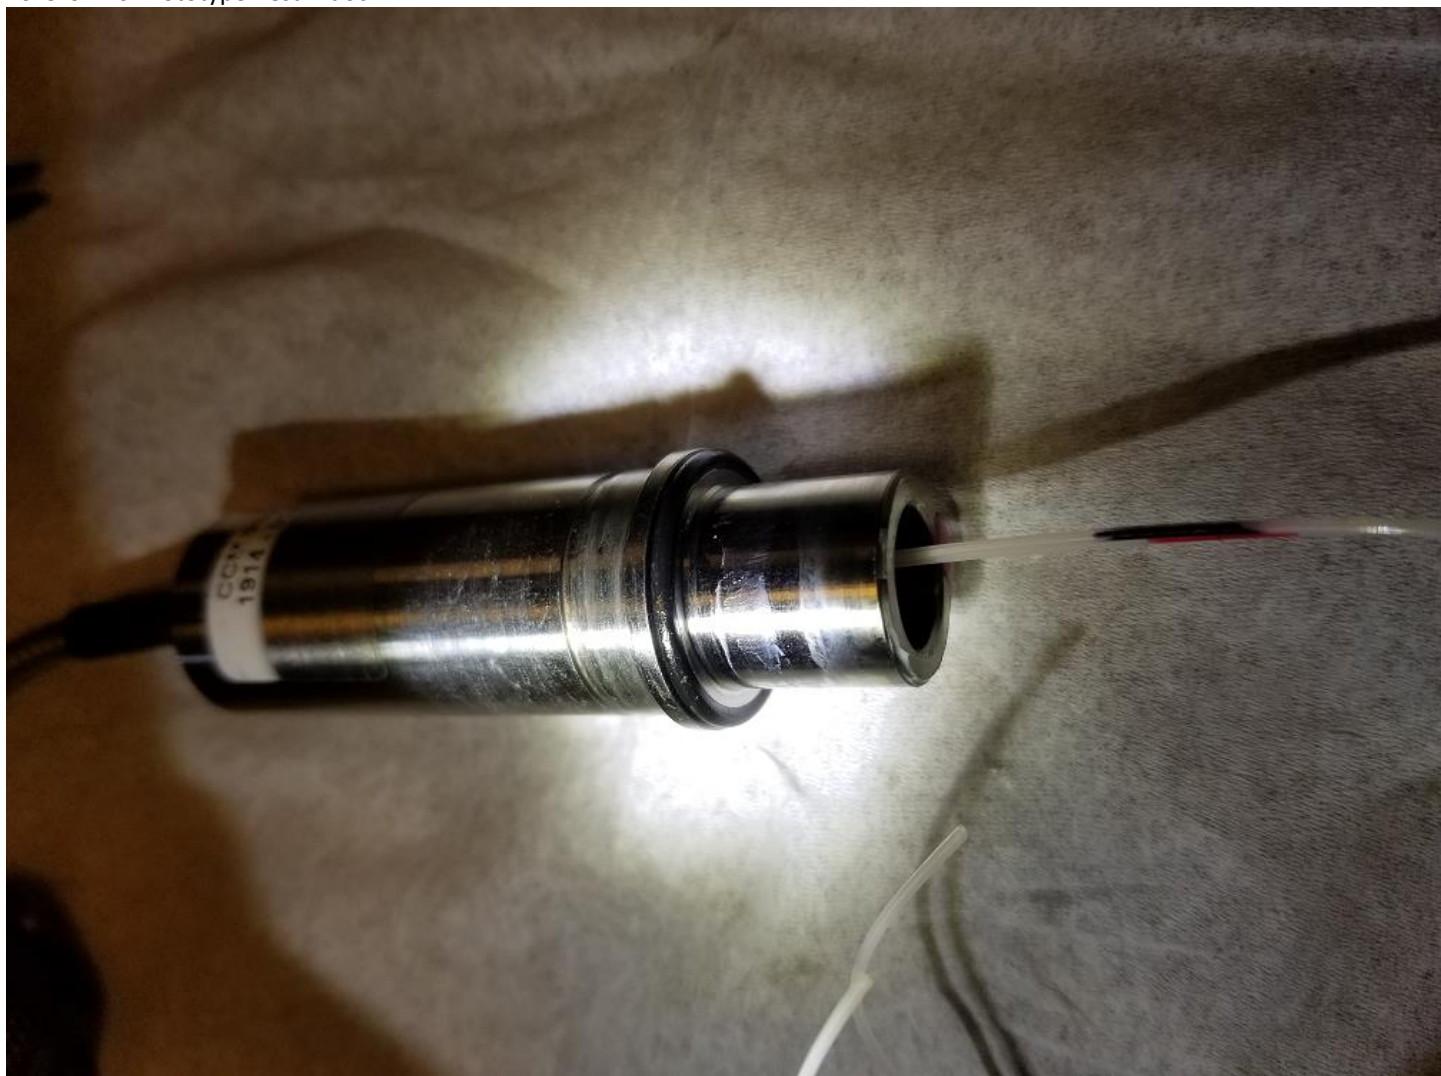
**Fig 17. Assembly opened after pressure testing. Penetrator photo (4/15/2019, photo by Schnittger)**

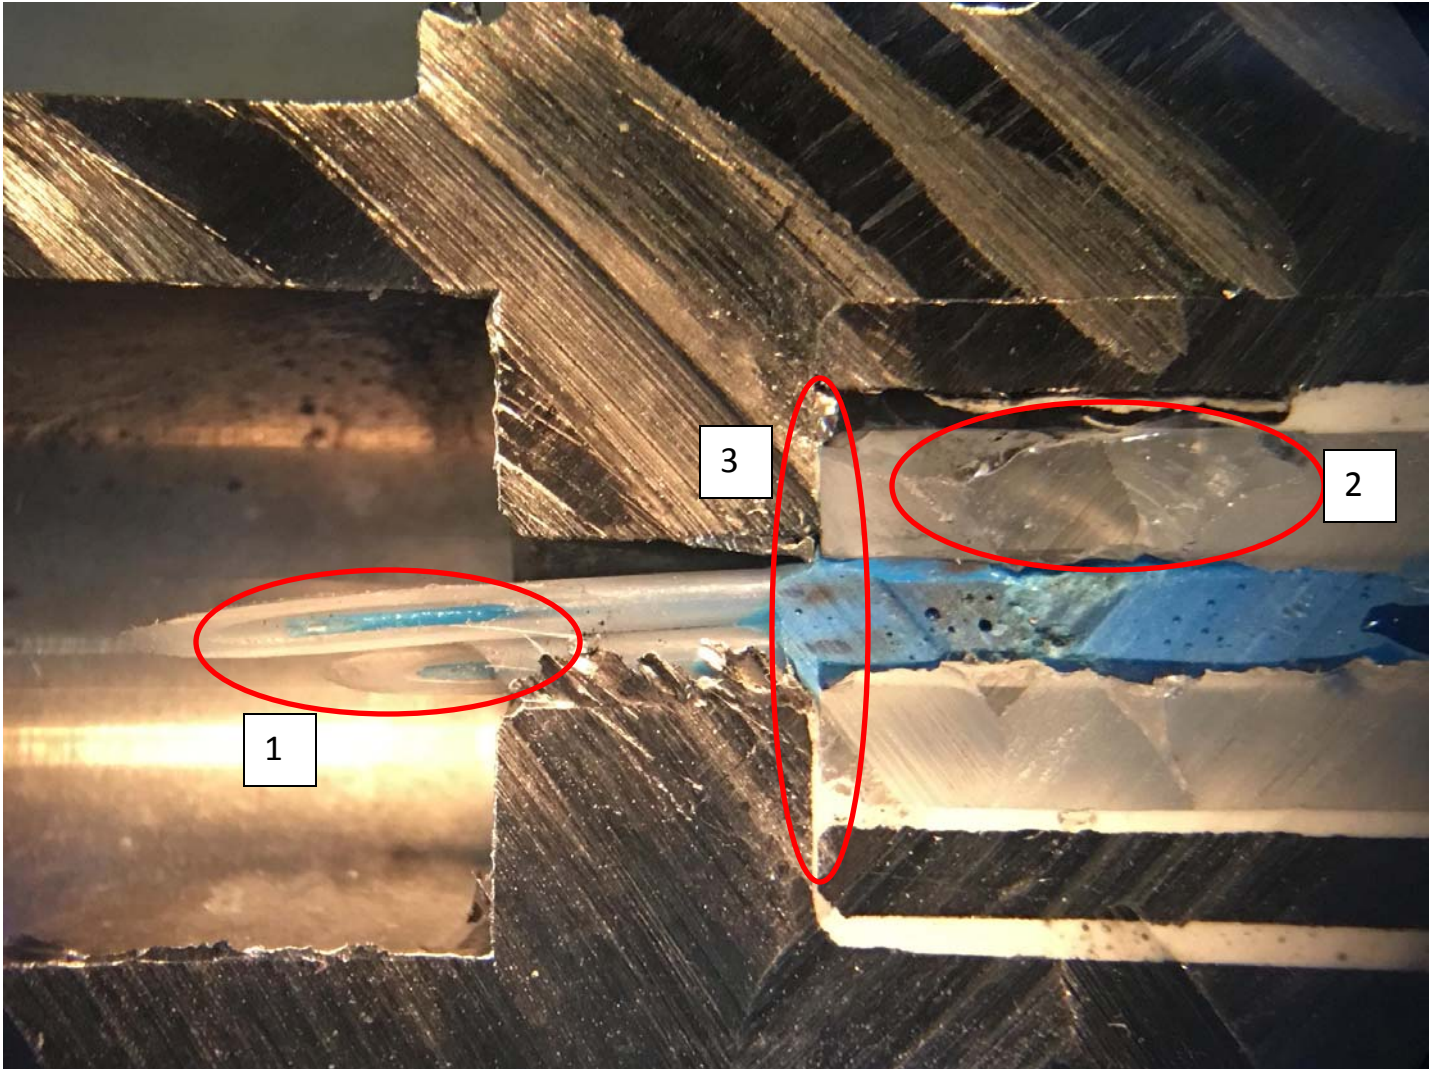
- Glass tube is observed to be fractured in multiple places. One could argue this happened during sectioning; however, diagonal fracture lines may indicate typical failure under axial load, as observed by Jon Erickson (Fig4, 13). This might be a result of too high/ uneven contact pressure on the glass tube in the point of contact with metal (Fig 2).

**Fig 2. Middle section photo 1 of 7 (counting left to right). Visible elements: (1): two fibers, blue in color; each is contained in individual clear plastic tube; (2): multiple fractures in the glass tube; (3): glass tube is placed in very close proximity (or touching) the base of metal penetrator**

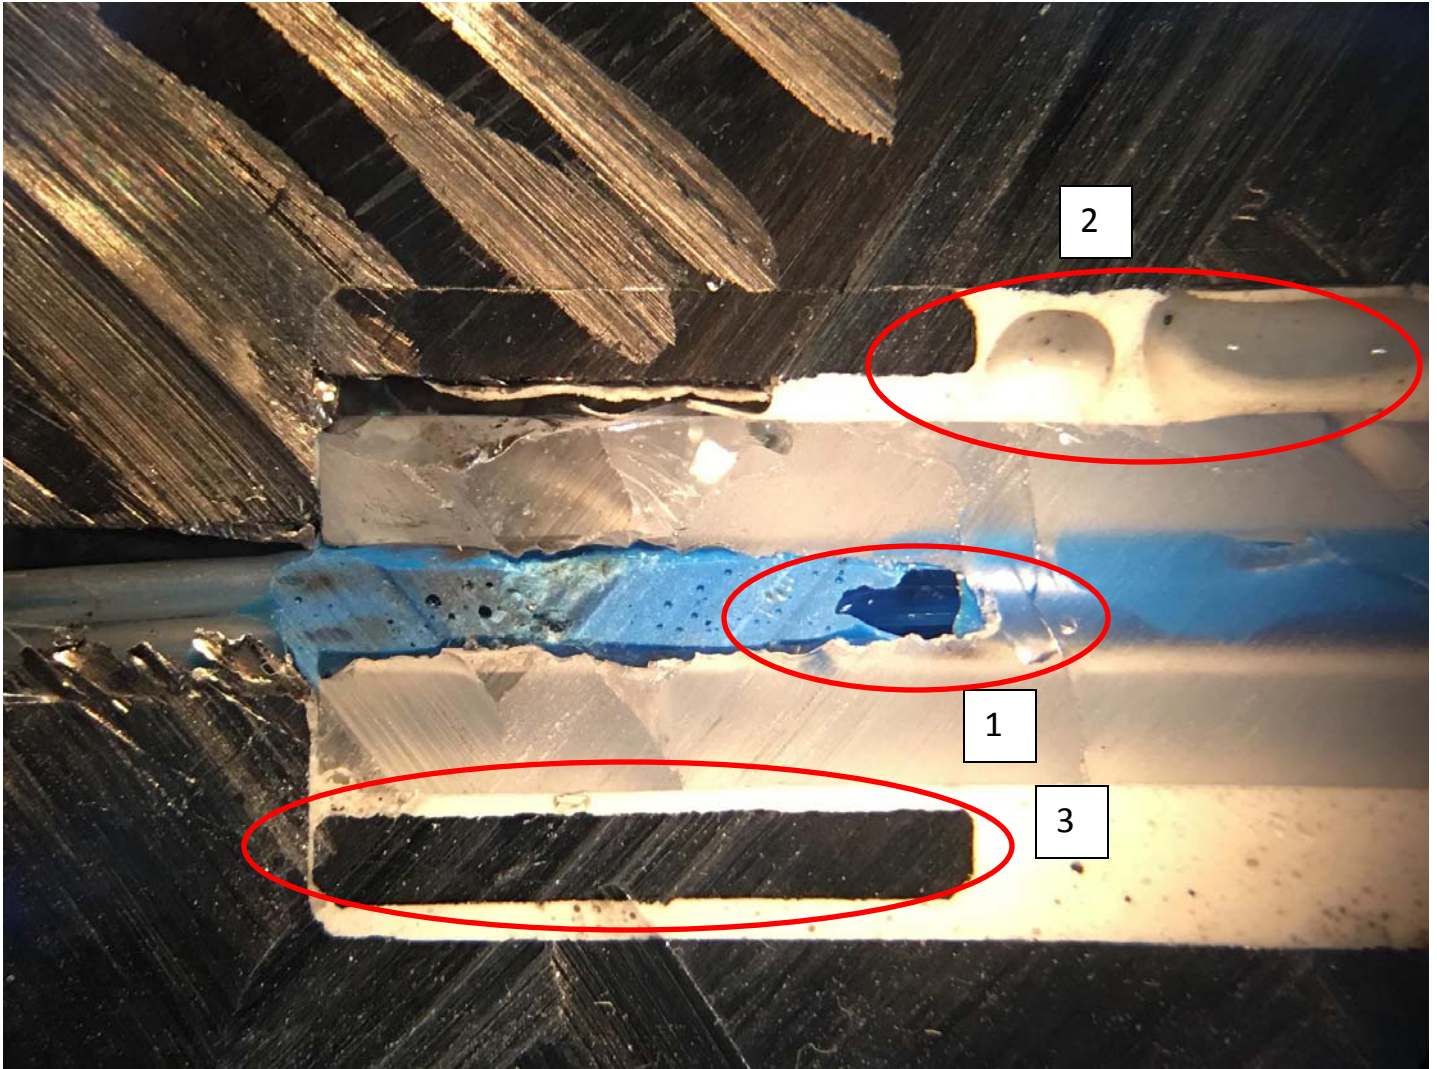
**Fig 3. Middle section photo 2 of 7 (counting left to right). Visible elements: (1), (2): large voids in blue and white epoxy; (3): metal alignment ring**

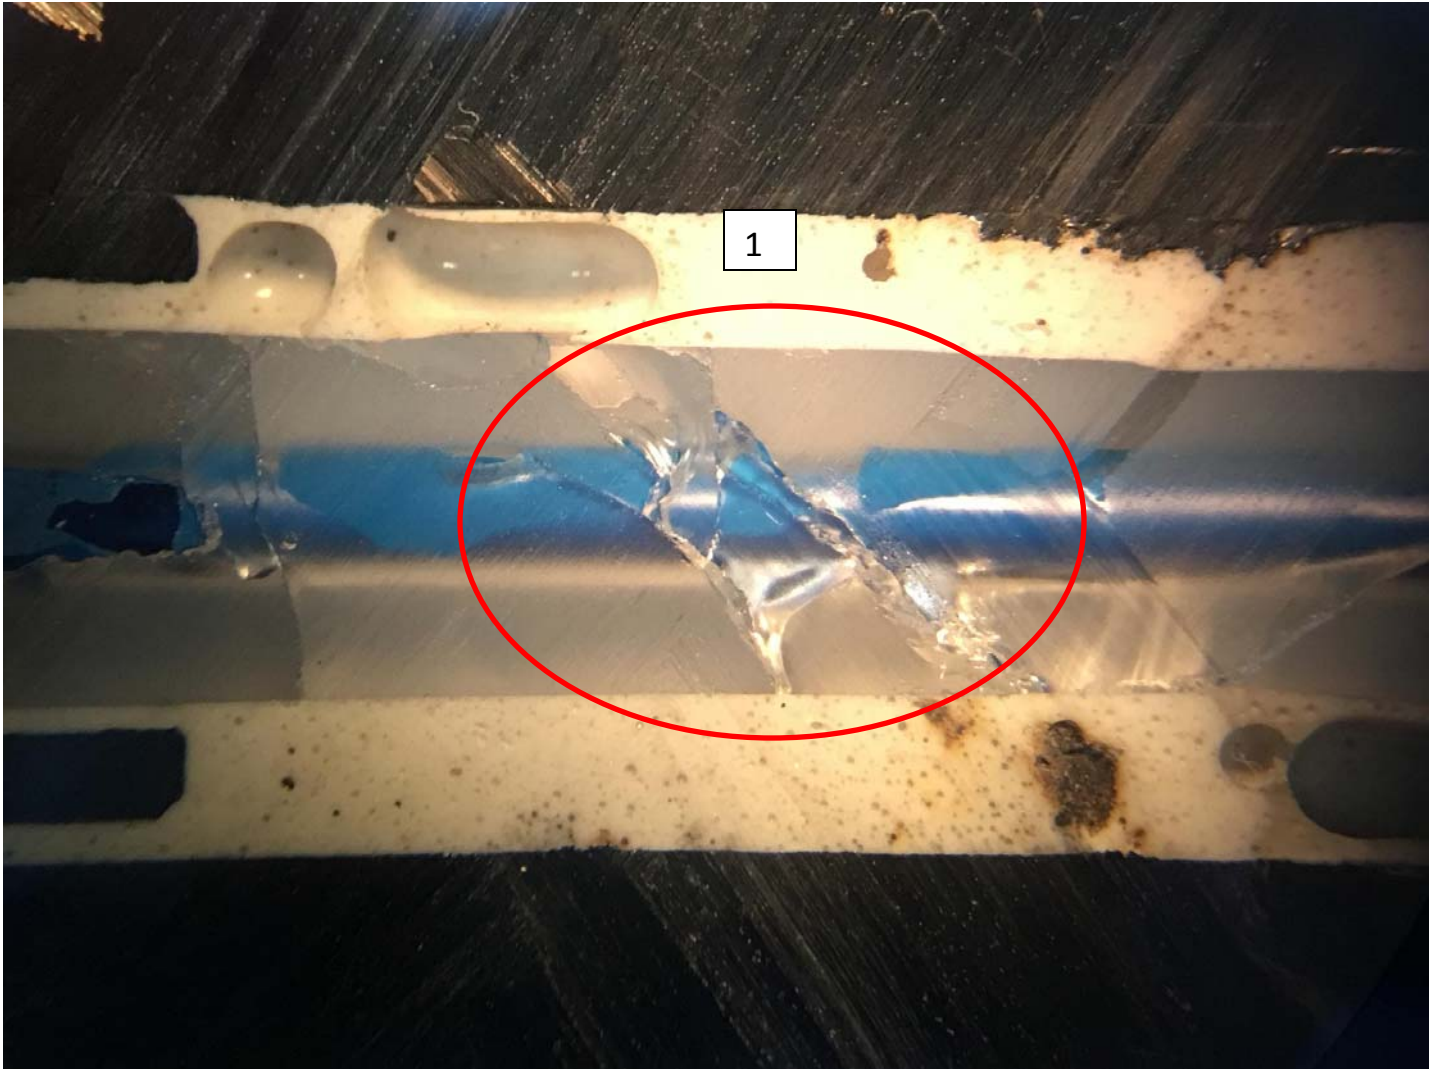
**Fig 4. Middle section photo 3 of 7 (counting left to right). Diagonal faults area (1) in the middle of glass tube, suggesting possible fracturing under axial load (observation by Jon Erickson)**

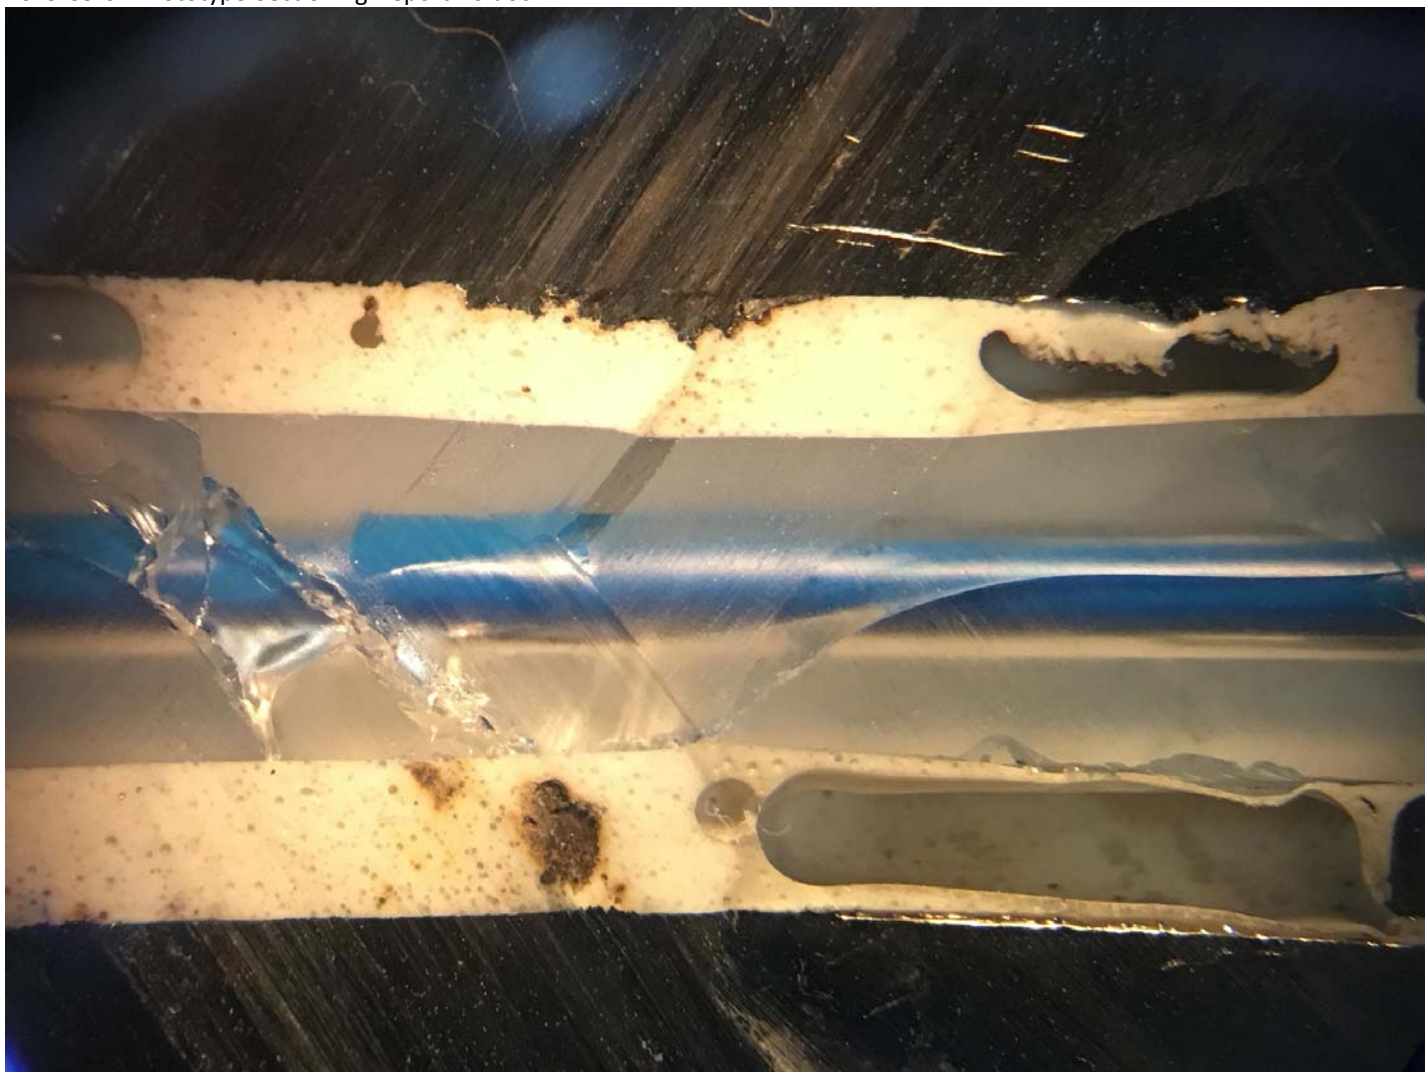
**Fig 5. Middle section photo 4 of 7 (counting left to right). Large cavities are visible in the white epoxy**

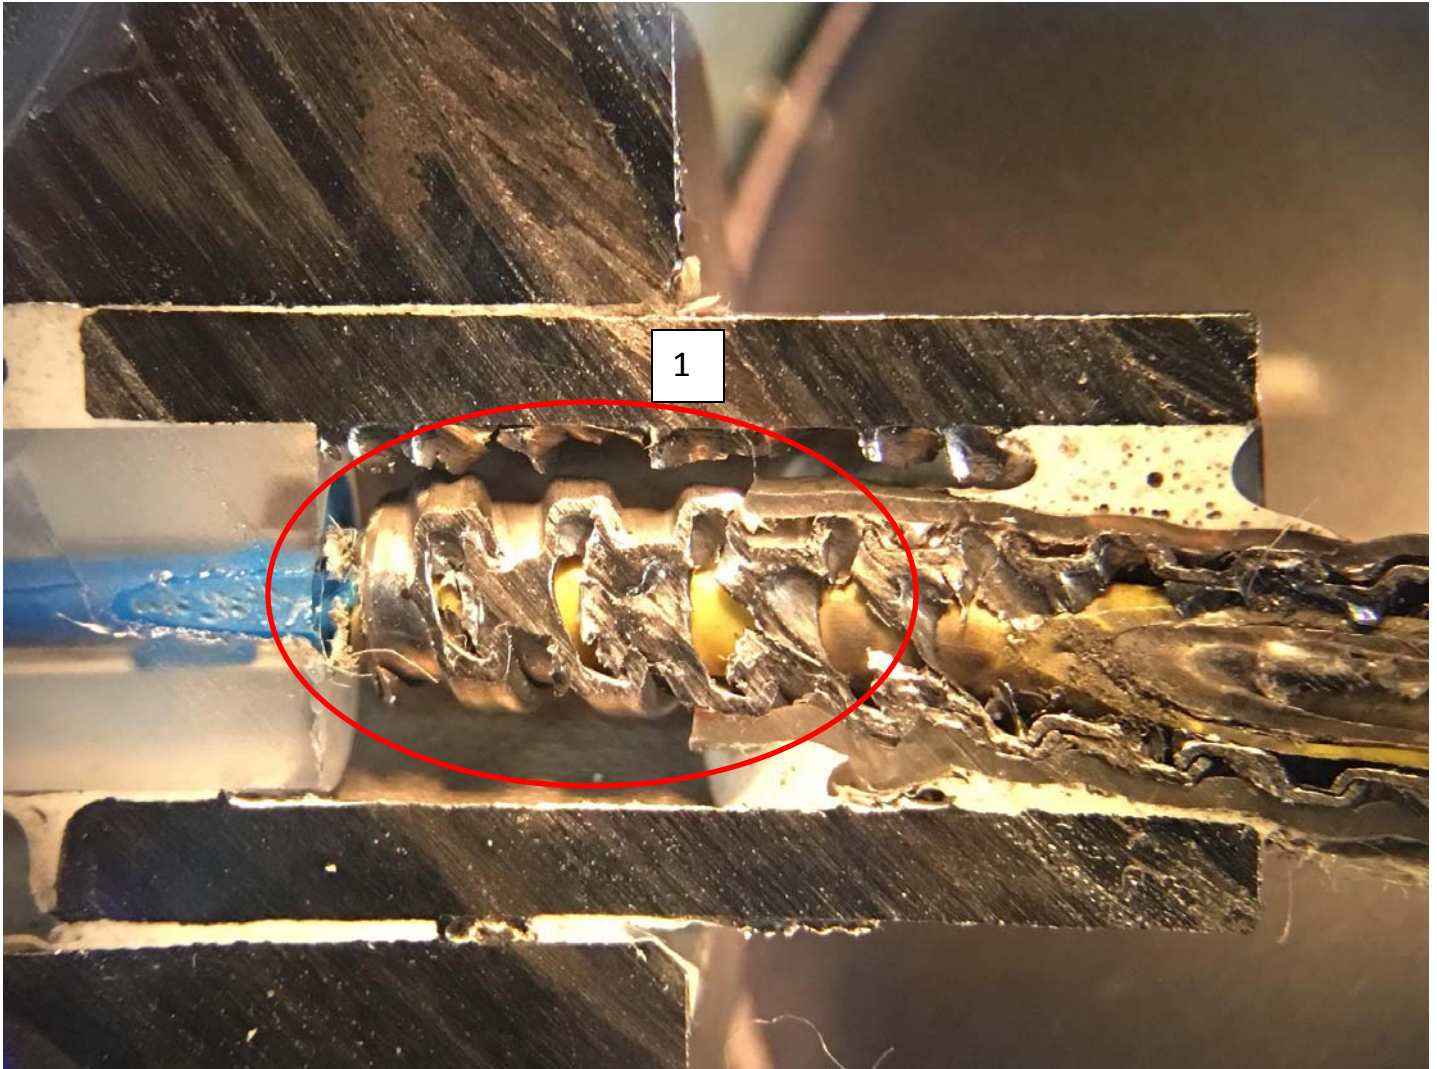
- It is not immediately clear why the optical fibers are blue on the one side of penetrator, and white/clear or another (Fig 11, 15)
- Failure of one optical fiber may indicate that the industrial-grade spiral jacket assembly is not rated for the type of axial loads exerted during pressure test. Alternatively, fiber failure could be explained by weak support of the spiral jacket near the glass tube (Fig 7)

**Fig 7. Middle section photo 6 of 7 (counting left to right). Weak support of the steel spiral tube in the area (1) where optical fibers are entering glass tube may lead to optical fiber fracture in this area (observation by Jon Erickson).**

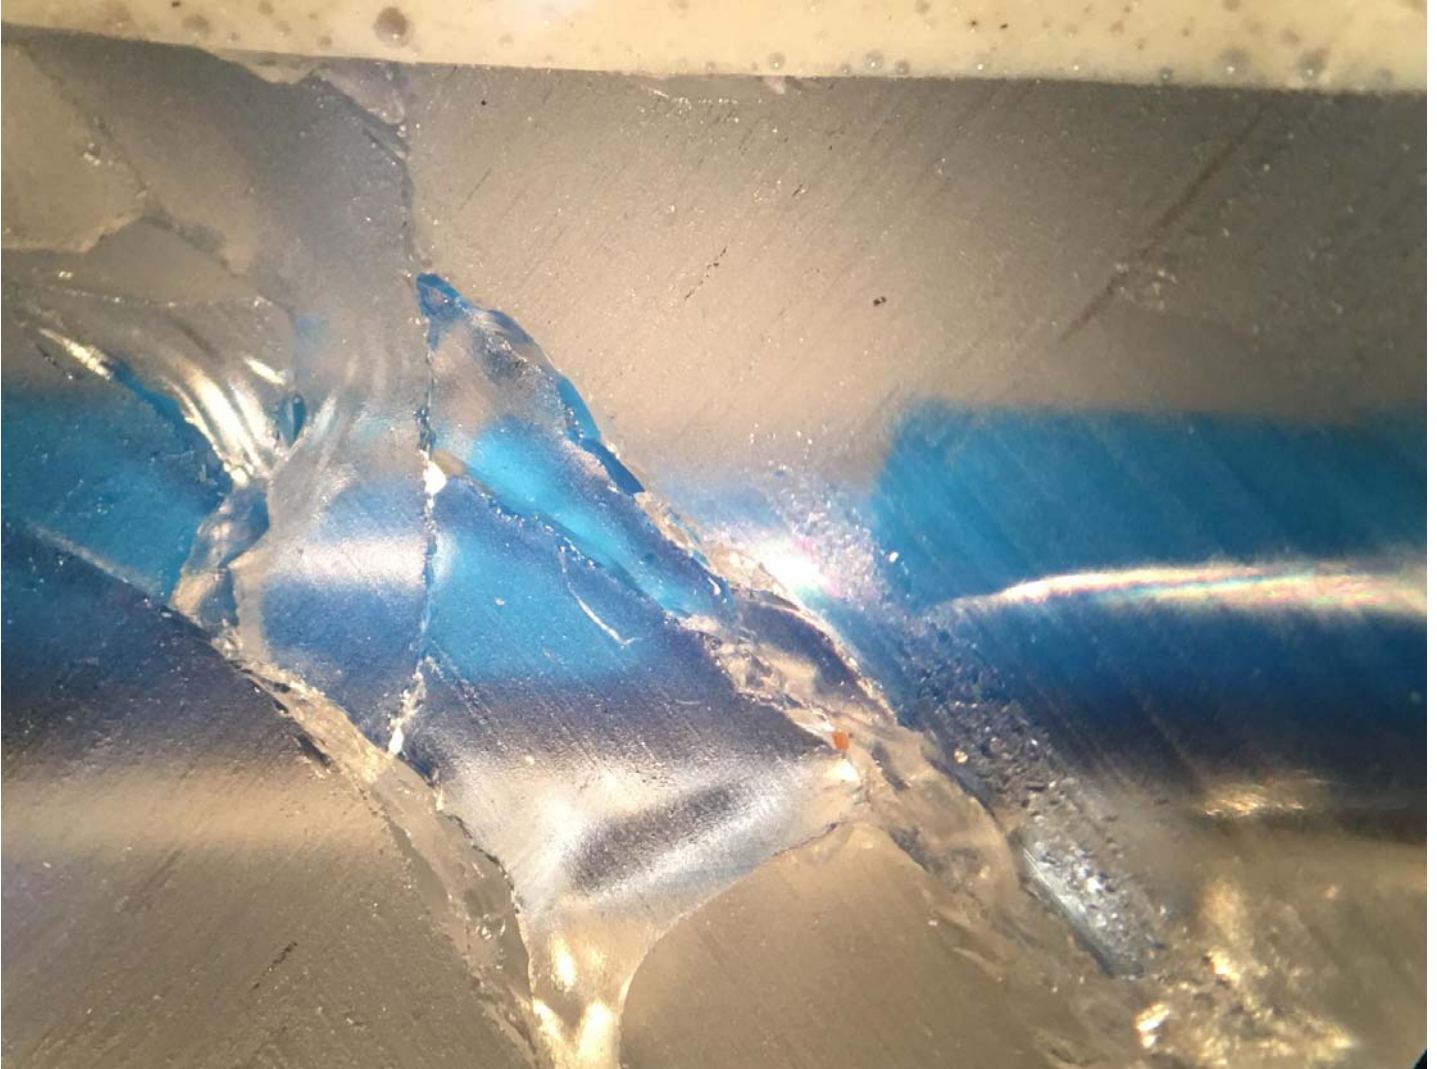
**Fig 13. Close-up photo 3 of 5. Diagonal faults area in the middle of glass tube, suggesting possible fracturing under axial load (observation by Jon Erickson)**

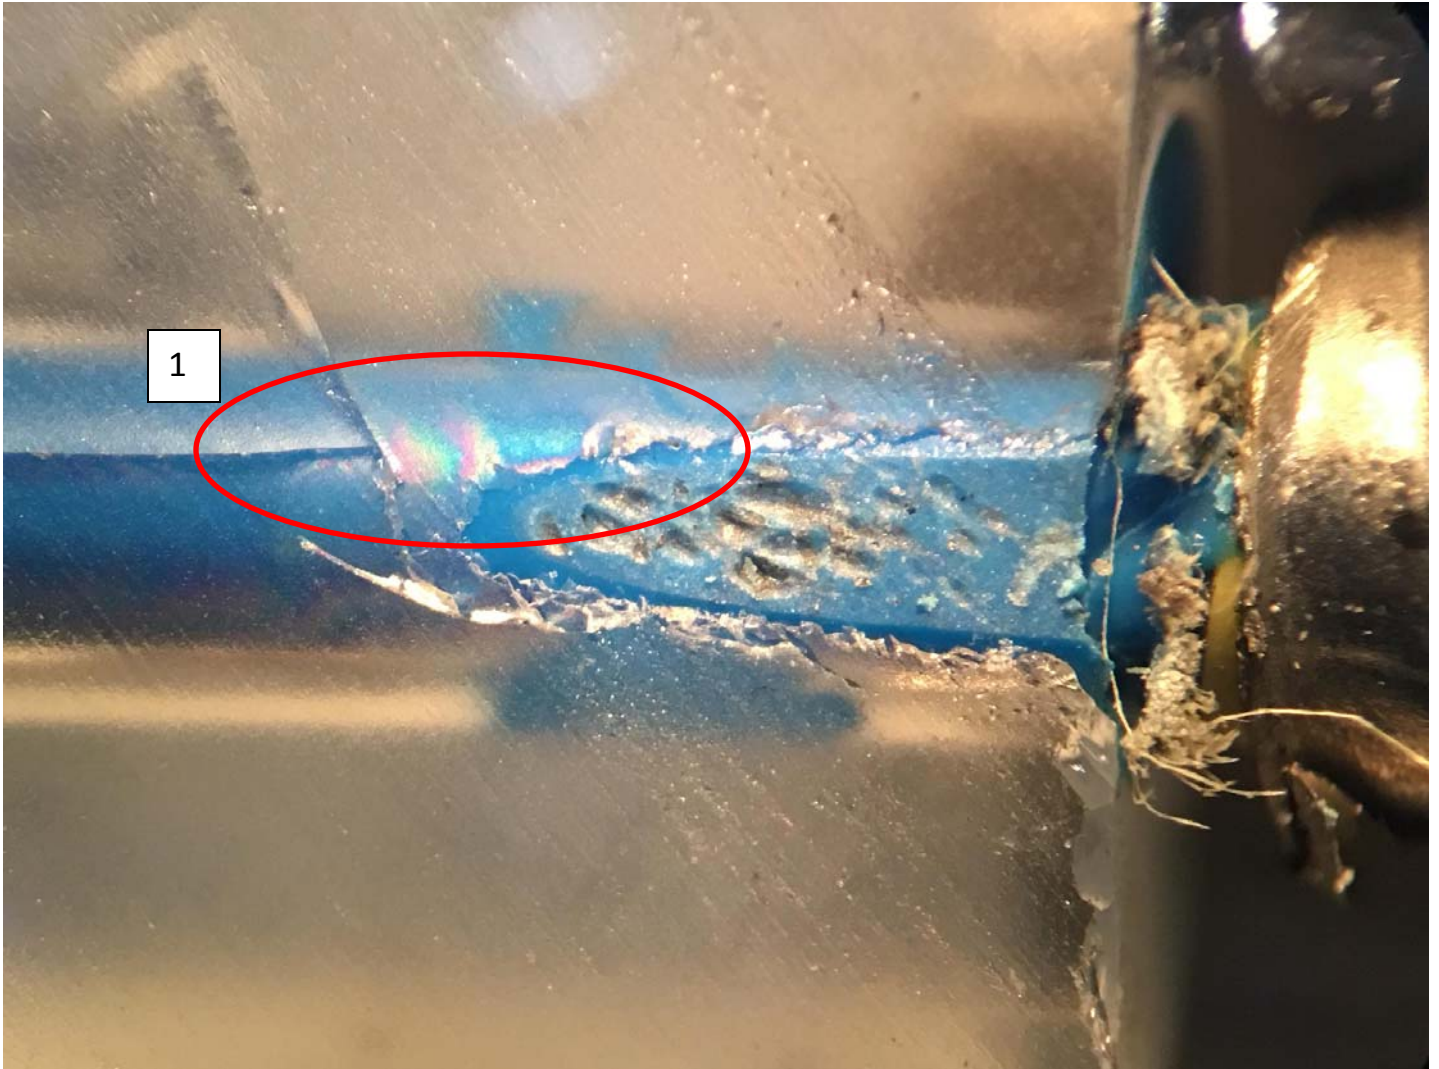
**Fig 14. Close-up photo 4 of 5. Optical Interference pattern on the interface between blue epoxy and glass tube suggests the gap to be on the range of several micrometers.**

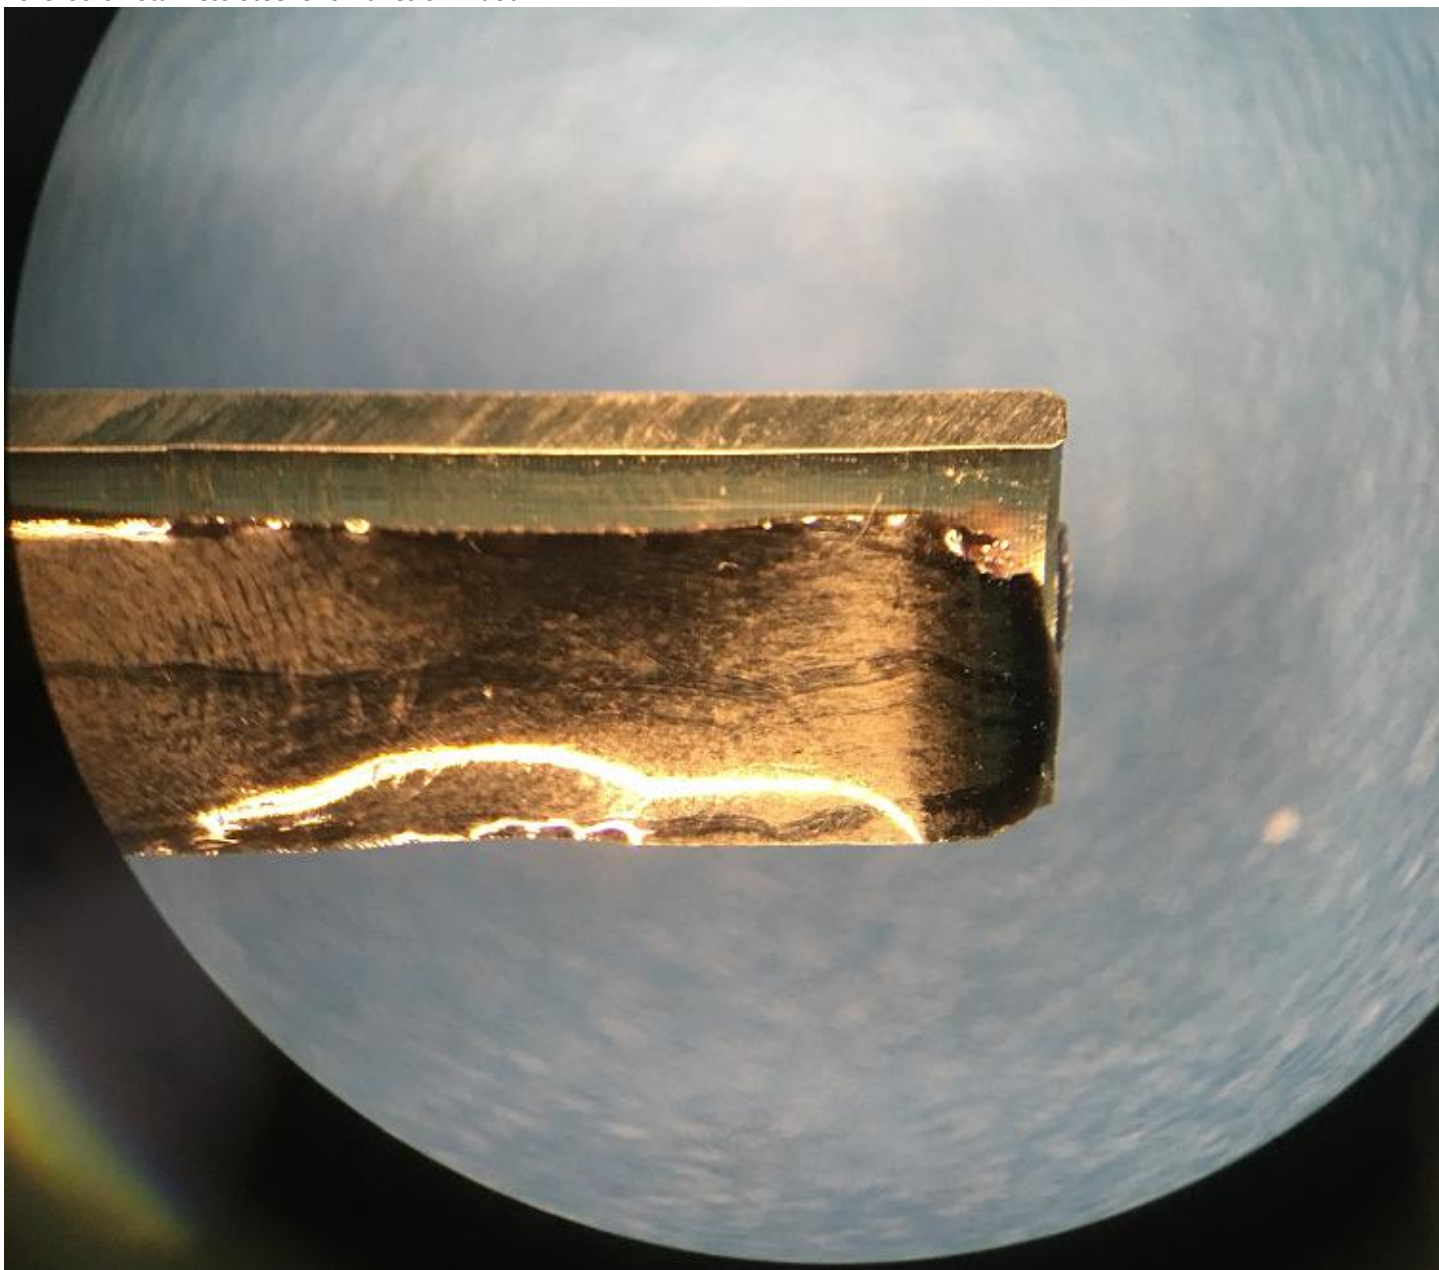
**Fig 4. Pull-test on sample #1 (control). Clean separation of epoxy from metal**

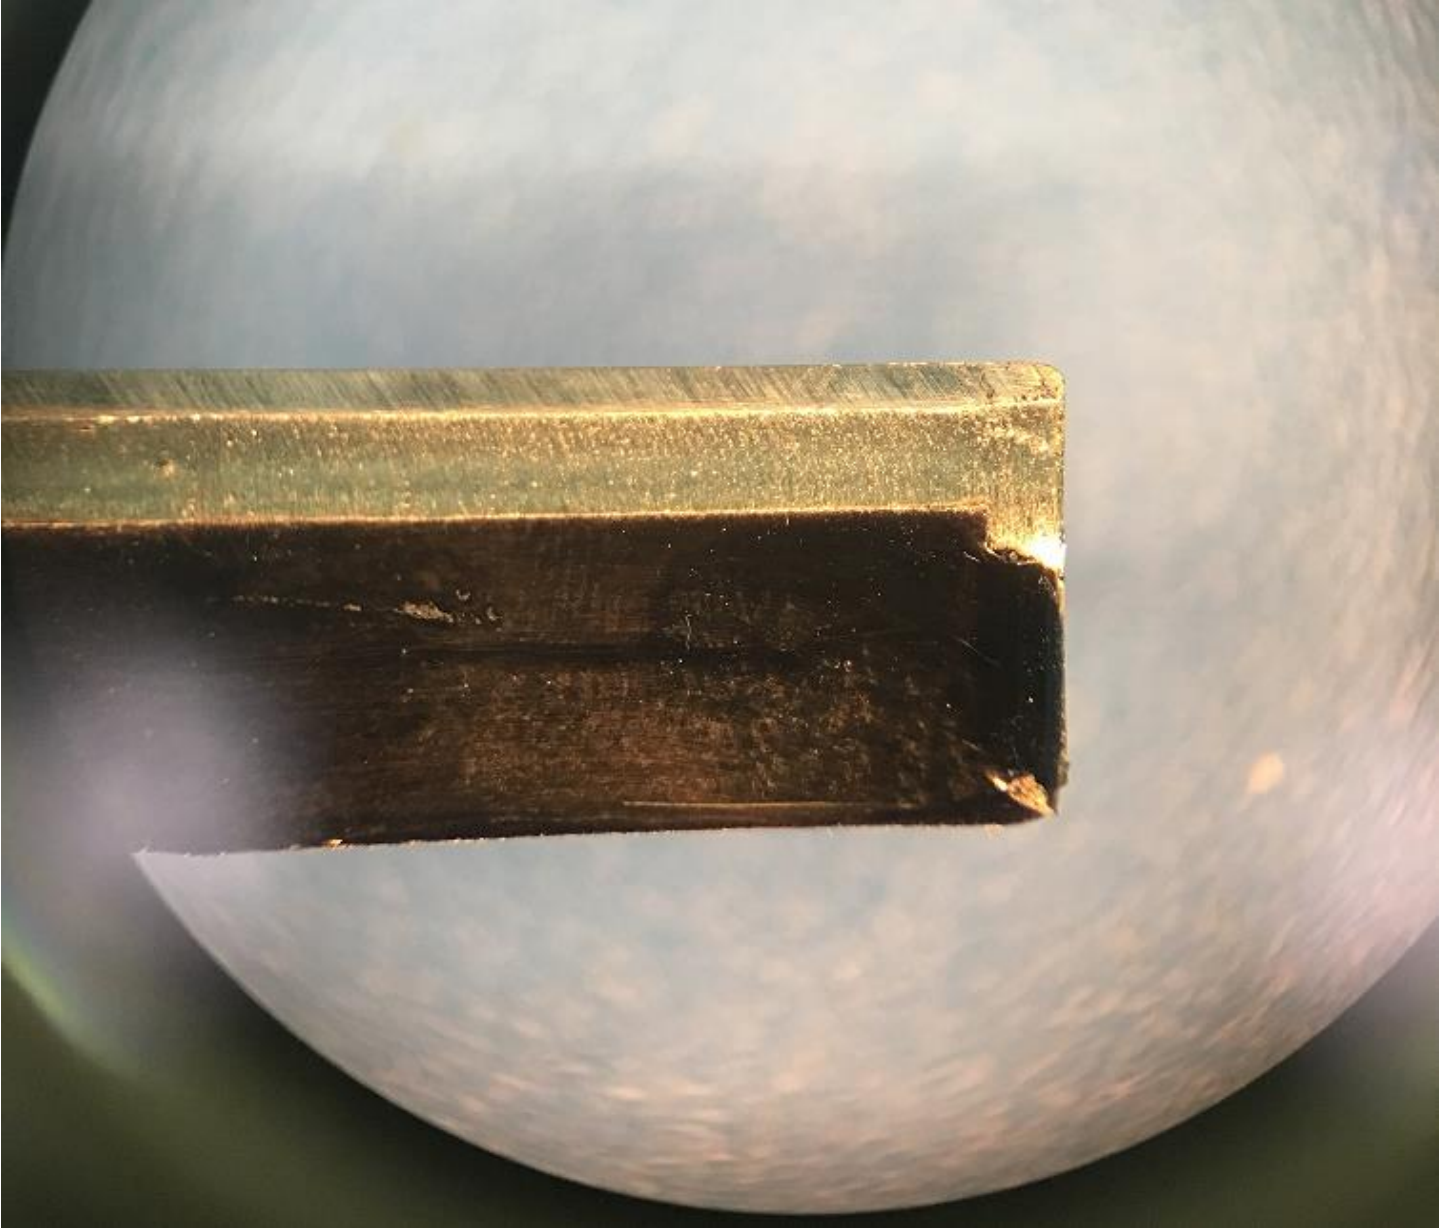
**Fig 5. Pull-test on Sample #2 (hone finish). Clean separation of entire epoxy strip from metal with slightly higher force compare to Sample #1**
