## **Deep PIV Fiber Optic Assembly Report**

**Project: 901809.00 DeepPIV/ Deep Sea Bioinspiration**

**Author: Denis Klimov (EE) (sectioning), with input from Aaron Schnittger (MT); (potting; pressure testing).**

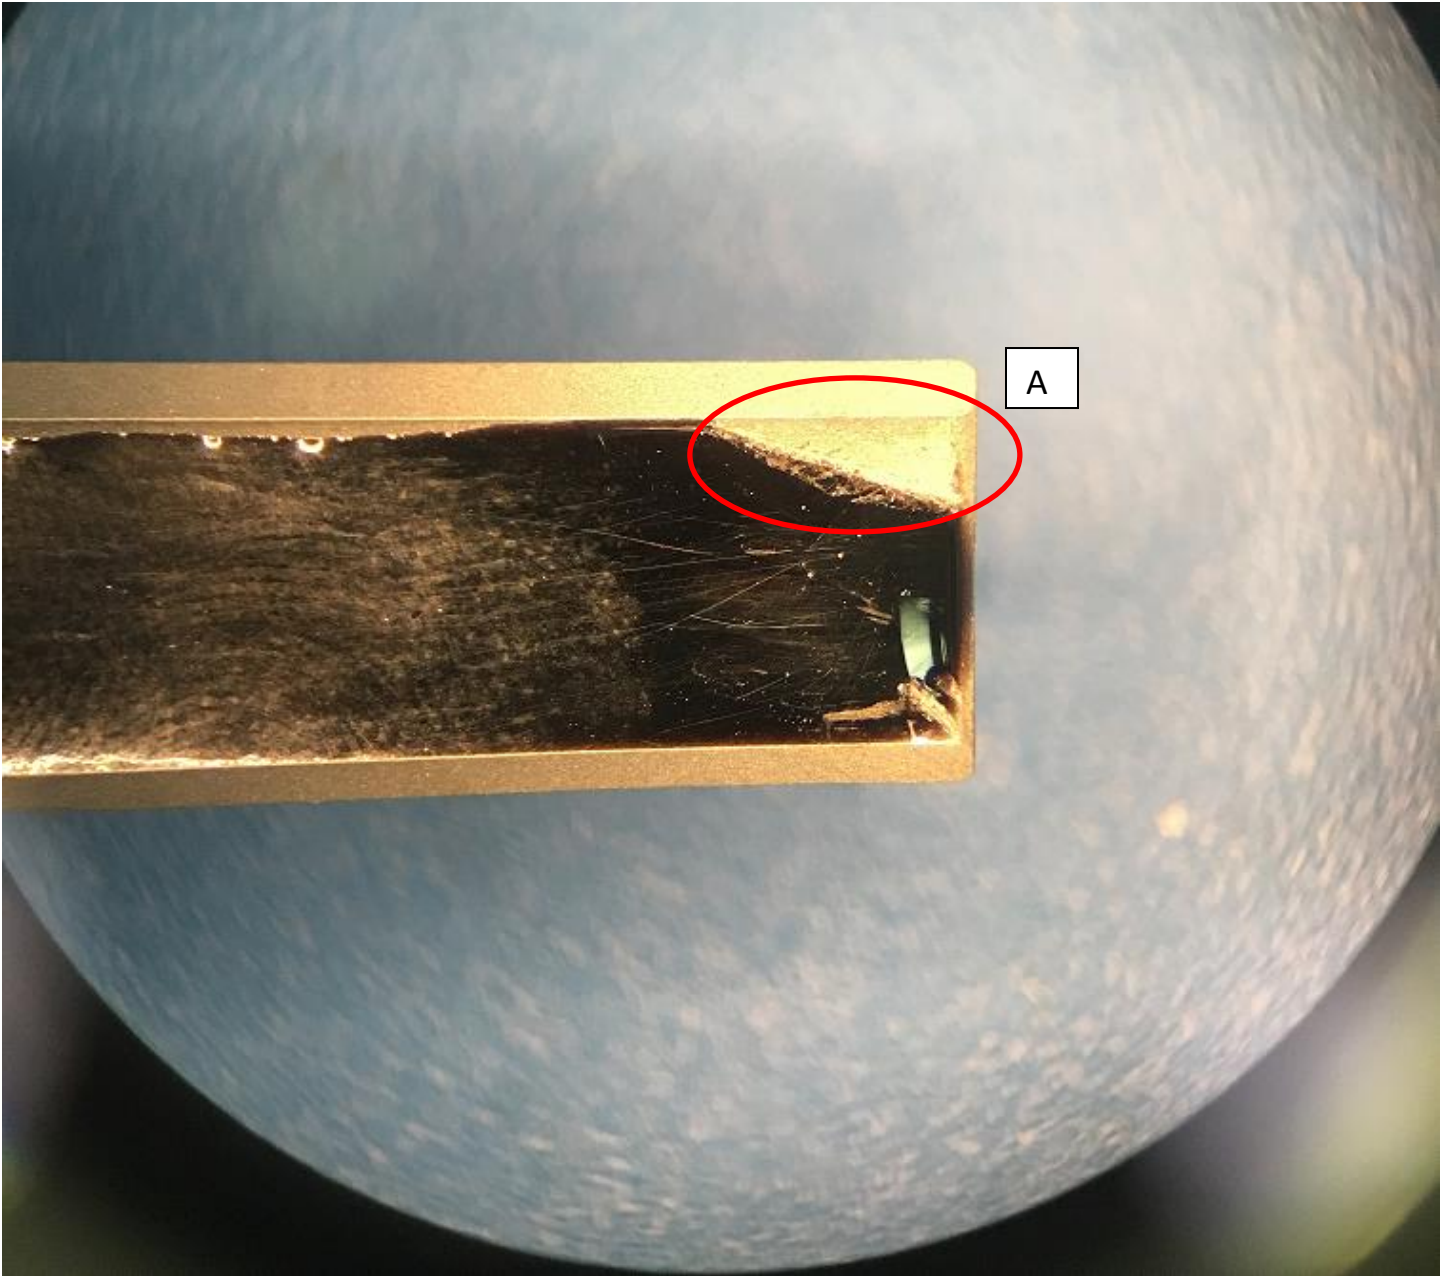
**Fig 6. Pull-test on Sample #3 (acid etching plus bead-blasting). Small pieces (A) can be broken off the epoxy strip relatively clean but the rest is staying attached.**

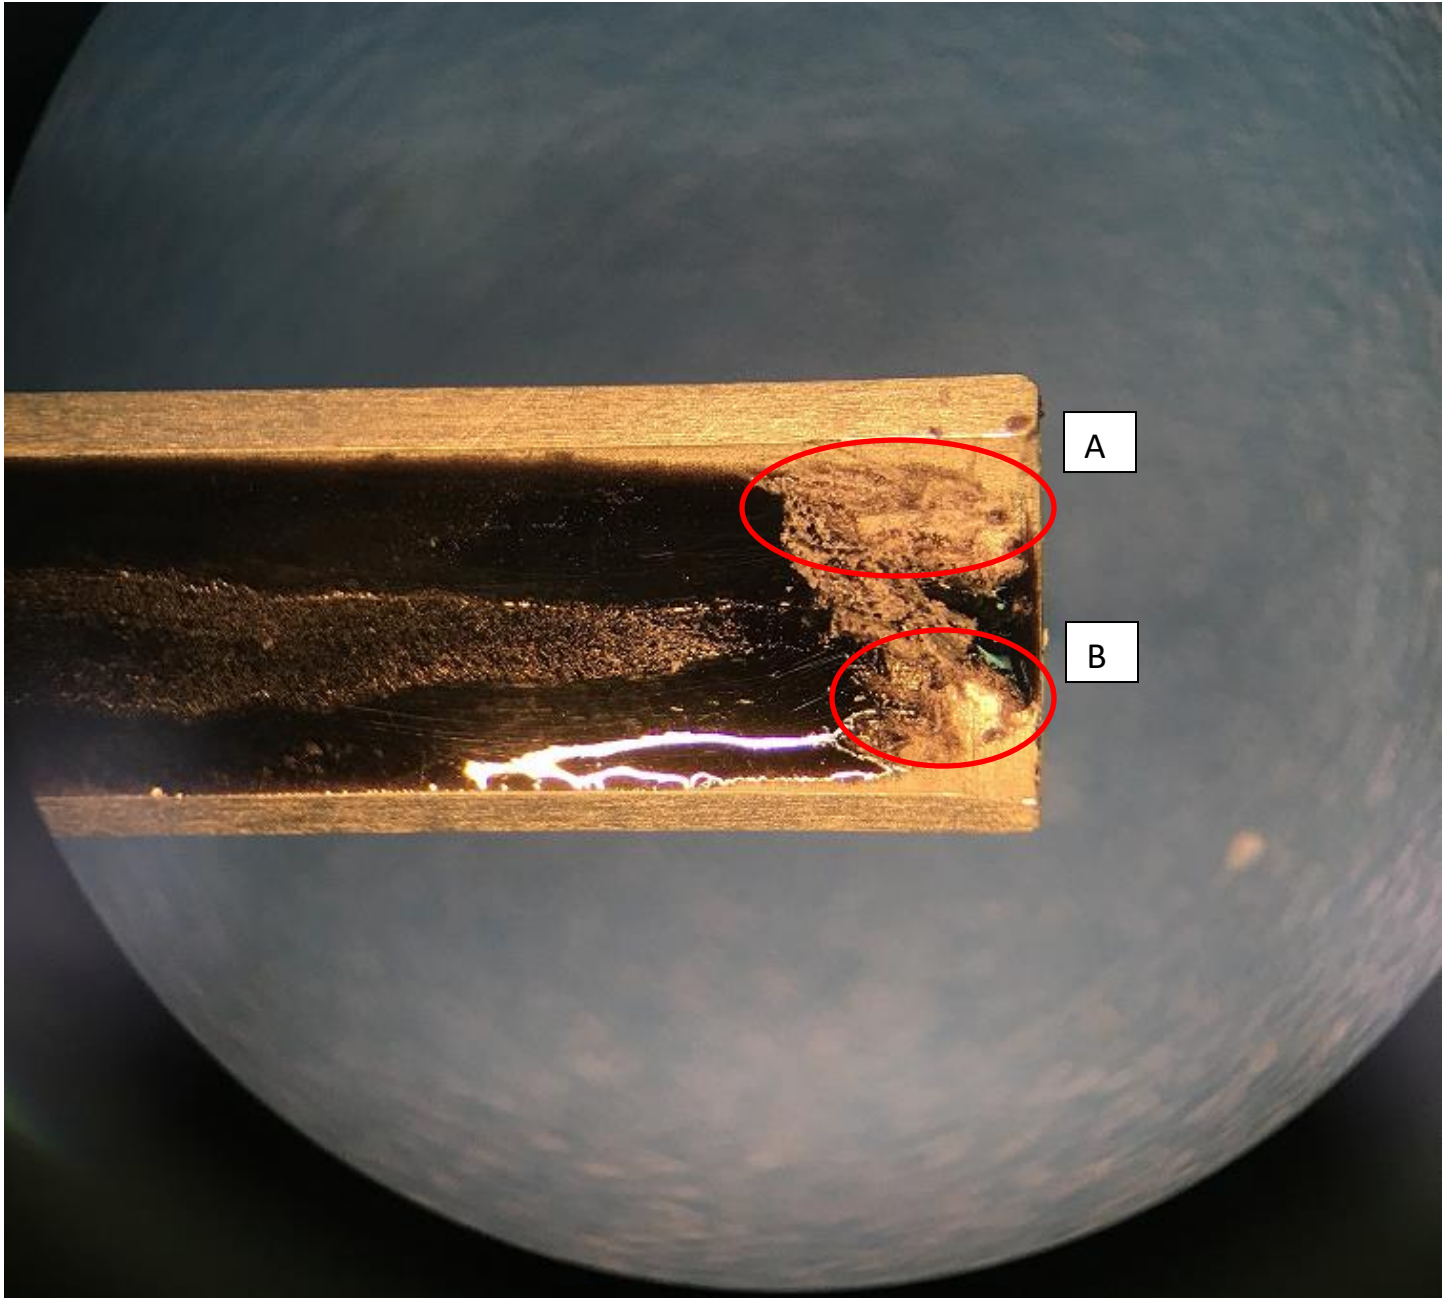
**Fig 7. Pull-test on Sample #4 (acid etching). Small pieces (A, B) can be broken off, but the layer of epoxy is still attached to metal indicating excellent adhesion**

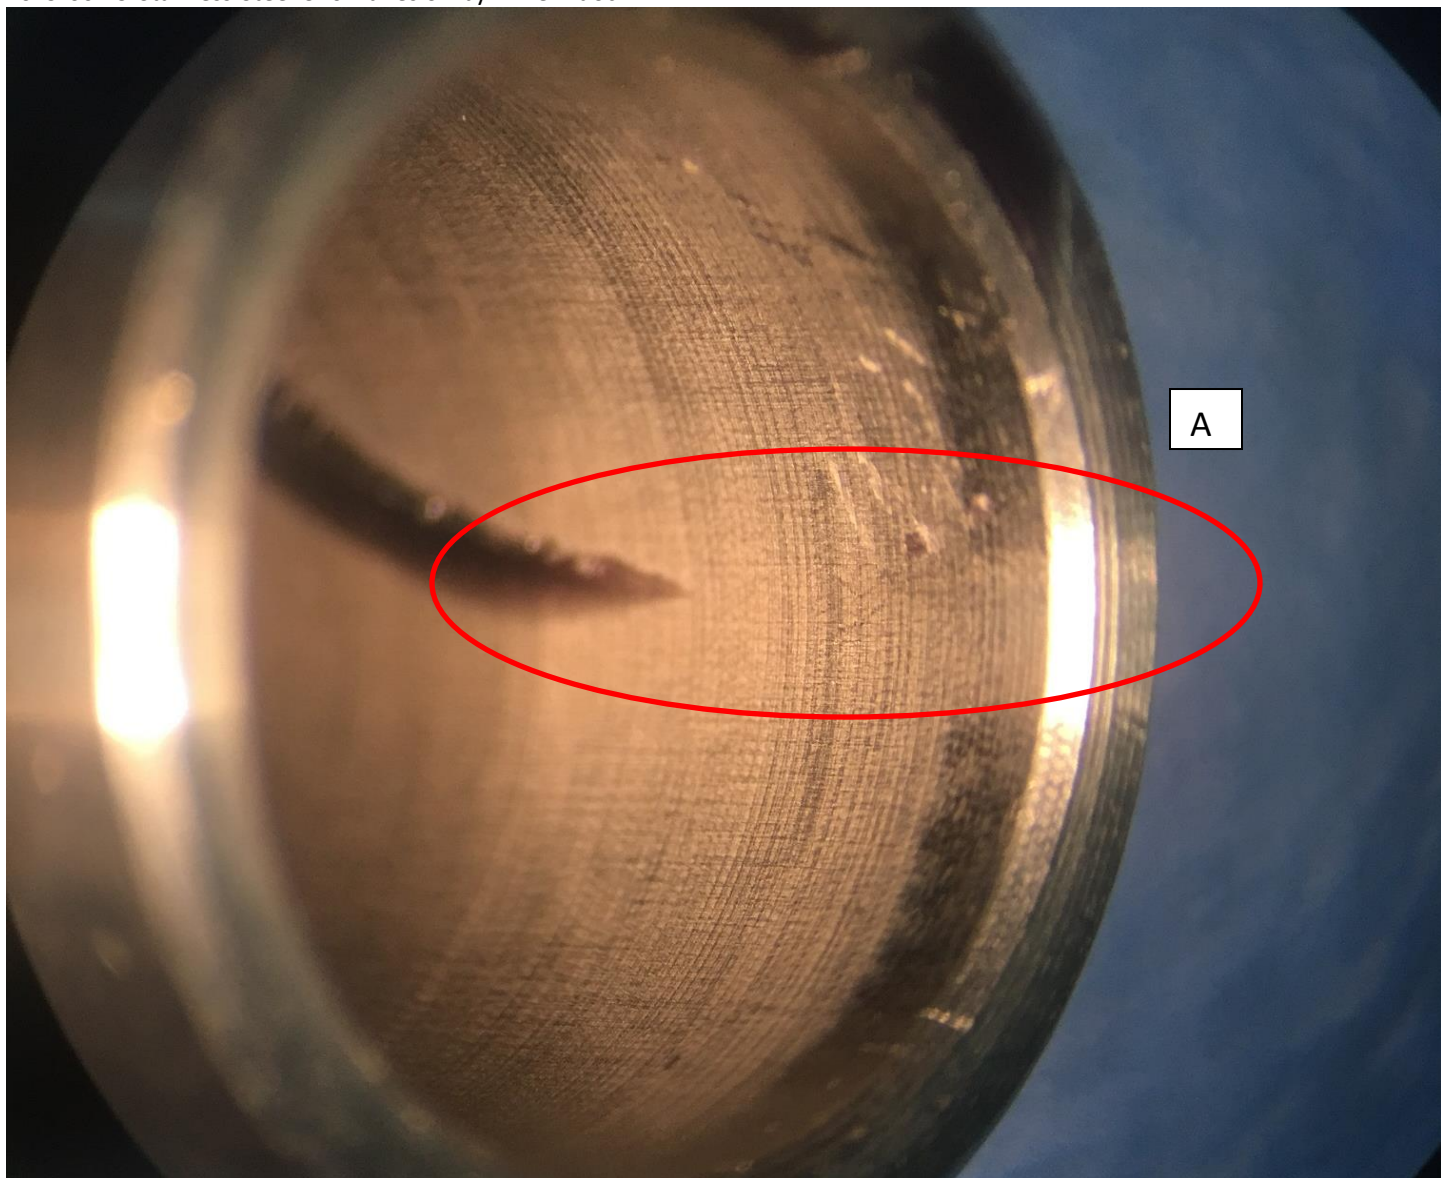
- Almost clean separation of epoxy layer from 2-hour etched stainless steel with considerable effort was observed; with edges and some traces of epoxy remain attached (Fig 5)

Fig 5. Sample #5 (2 hours etching) internal wall. Area "A" is compared with 17 hours etching sample #4 (see Fig 7)

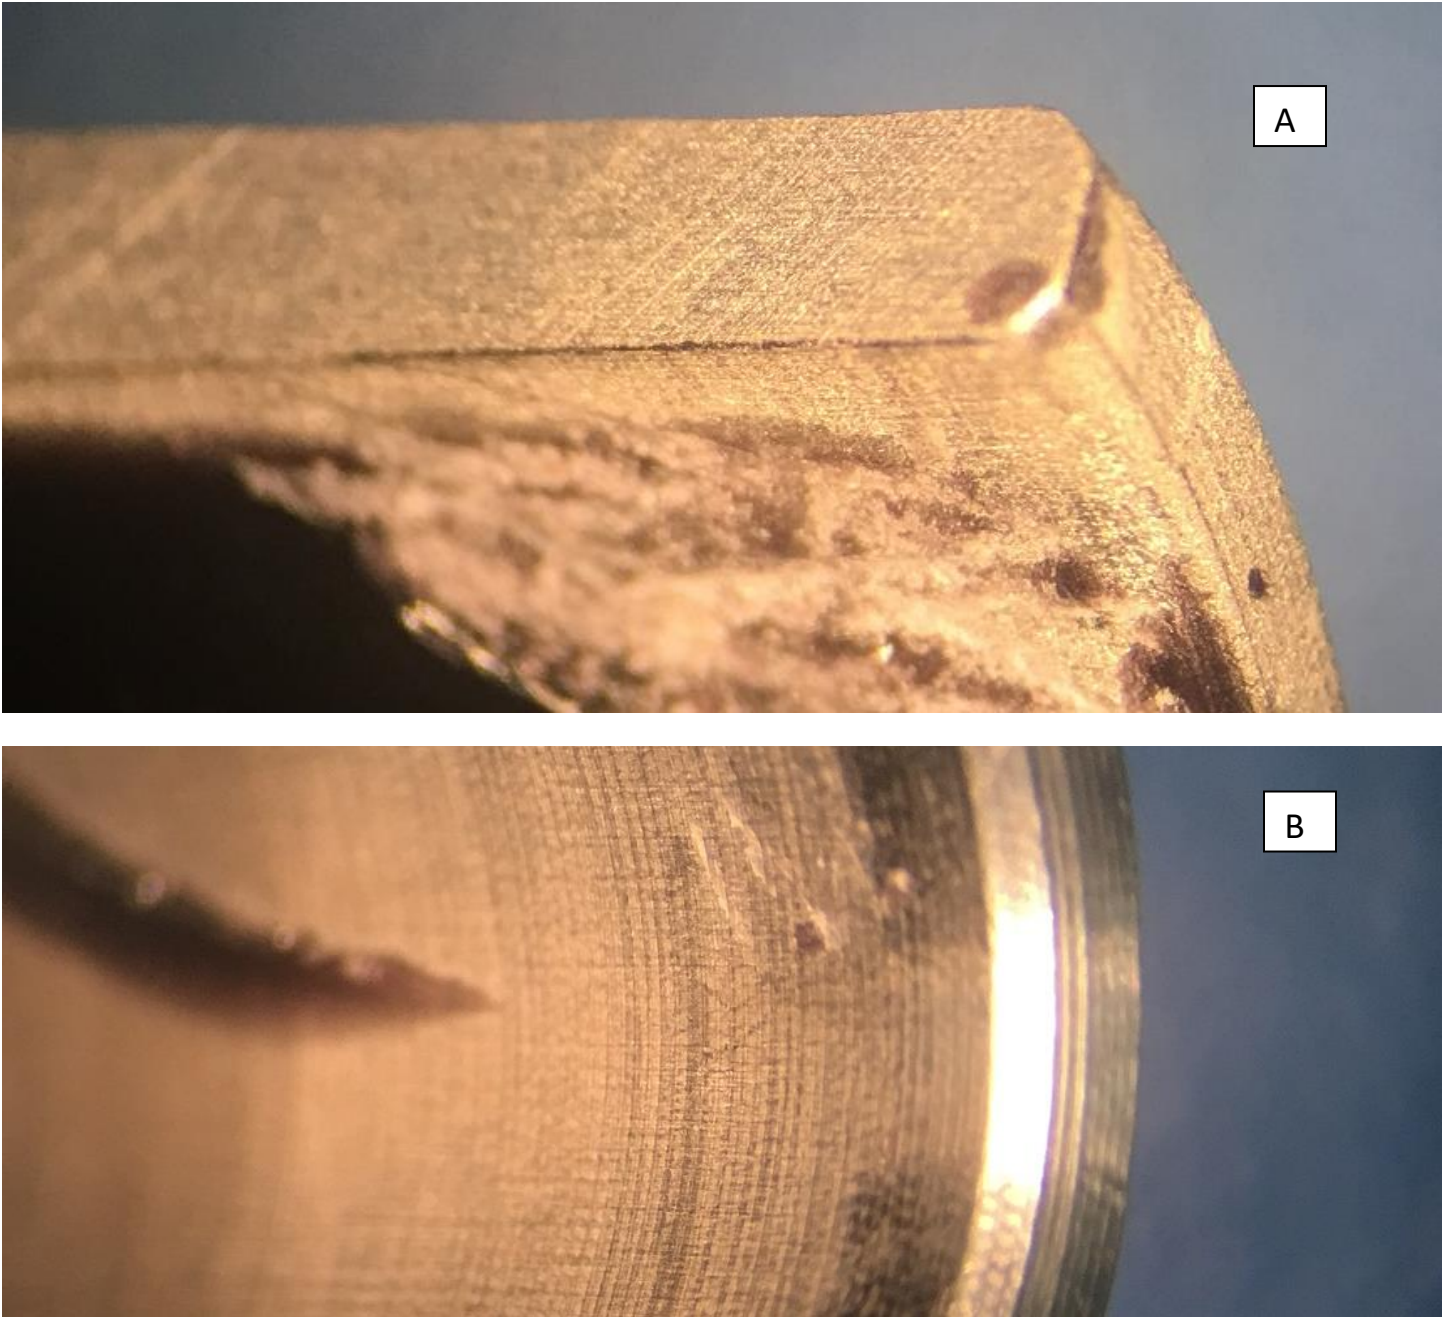
**Fig 7. Visual comparison of surface structure between 17 hours etched sample #4 (A) and 2 hours etched sample #5 (B). Deeper, more granular surface structure is evident in 17 hours sample.**

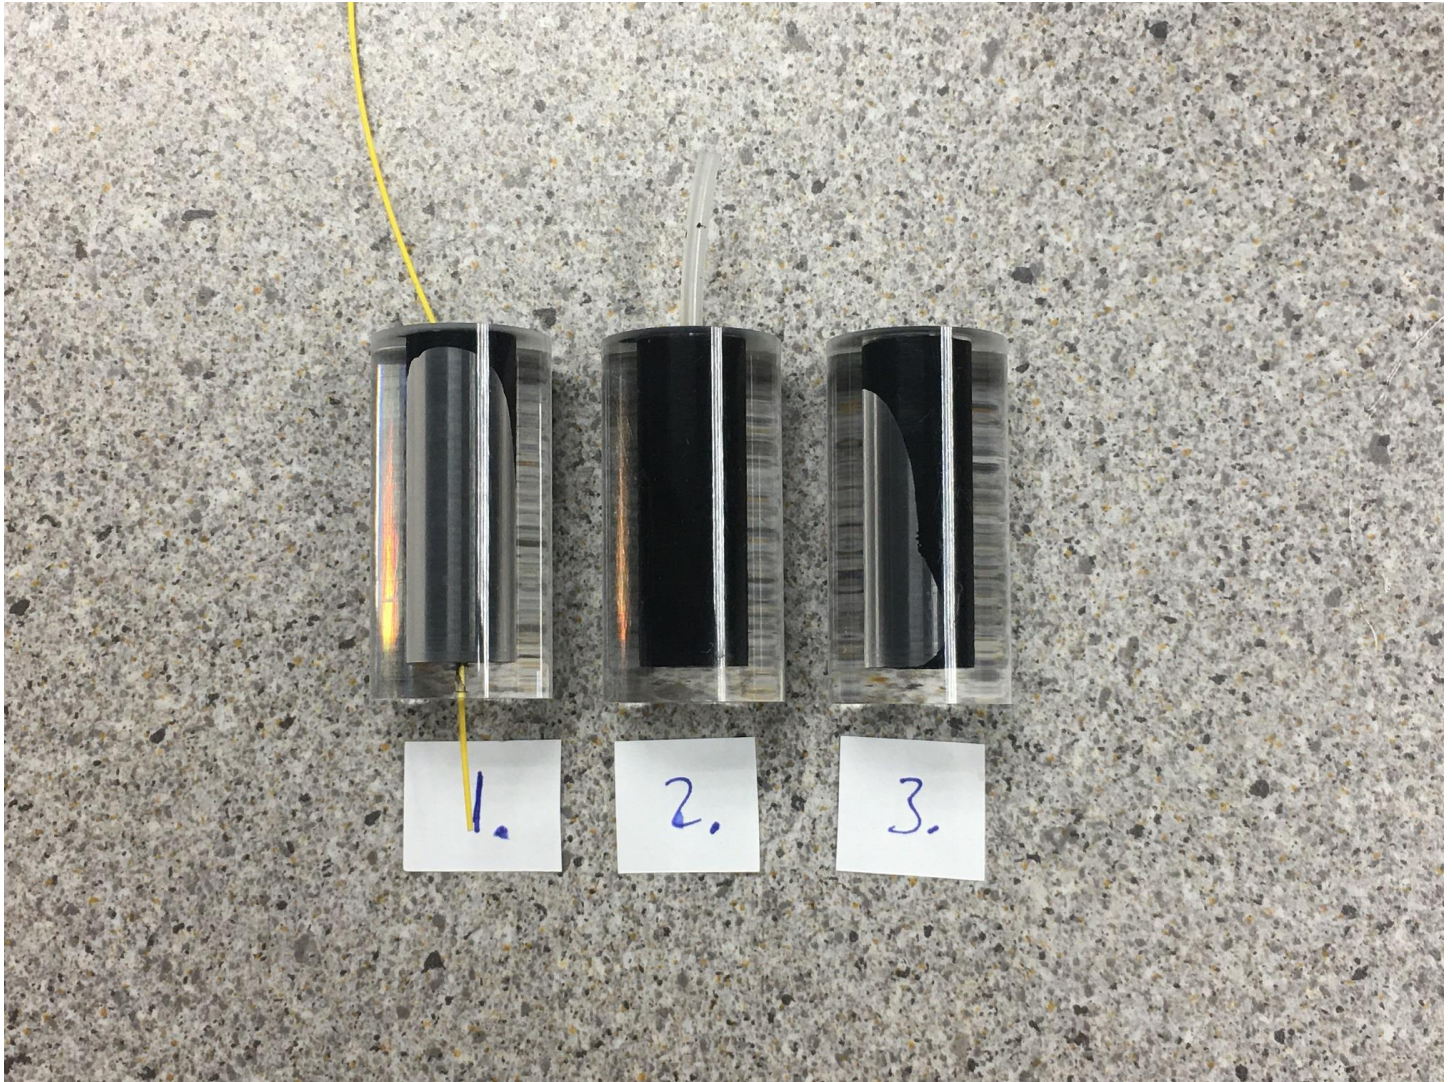
- Hard epoxy test (Samples 1-3, **Fig 1**)
  - Sample 1: 7/8/2019 hard black epoxy, with yellow fiber. Delamination from the inner wall observed after epoxy had being cured, visible on the photo.

- Sample 2: 7/9/2019 hard black epoxy, with strain relieve tube installed. No delamination from inner wall observed.
  - Sample 3: 7/8/2019 hard black epoxy fill. Delamination from the inner wall observed after epoxy had being cured, and is visible on the photo

**Fig 1. Hard epoxy, single fill volume samples**

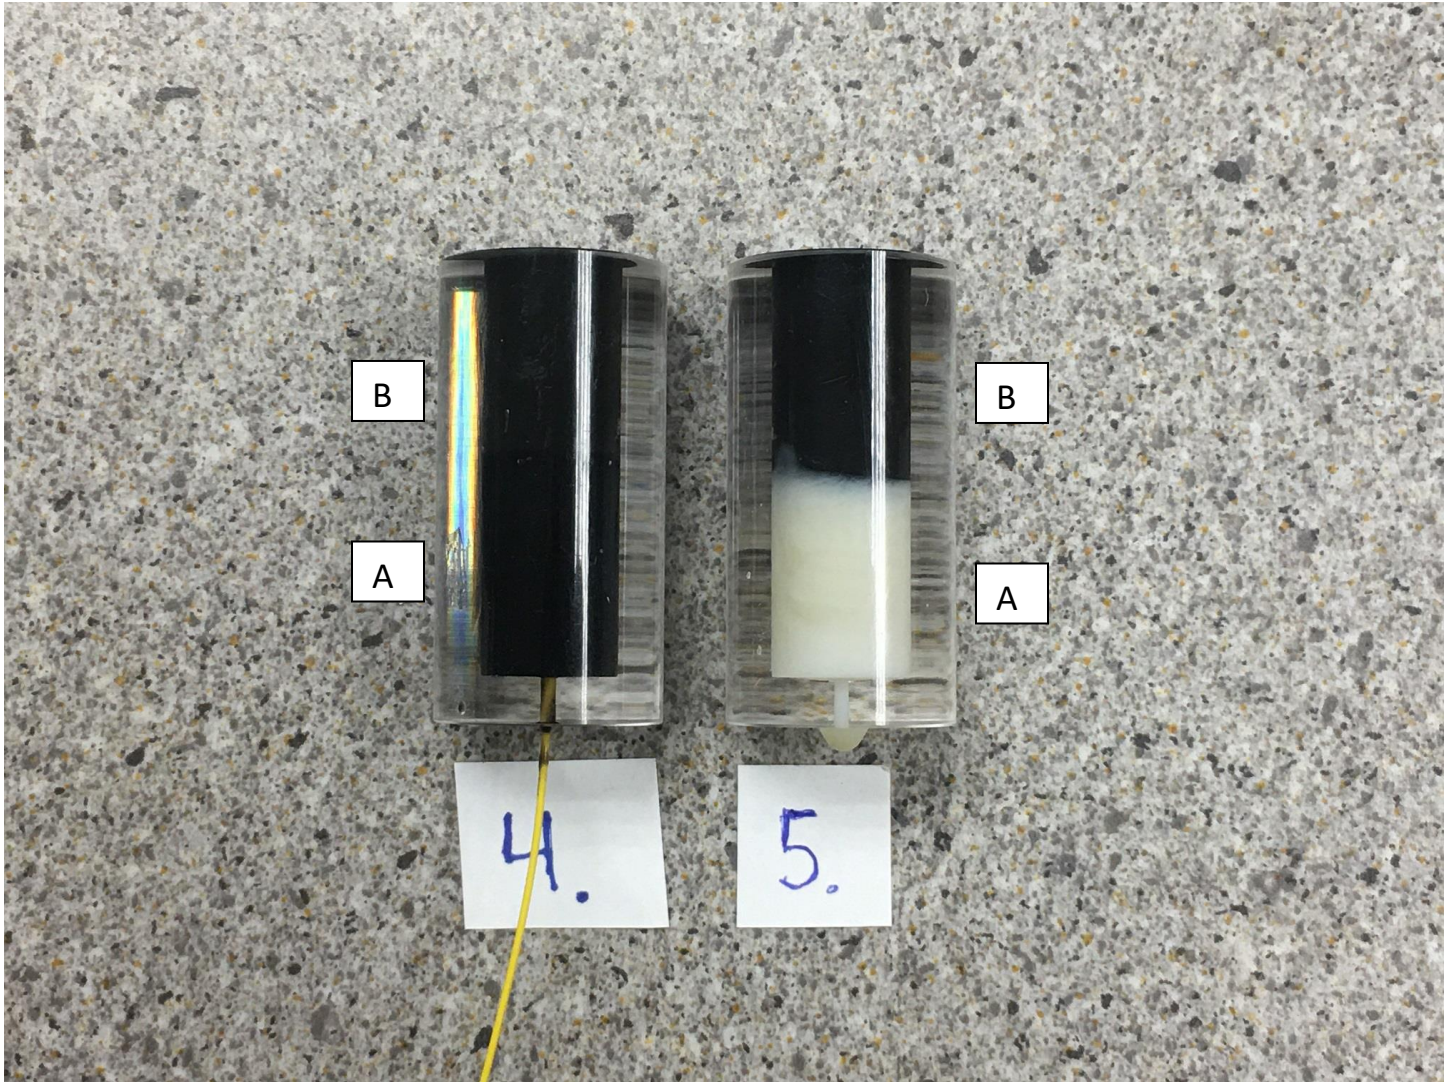
Fig 2. Two-volume fill, hard epoxy (Volume A) + Devcon rubbery fill (Volume B)

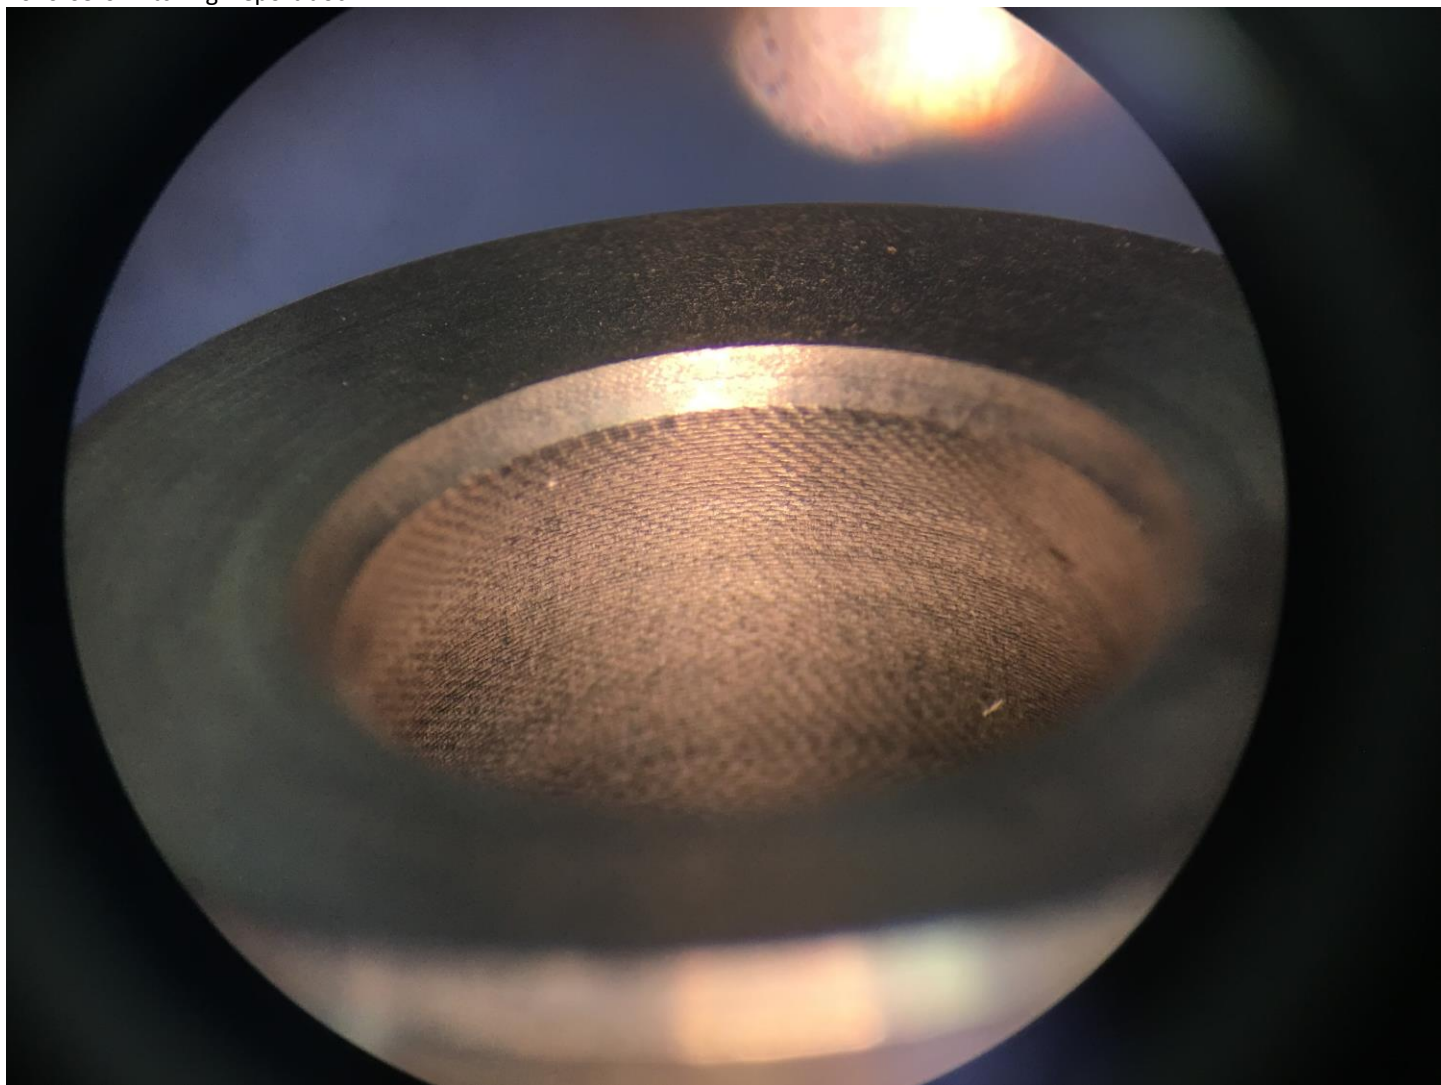
- Insufficient etching typically looks like in Fig 10. Continue etching the next day/session.
    - Issue with corrosion due to insufficiently neutralized acid typically looks like in Fig 11.

**Fig 10. Typical insufficient etching**

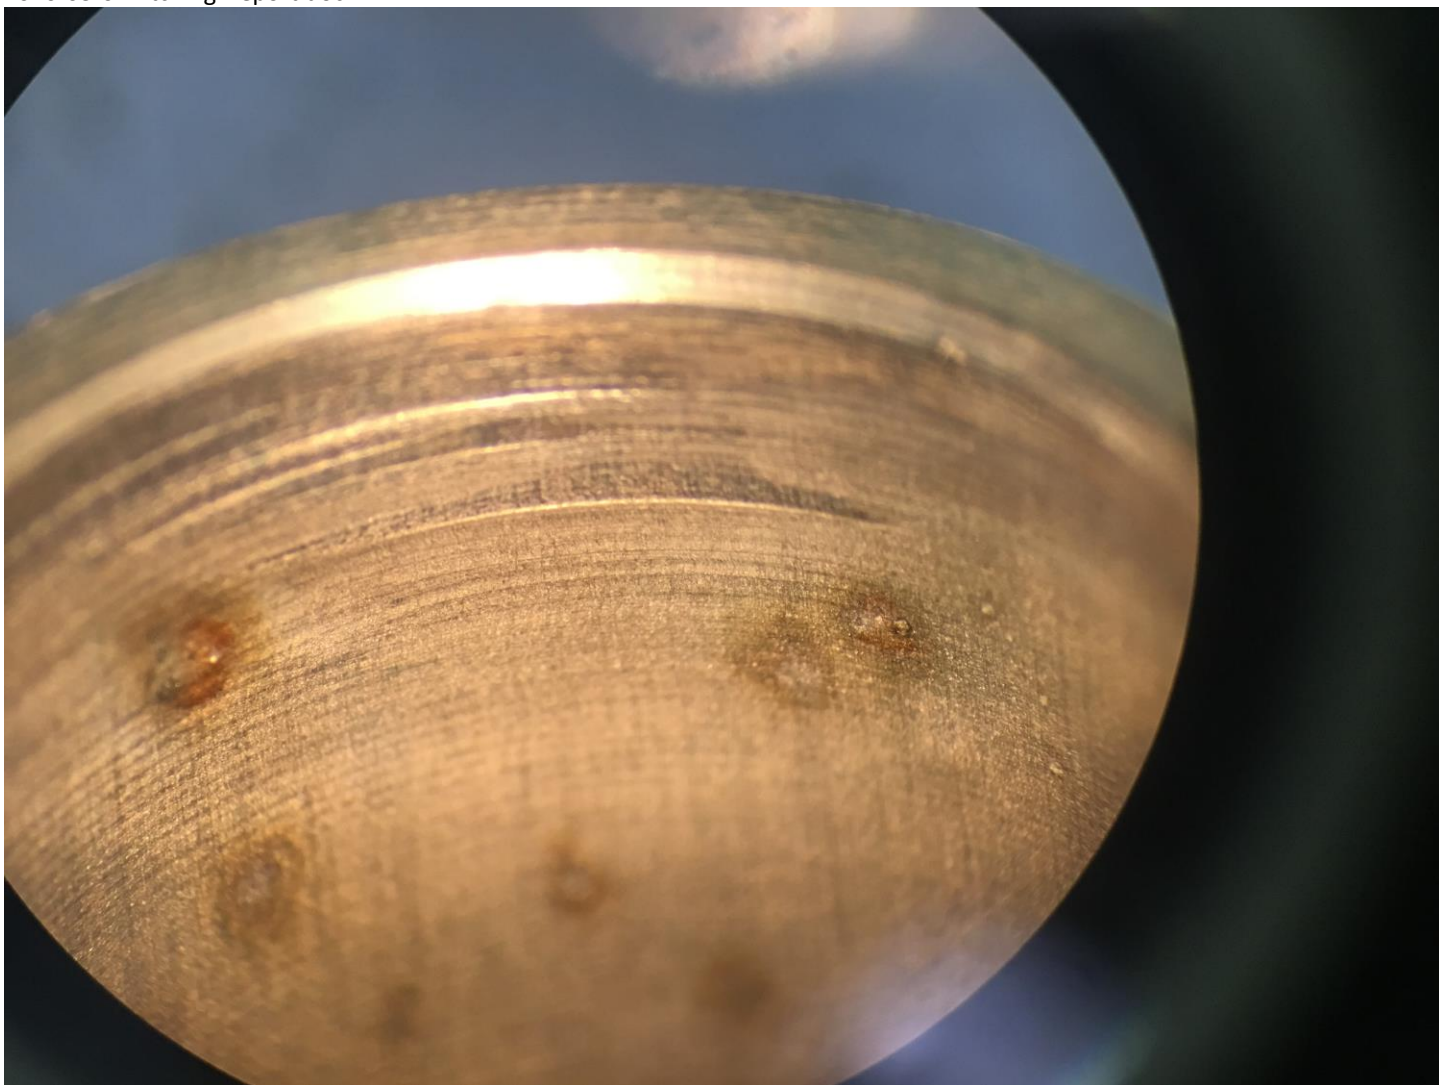
**Fig 11. Typical issue with corrosion spots due to insufficient neutralization of acid after etching**
