# Benthic Observation System Failure Report

**MBARI Project:** 901704 Benthic Observation System

**Date:** November 14, 2019

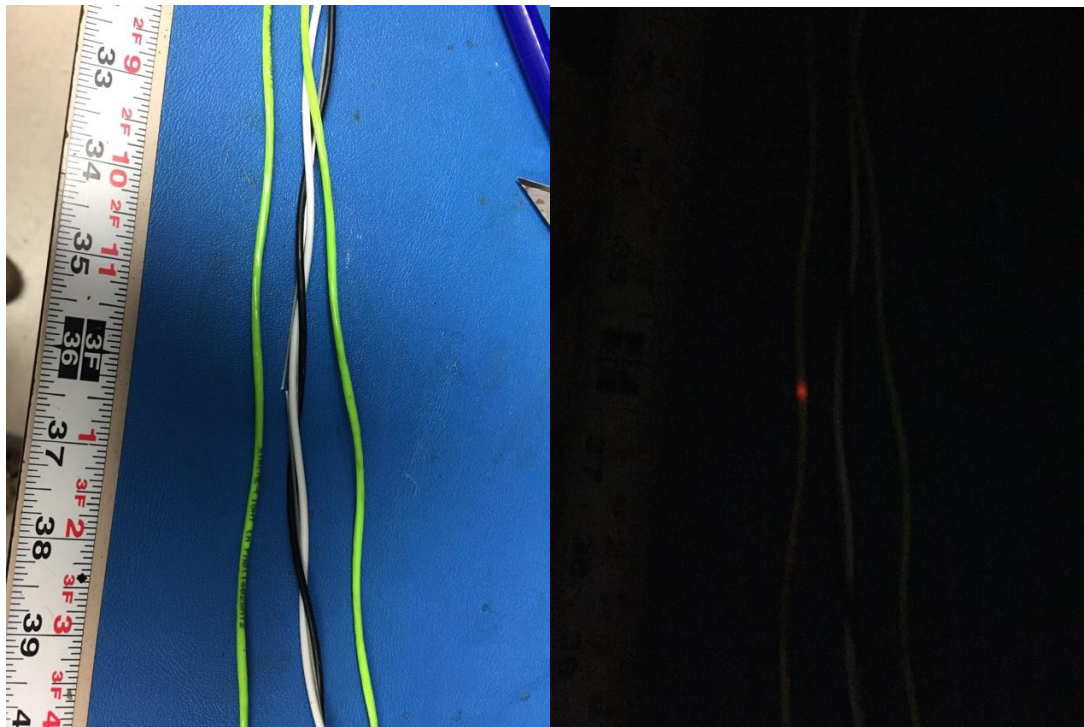
Dissection of the tether was able to localize the fault to a break in the tether, 12-meters from the attachment point of the clump. Pictures below show the broken section after the outer jacket has been removed. The left image shows the unbundled conductors (white and black) and the two fiber optic cables (green). The only proof of damage here is the broken fiberglass fill element that is the core member of the tether. The right image shows the visible break in the fiber when illuminated by a visible light source injected at the far end of the tether. I would expect more damage held as small bends in the copper conductors, but their straight nature might be explained as a result of being pulled back through the sheaves under load on final recovery. No other local damage was visible.

The physical damage and data support a conclusion that the tether experienced a failure as a result of a twist in the tether and a potential self-tangling incident subsea. Since there are no kinks in the copper conductors near the failure point, I believe that the system did not get caught on a float or the clump weight. Because the system was recovered through the sheaves on-board, some other kinks may have been removed. Since the failure did not occur at an attachment point of the floats or depressor weights, I believe the design remains sound.

- Move the clump attachment point higher on the tether.
- Log the calculated value of turns on the platform.

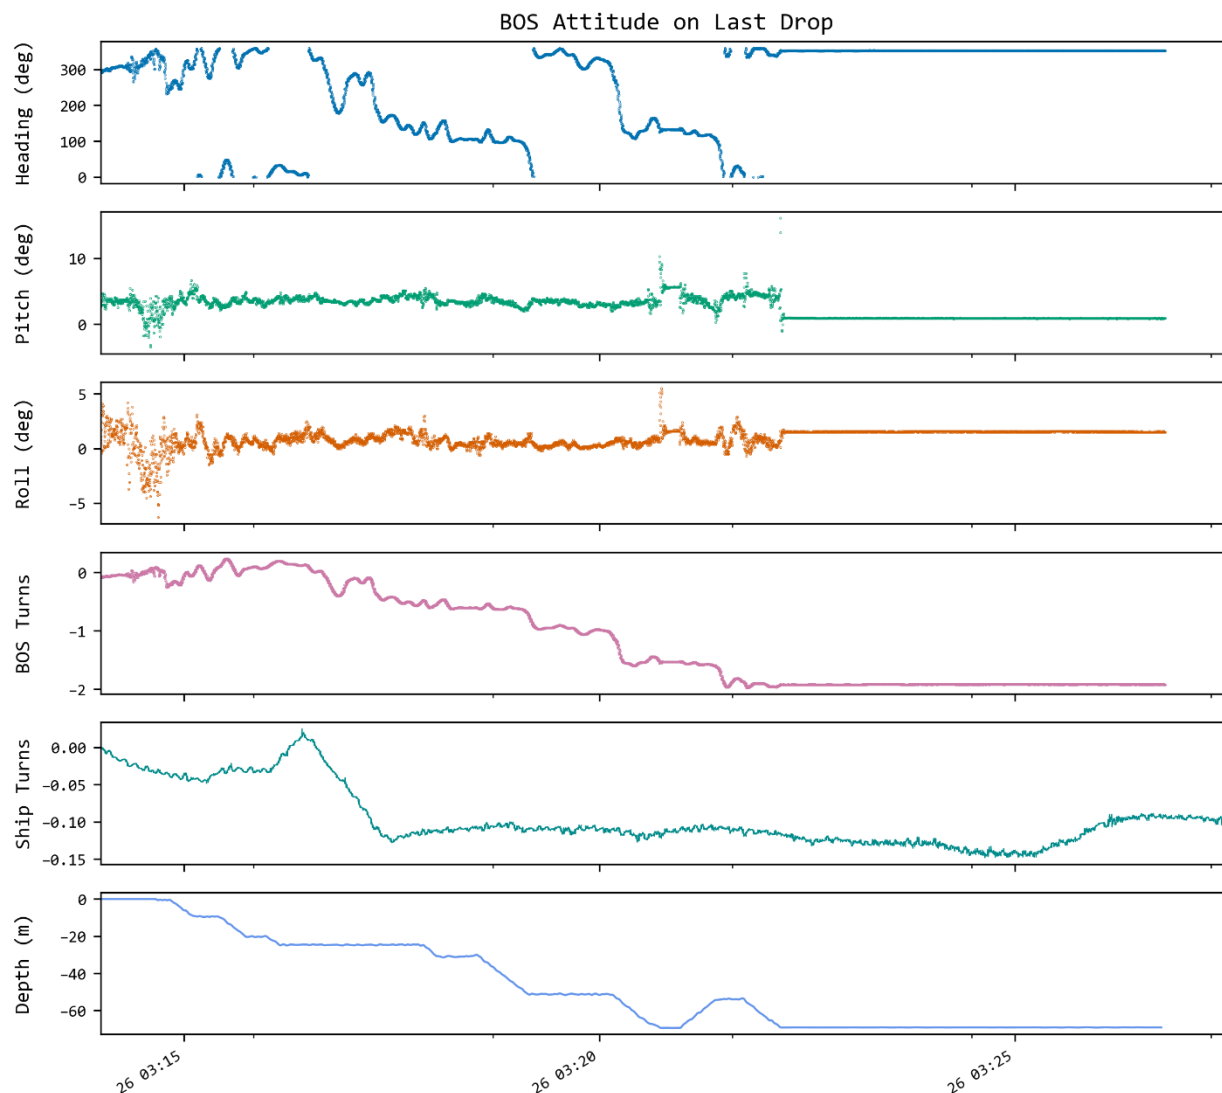
Data files were supplied for analysis, ones that captured all available data leading up to the failure. See below for a set of relevant signals. Heading, pitch and roll are from the attitude sensor on the BOS. A similar sensor provides the heading of the ship. Integrating the change in heading over time gives us the values of “turns”, which is the number of times the heading has completed a revolution of  $360^\circ$ , and it’s sign indicates a clock-wise (positive) or counter-clock-wise (negative) turn. In these plots the turns are presented as the value with respect to its platform. What is operationally important is the instantaneous value of difference between the ship’s turns and the BOS’s turns. If the two drift far apart, and there is slack tether, the tether will develop a hockle, or a twist, that can result in damage when tension is applied again.

The data above is just the final segment of the file provided that encompassed the incident. Within just this file, it is clear that the BOS develops a -1.97 turns value, and the boat has a -0.15 value. The net turns captured in the tether is  $\sim -2.15$  turns, enough to develop a hockle.

- The turns counters must exist, be reliable and visible to the BOS operator, so that informed operational decisions can be made.
- Operators should wait for a high turns estimate to equalize before bottoming the platform.
