# Benthic Observation System Failure Report

**MBARI Project:** 901704 Benthic Observation System

**Date:** November 7, 2019

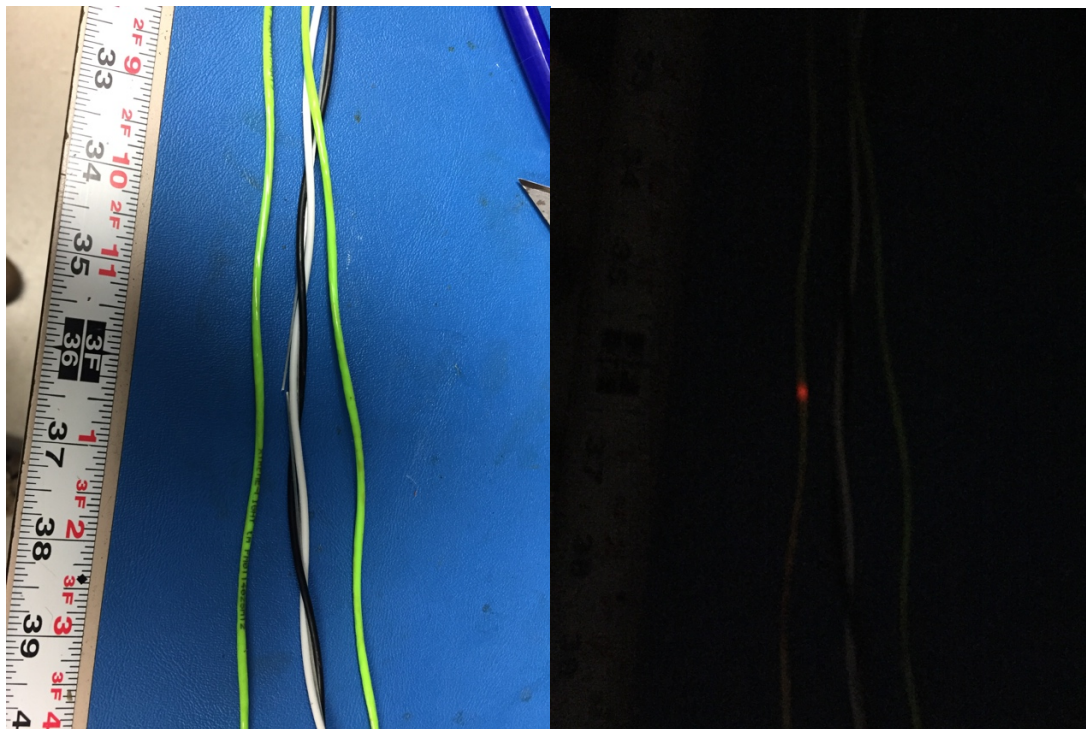
Dissection of the tether was able to localize the fault to a break in the tether, 12-meters from the attachment point of the clump. Pictures below show the broken section after the outer jacket has been removed. The left image shows the unbundled conductors (white and black) and the two fiber optic cables (green). The only proof of damage here is the broken fiberglass fill element that is the core member of the tether. The right image shows the visible break in the fiber when illuminated by a visible light source injected at the far end of the tether. I would expect more damage held as small bends in the copper conductors, but their straight nature might be explained as a result of being pulled back through the sheaves under load on final recovery. No other local damage was visible.

The physical damage and data support a conclusion that the tether experienced a failure as a result of a twist in the tether and a potential self-tangling incident subsea. Since there are no kinks in the copper conductors near the failure point, I believe that the system did not get caught on a float or the clump weight. Because the system was recovered through the sheaves on-board, some other kinks may have been removed. Since the failure did not occur at an attachment point of the floats or depressor weights, I believe the design remains sound.

- The turns counters must exist, be reliable and visible to the BOS operator, so that informed operational decisions can be made.
- Operators should wait for a high turns estimate to equalize before bottoming the platform.

- Move the clump attachment point higher on the tether.
- Log the calculated value of turns on the platform.

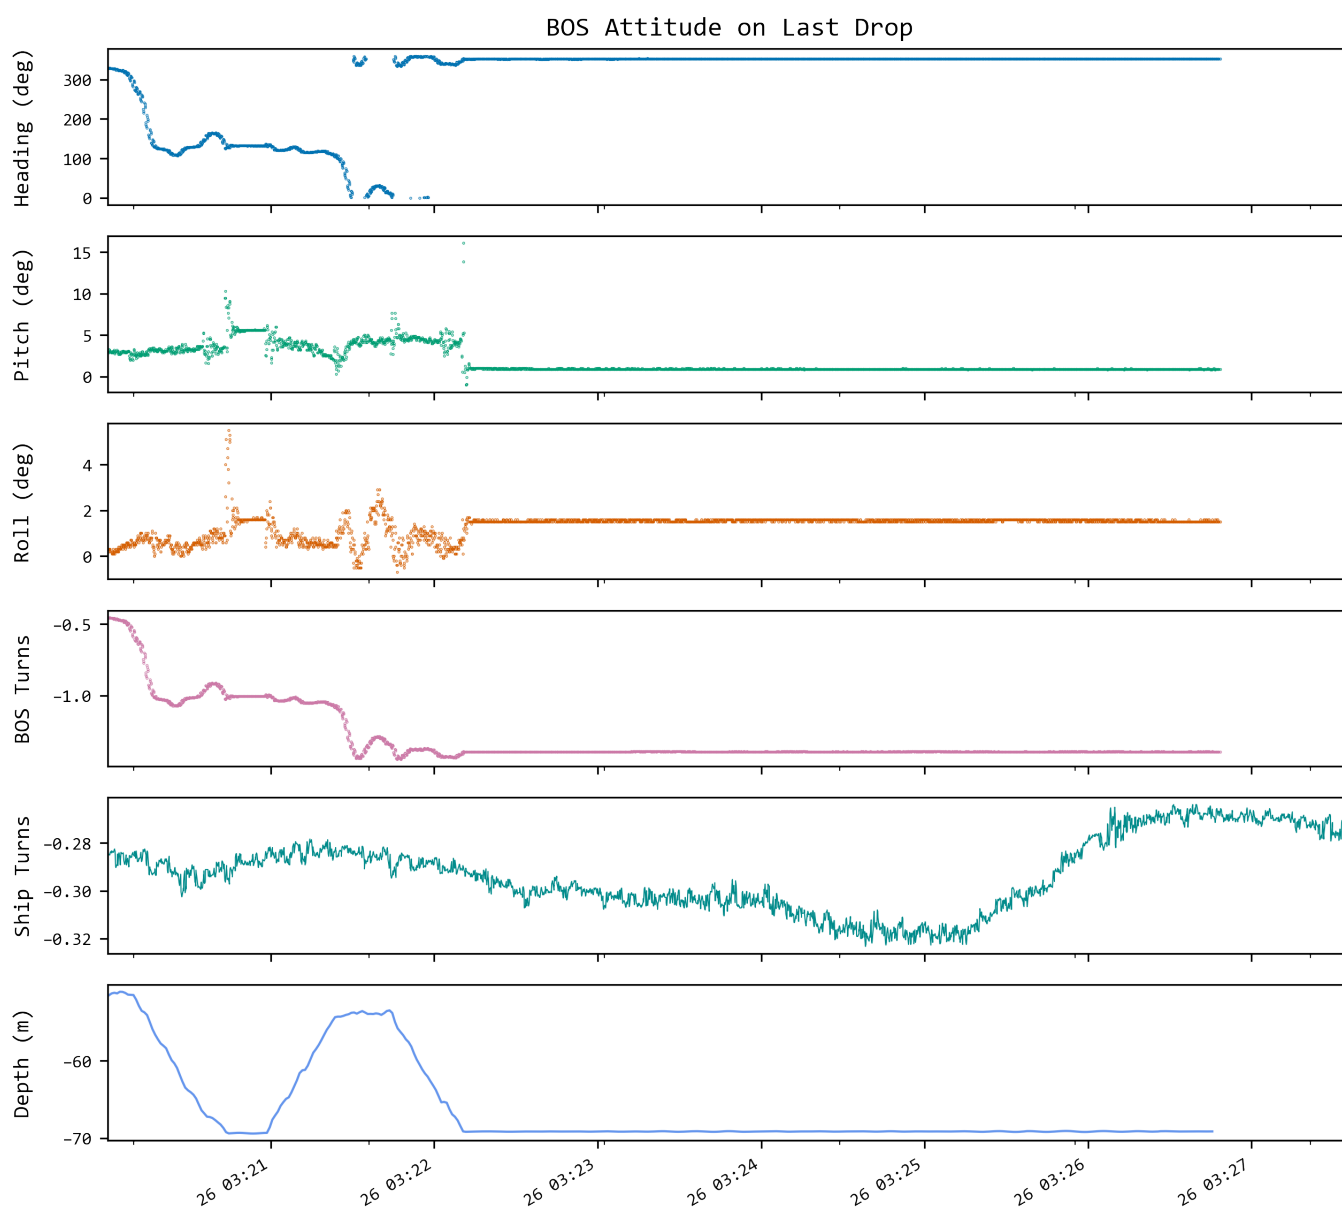
Data files were supplied for analysis, ones that captured all available data leading up to the failure. See below for a set of relevant signals. Heading, pitch and roll are from the attitude sensor on the BOS. A similar sensor provides the heading of the ship. Integrating the change in heading over time gives us the values of “turns”, which is the number of times the heading has completed a revolution of  $360^\circ$ , and it’s sign indicates a clock-wise (positive) or counter-clock-wise (negative) turn. In these plots the turns are presented as the value with respect to its platform. What is operationally important is the instantaneous value of difference between the ship’s turns and the BOS’s turns. If the two drift far apart, and there is slack tether, the tether will develop a hockle, or a twist, that can result in damage when tension is applied again.

The data above is just the final segment of the file provided that encompassed the incident. Within just this file, it is clear that the BOS develops a -1.44 turns value, and the boat has a near -0.2 value. The net turns captured in the tether is  $\sim$ -1.6 turns, enough to perhaps develop a hockle. Since the data supplied does not cover the headings on deck, it should be noted that the turns values could be better or worse if more data were available to analyze.
