Difficulty with S.W. incursion into the SMA connectors to Tethys antenna after a deep dive to 280 meters on March 8, 2012 disallowed reestablishing communication and the vehicle was searched for but not found. Tethys was adrift for nearly 2 weeks until recovered by a fishing boat. The seal at that time was 3M Fast Seal 5200 which had worked fine during multiple ~50meter shallower dives. During the

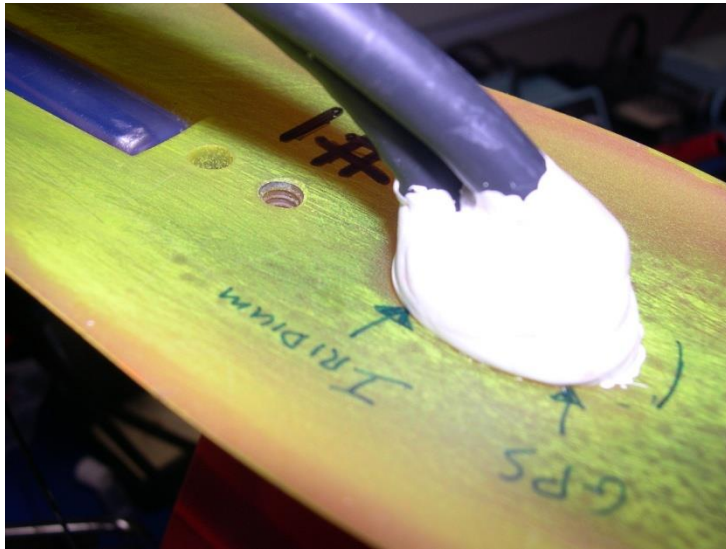
deep dive the 3M 5200 seal had apparently pulled away from the wire and heat shrink over the crimp on the SMA connector allowing S.W. to seep in. It was thought that the high viscosity allowed a large enough air bubble to exist within which collapsed under pressure and caused the seal to be compromised. To reduce trapped bubbles a new idea of cutting the 5200 1/5 with Acetone gave a honey like flowability. Trials gave apparent good adhesion and workability on abraded and cleaned surfaces. The antenna wire is Rochester C-N-4 neoprene coated coax.

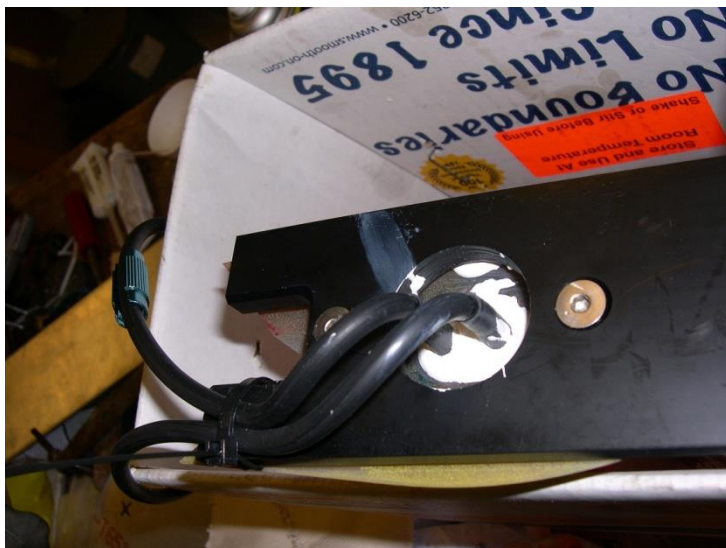
The well interior was abraded and a chamfer added to the upper edge then acetone wiped. The ferrule ends of wire covered with 0.5" length of adhesive lined heat shrink to equalize wire diameter and cover ferrule, 1.5" adhesive lined heat shrink over that. Assembled and preset wires to final positions. Connectors and heat shrink acetone wiped. 15 gm of 5200 cut with 3 gms acetone, well mixed. Degas to pop bubbles, ~15-20 in Hg. Quick to reduce loss of volatiles. Poured carefully into cavity to a slightly moulded shape and left to cure in vertical position at Room temperature. Unit double bagged in test-tank S.W. and cycled 5X to 500 psi @ 100psi/min. Adhesion to the urethane mast very good but poor to heat shrink and metal connectors which resulted in water leakage and air bubbling in post testing. The varied substrates were proving to be troublesome.

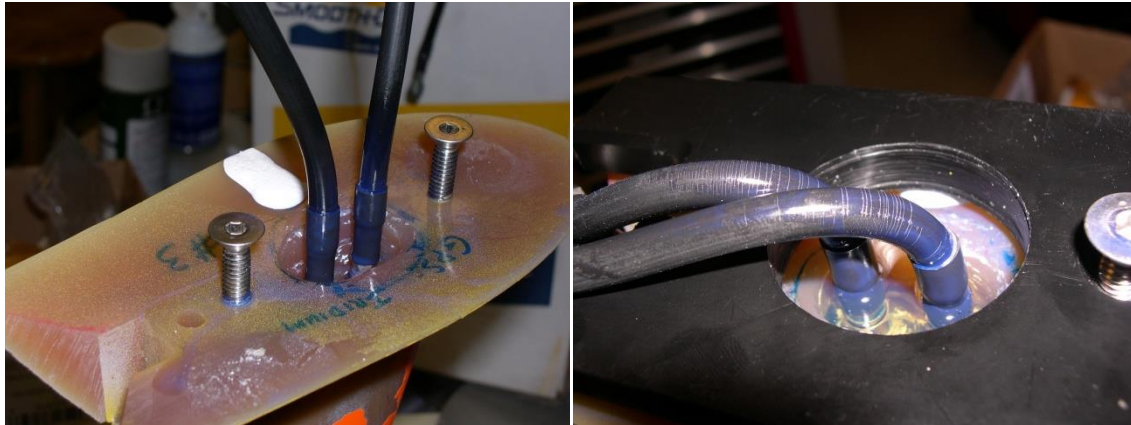
Note cracks in the Turbo-Coating on the neoprene wire covering. As before the unit was double bagged in test-tank S.W. and cycled 5X to 500 psi @ 100psi/min. This time no leakage of water upon inspection or air leakage during post cycling testing was noted. The adhesive in the heatshrink worked well.

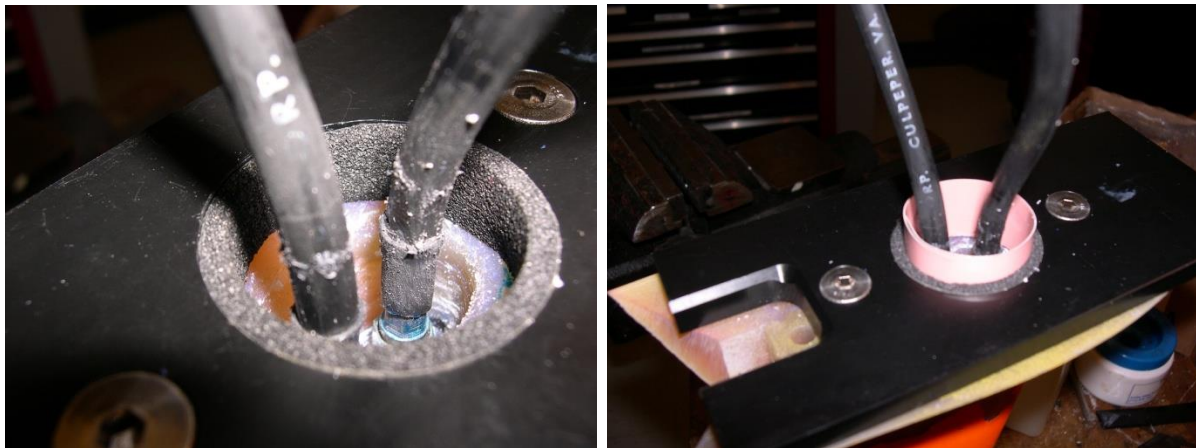
An additional test for a permanent, no access, solution was also performed. A shorter piece of heat shrink over the metal ferrule but with only 0.15" overlap onto the wire covering was installed. The SMA connector was bead blasted then FL-10 primer applied. The heat shrink was abraded then acetone cleaned. No conformal coatings were applied. The well area and cabling were abraded and acetone cleaned then the SMA test leads were installed. Since a deeper seal was desired to improve contact to the wires and form a strain relief a temporary circular casting form was installed above the antenna well. This was made of foam and metal shim materials.

The antenna attachment "shoe" was used to hold the casting form in place. 3M ScotchCast 2130 was poured and allowed to cure. This sealed very well but other problems with the antenna were found.

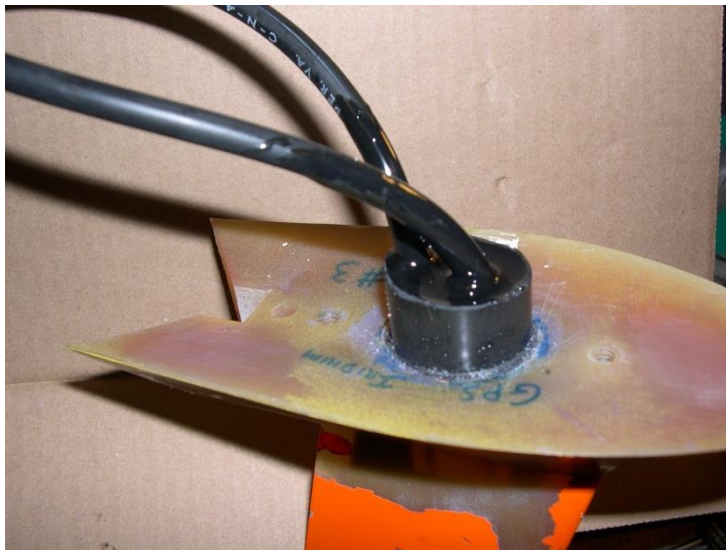
A pin hole in the upper portion of the mast was admitting water after the antenna had been in use for awhile which cracked the urethane in a thin section. Also, cutting apart our test article revealed the urethane had poor adhesion to the (ABS) SMA Mount Block which allowed water to enter the base of the antenna by travelling up the ¼-20 shoe mounting threads up to the poor interface surface within the antenna base structure.

The ¼-20 mounting arrangement was changed to 4 x 10-24's and the ¼-20 holes were backfilled. On 4/27/12 a new antenna was wired and prepared as above, cycled 5X to 500 psi in S.W. with perfect results. It was installed on Daphne in preparation for her next sea trials.
