## AUV Dock Camera Housing Failure, Fall 2022

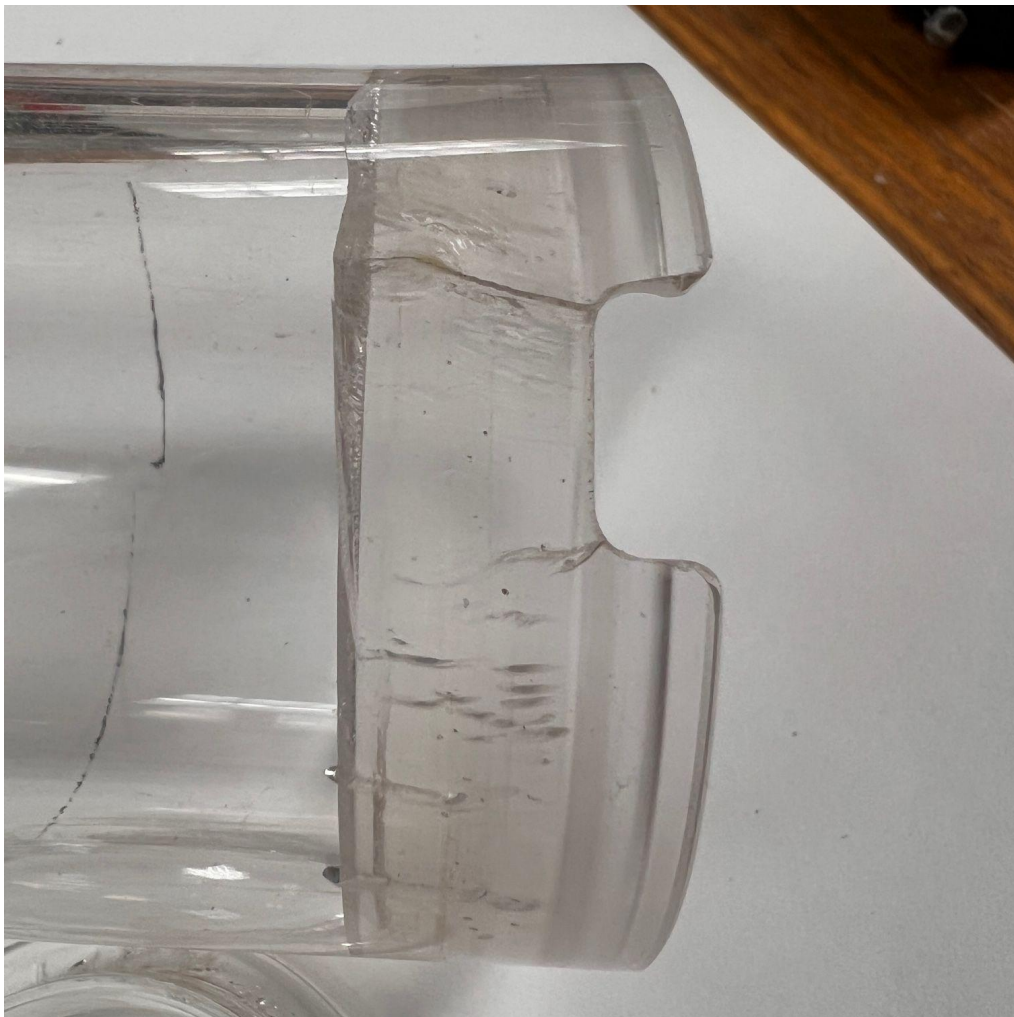
The upward looking camera on the AUV docking station failed about four months into a six month deployment. When the dock was recovered on Dec. 8th, it was clear the camera housing was full of water, so it appears there was a delayed pressure housing failure. On Dec 16th I finally took a close look at the housing and it is clear that the acrylic tube failed across the o-ring seals. The diagram below shows the endcap with two radial O-rings. The tube failed in tension (cracked) above the O-rings, letting water rush past the seals. The housing is a COTs housing from Blue Robotics rated to 200m. We had planned to use an aluminum tube, rated to 950m but switched to plastic to reduce the corrosion potential. This was a bad decision because acrylic is known to have long-term creep problems. In addition to this failure there were three other problems which are all listed below.

1. Seal failure due to cracks in the tube above the O-rings

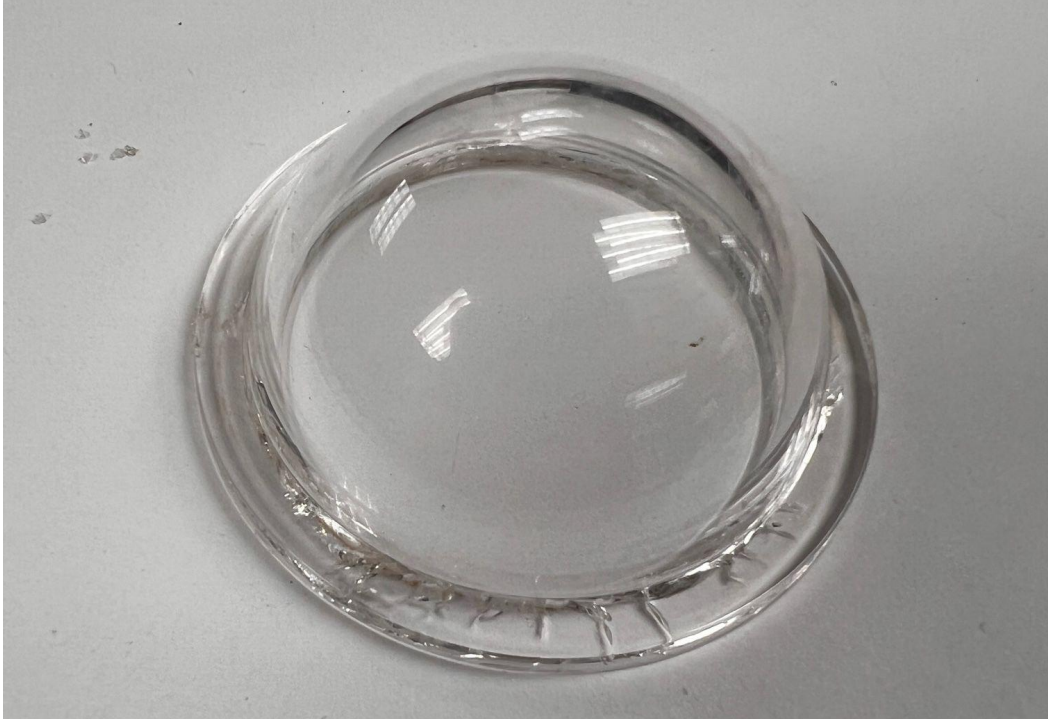
2. crazing/cracks on camera dome - didn't fail, yet

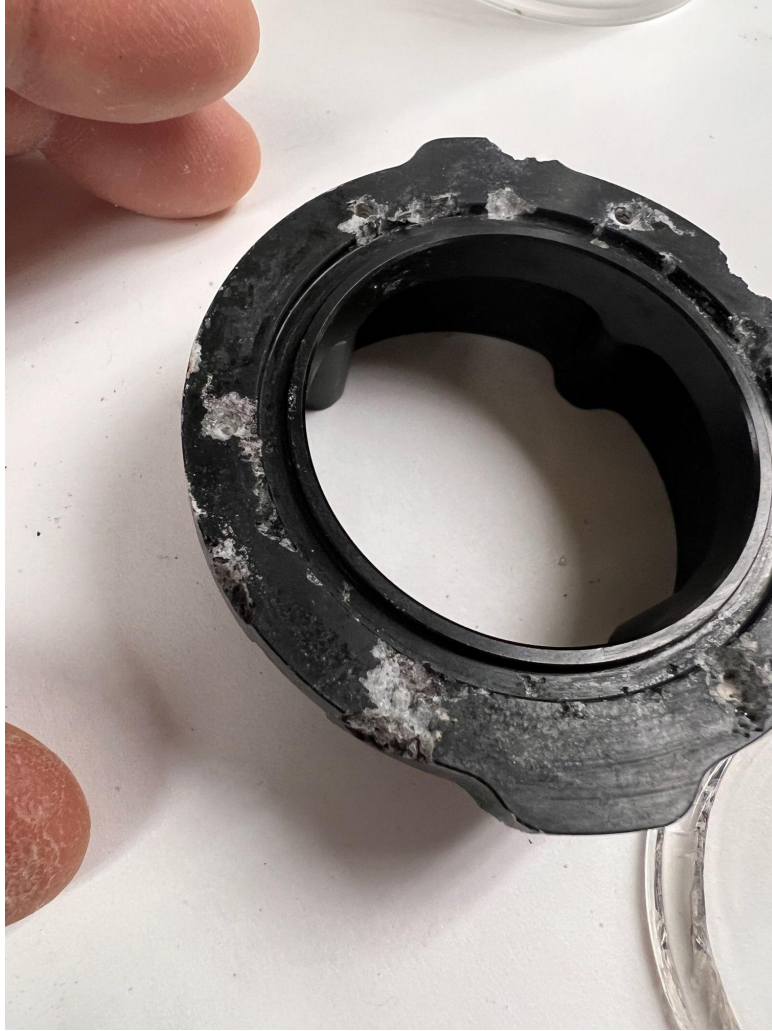
3. Endcap corrosion: Significant corrosion around the dome retainer plate screws. We know stainless steel screws in an aluminum housing are trouble, but the extent of this seems quite excessive. There was a copper ring added for biofouling reduction, which was galvanically connected to the stainless steel screws, then to the aluminum endcap which likely accelerated the corrosion of the aluminum due to the large surface area and galvanic potential. Recommend isolating the copper next time, and using Lanocote on the stainless steel screws.

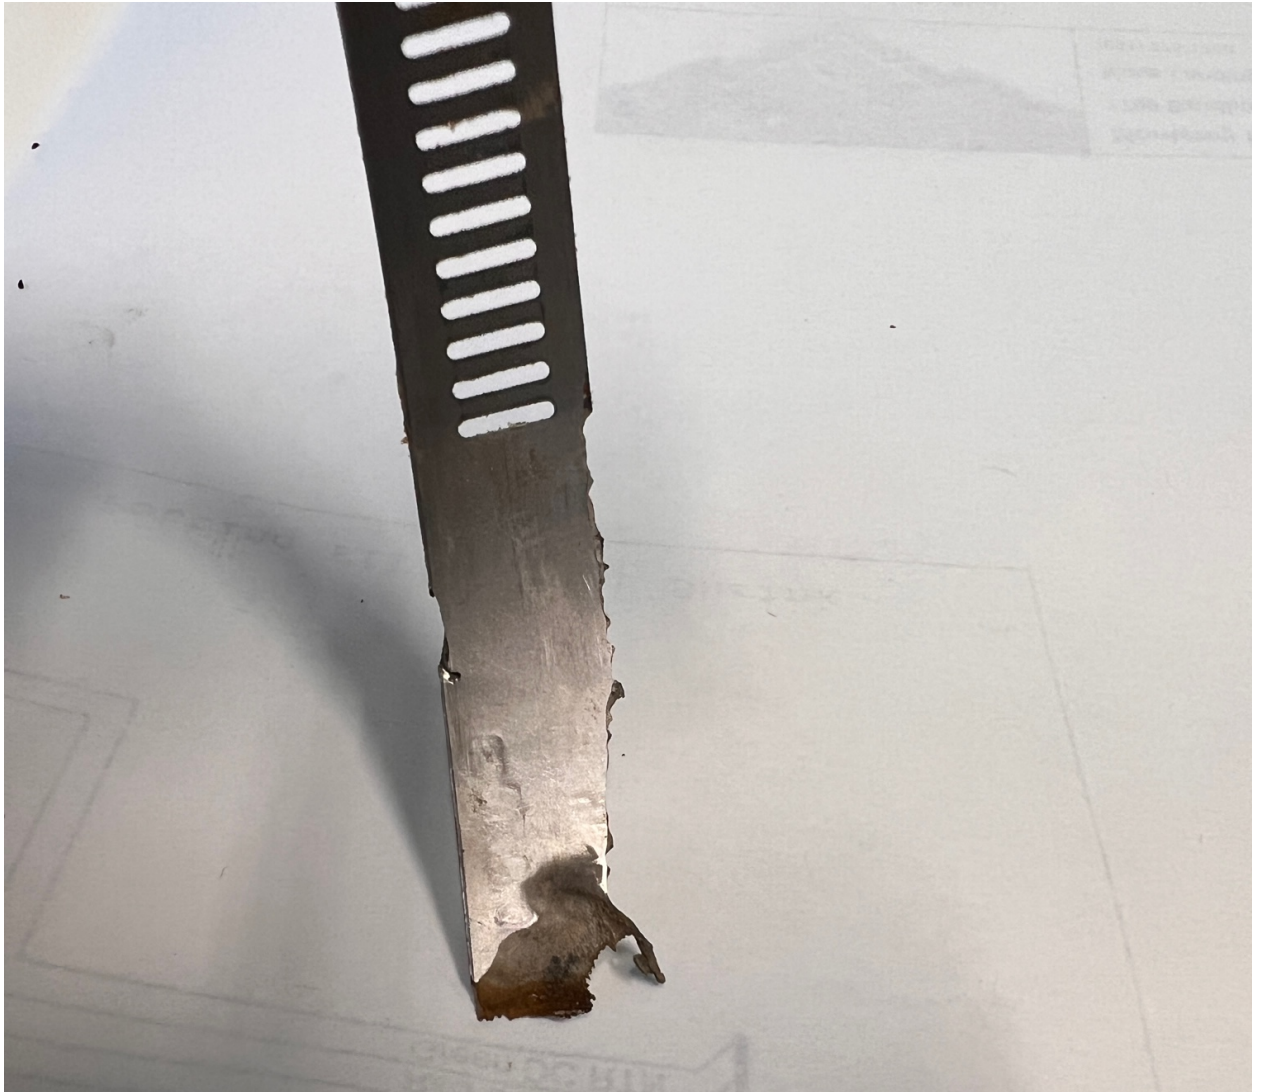
4. Hose clamp failure - Hose clamp camera strap failed due to corrosion. This component was galvanically isolated, and all stainless, so it isn't clear why it would have failed, but maybe the heat shrink tubing which was added to cushion the strap against the acrylic tube caused a local environment of oxygen depletion which accelerated crevice corrosion.
