## Radiometer Service Report

Date 10/29/19 SR #: 1005508931 Sensor Type: HyperOCR R08W

S/N 254 Customer MBARI

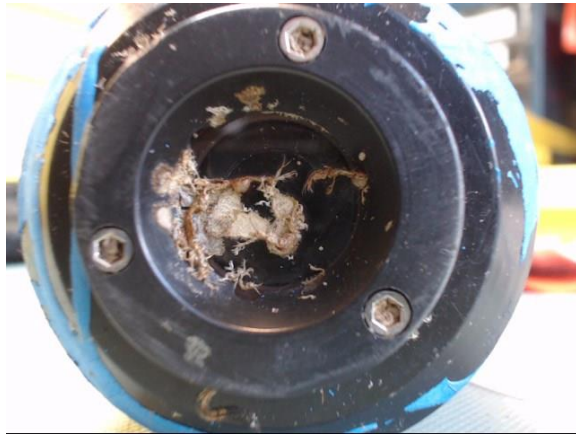
Received without Protective Cap.

Window was covered with Algae.

Standard Service.

Did Post Calibration after cleaning window.

Passed Calibration and Reality Check.

Added Protective Cap.
