## Radiometer Service Report

Date 11/5/19 SR #: 1005508931 Sensor Type: HyperOCR ICSW

S/N 295 Customer MBARI

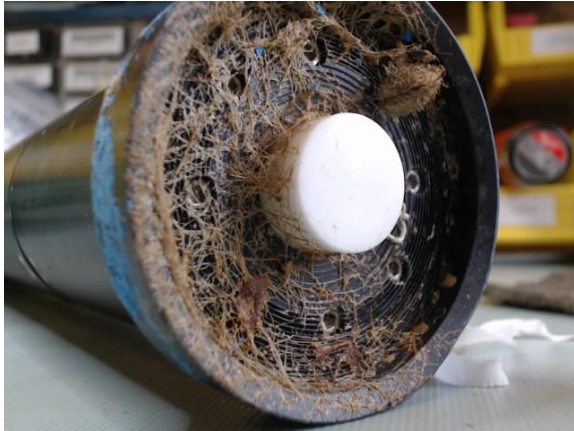
**Diffuser was covered with Algae & Mussels.**

**Failed Calibration.**

**Did Post Calibration after cleaning Optics Head.**

**Replaced the Inner Diffuser.**

**Passed Calibration and Reality Check.**
