# Investigation Procedure

## Monterey Bay Aquarium Research Institute (MBARI)

### Electrical Fault Investigation ROV Umbilical RM0011

### 70m Returned Section

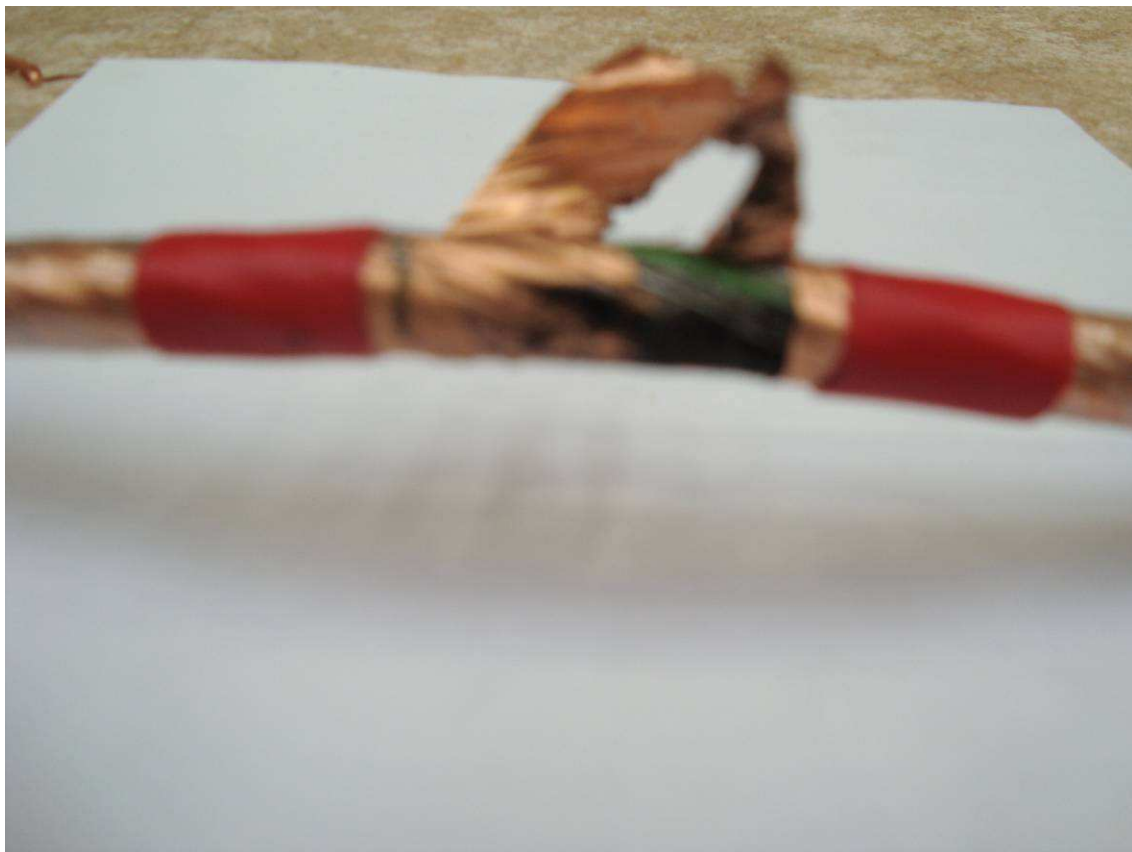
| Observation | Location | Photograph Reference |
|---|---|---|
| Generally the copper tape is in good condition however a small burn in the copper tape is visible. | 3.1m from end A | Photograph A |

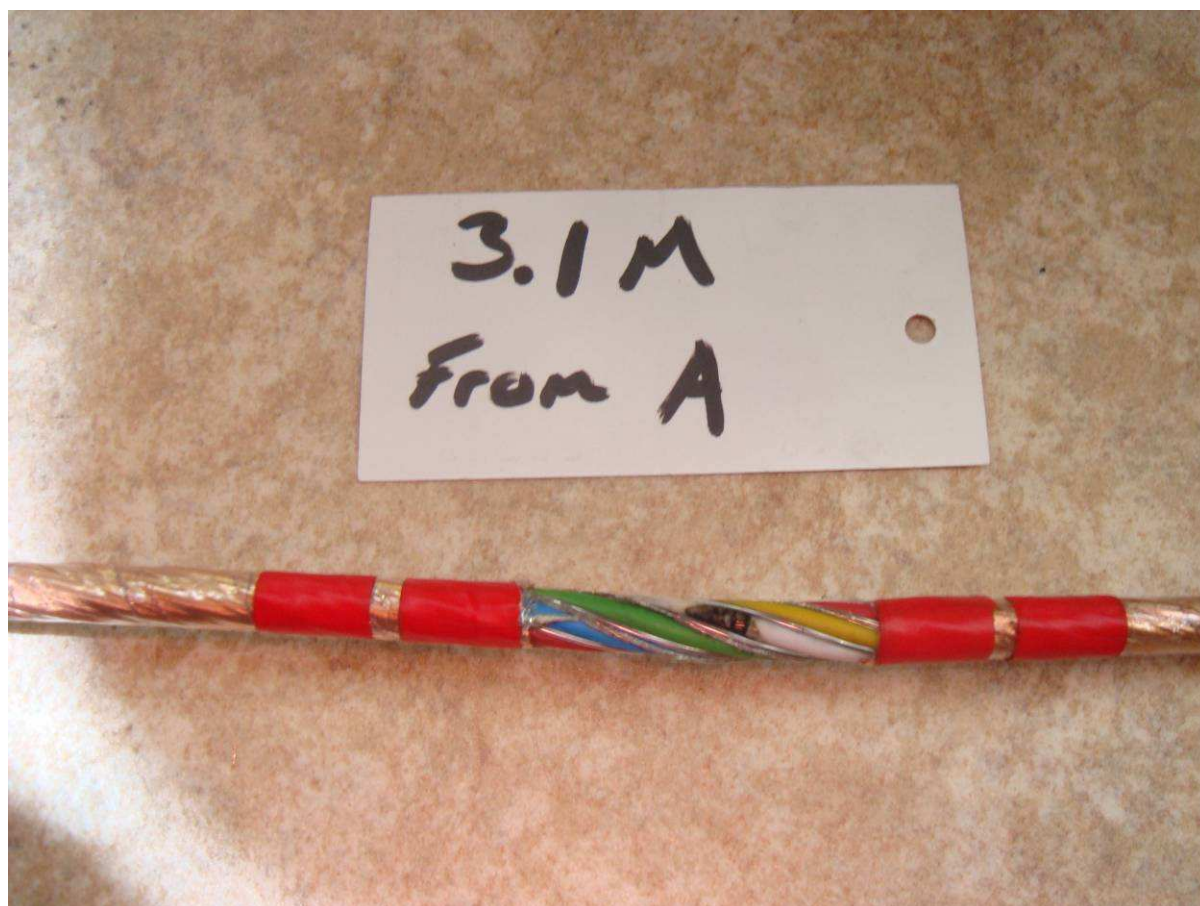
| Observation | Location | Photograph Reference |
|---|---|---|
| Fault in white core located.<br>Unable to locate fault in blue core (no obvious marking in copper tape to show location). | 3.1m from end A | Photograph B |

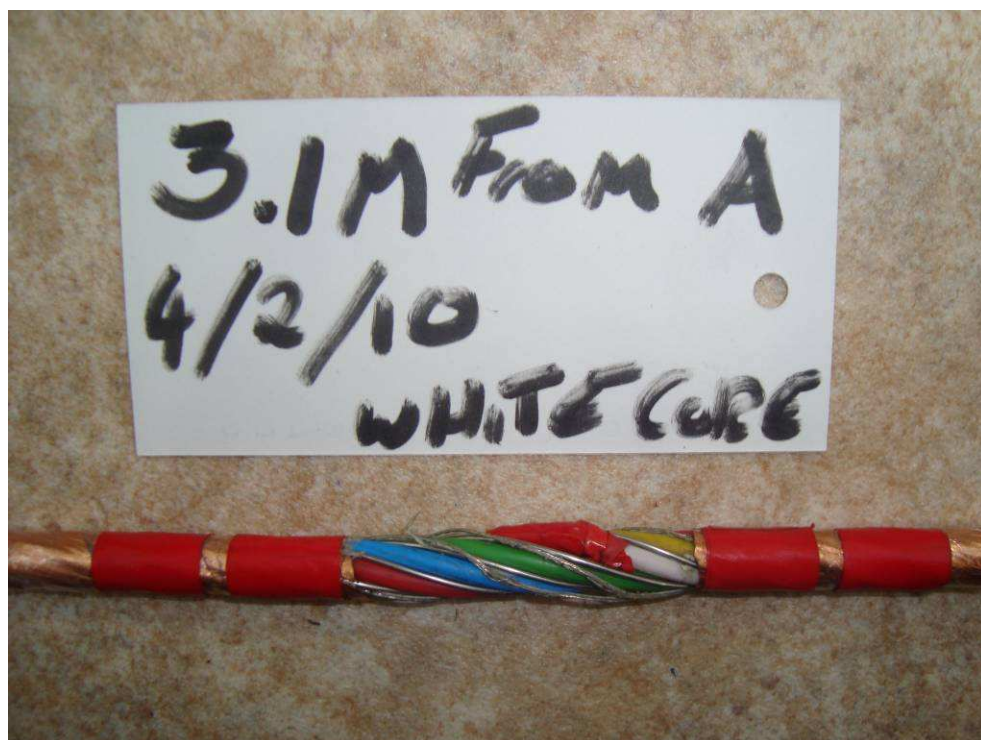
| Observation | Location | Photograph Reference |
|---|---|---|
| Repaired fault in white core. | 3.1m from end A | Photograph E |

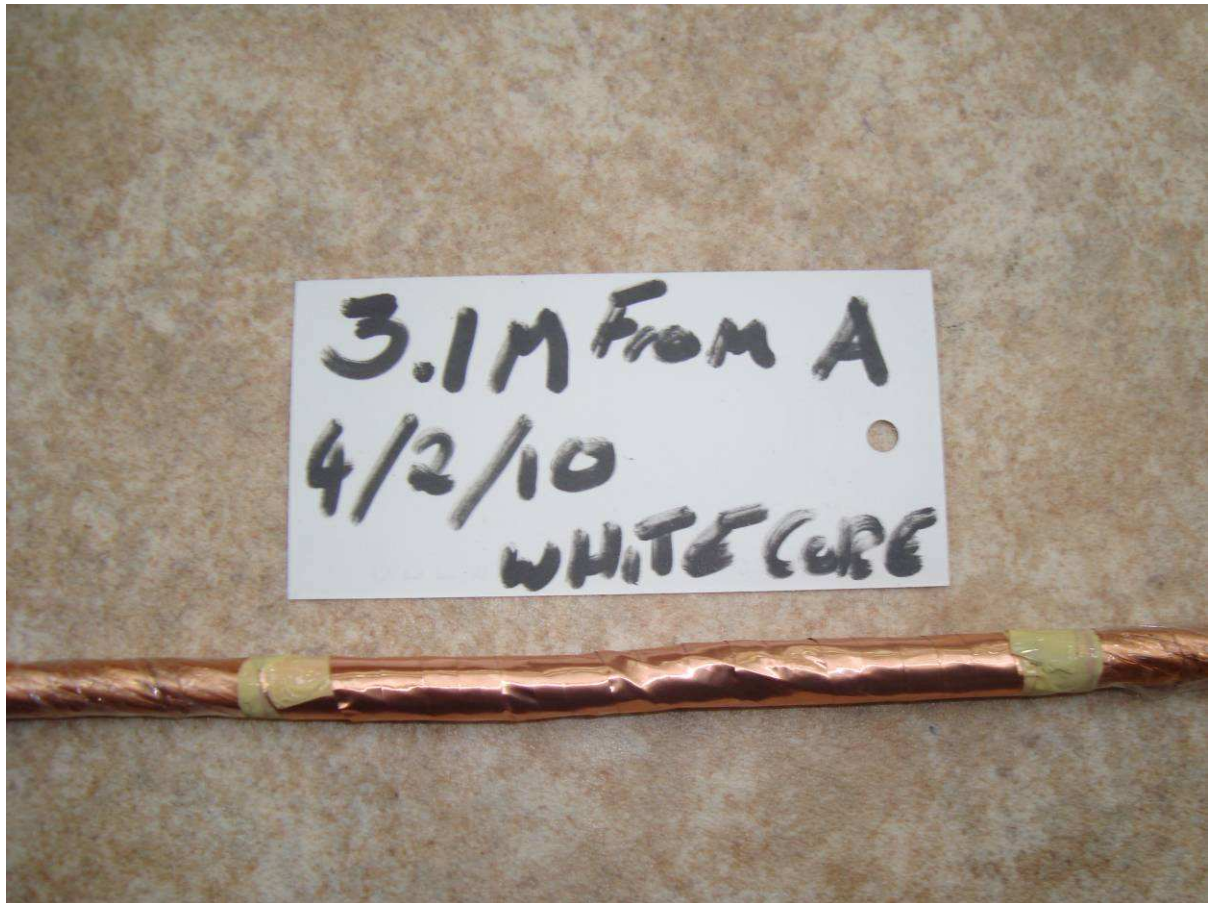
| Observation | Location | Photograph Reference |
|---|---|---|
| Reinstated copper tape screen. | 3.1m from end A | Photograph F |

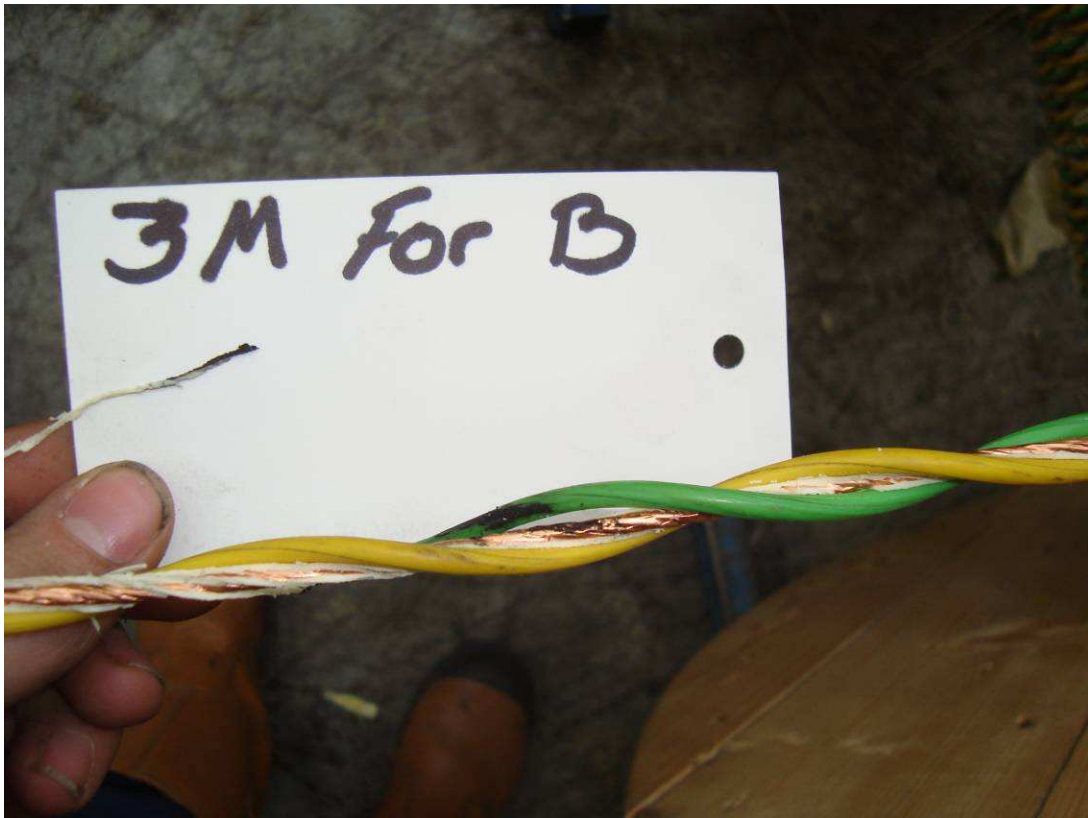
| Observation | Location | Photograph Reference |
|---|---|---|
| Scorch mark on green core caused by blue core fault. | 3.0m from end B | Photograph H |

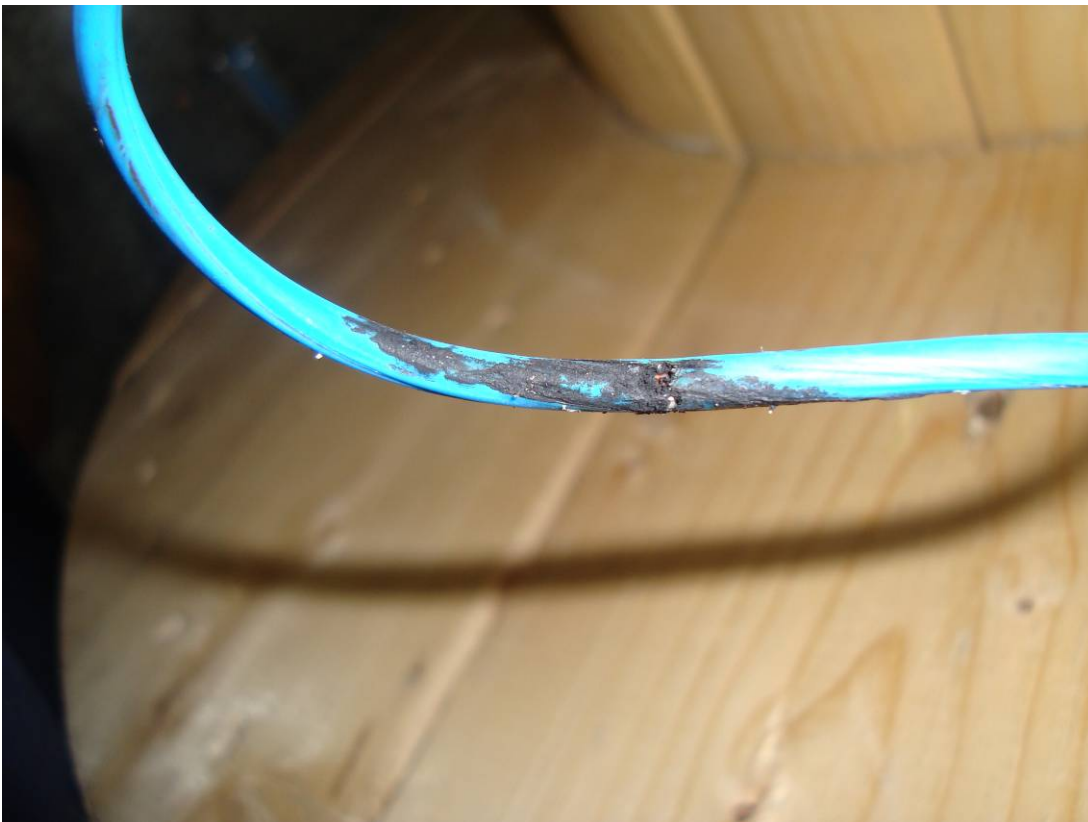
| Observation | Location | Photograph Reference |
|---|---|---|
| Close up of blue core fault. | 3.0m from end B | Photograph I |

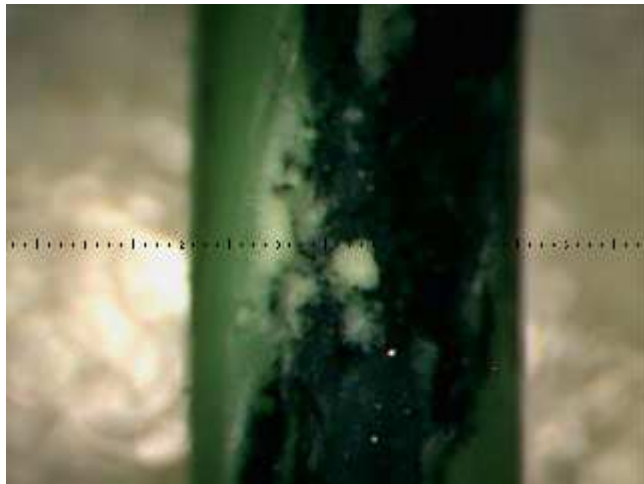
| Observation | Location | Photograph Reference |
|---|---|---|
| Close up scorch mark on green core caused by blue core fault. | 3.0m from end B | Photograph L |

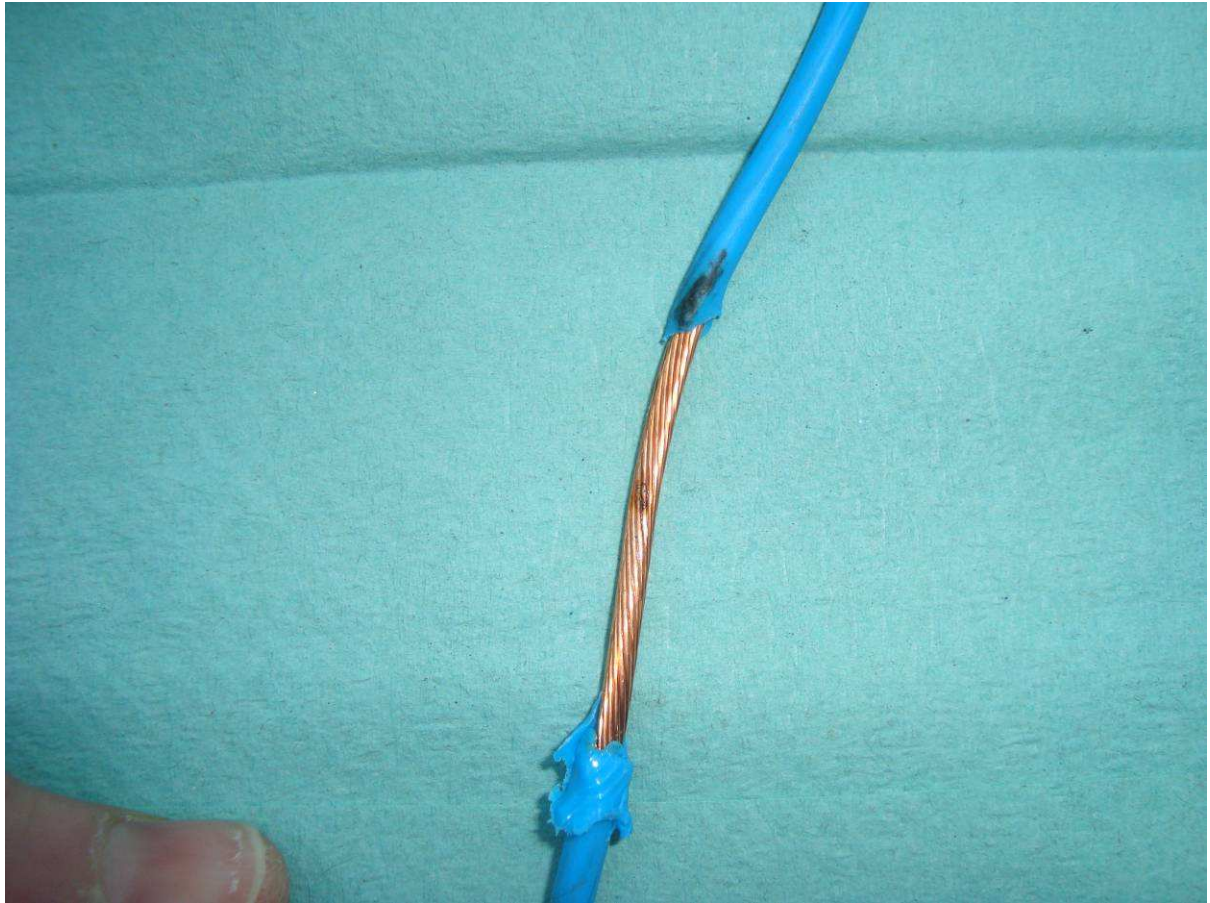
| Observation | Location | Photograph Reference |
|---|---|---|
| Photograph of fault in blue core with insulation removed. | 3.0m from end B | Photograph O |

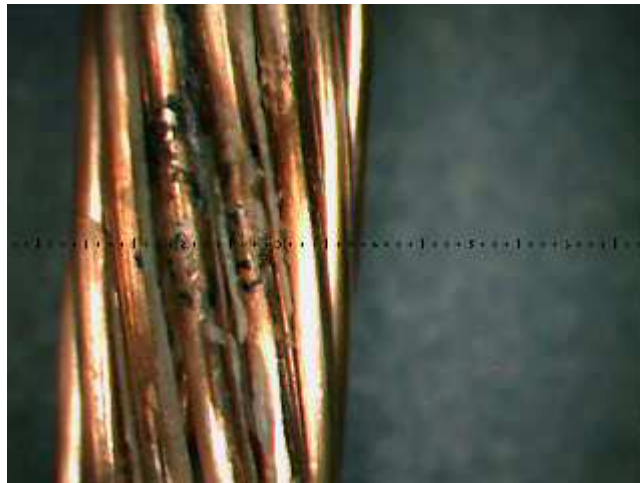
| Observation | Location | Photograph Reference |
|---|---|---|
| Close up photograph of fault in blue core with insulation removed. | 3.0m from end B | Photograph P |
