# **AM335x ARM Cortex-A8 Microprocessors (MPUs) Silicon Revision 1.0**

## **Silicon Errata**

Literature Number: SPRZ360C  
October 2011–Revised September 2012

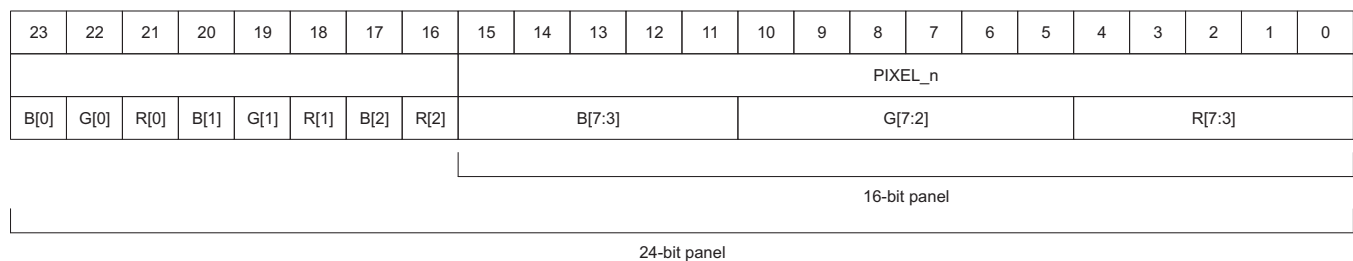
**Figure 2. RGB888 Mode LCD Controller Output Pin Mapping (LCD\_DATA[23:0])**

The blue and red color assignments to the LCD data pins are reversed when operating in RGB888 (24bpp) mode compared to RGB565 (16bpp) mode. In order to correctly display RGB888 data from the SGX, or any source formatted as RGB in memory, it is necessary to connect the LCD panel as shown in [Figure 2](#). Using the LCD Controller with this connection scheme limits the use of RGB565 mode. Any data generated for the RGB565 mode requires the red and blue color data values be swapped in order to display the correct color.

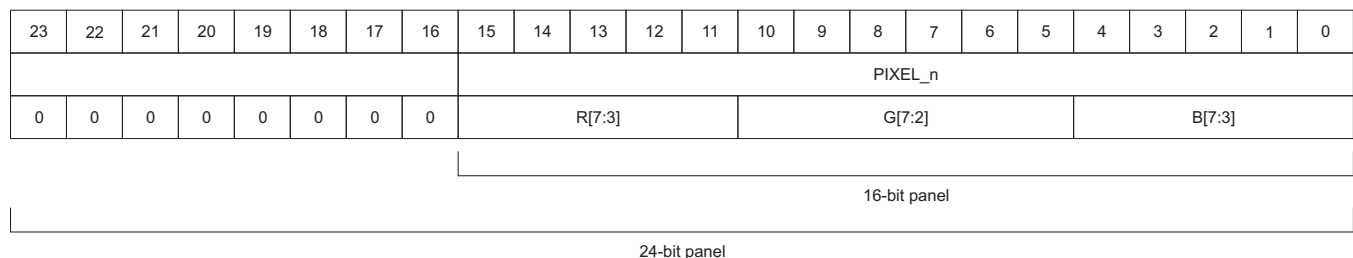
**Figure 3. RGB565 Mode LCD Controller Output Pin Mapping (LCD\_DATA[23:0])**

When operating the LCD Controller in RGB565 mode the LCD panel should be connected as shown in [Figure 3](#). Using the LCD Controller with this connection scheme limits the use of RGB888 mode. Any data generated for the RGB888 mode requires the red and blue color data values be swapped in order to display the correct color.
