## REPORT FROM THE 1st ARGO TECHNICAL WORKSHOP

September 19-21, 2005

University of Washington, Seattle, USA

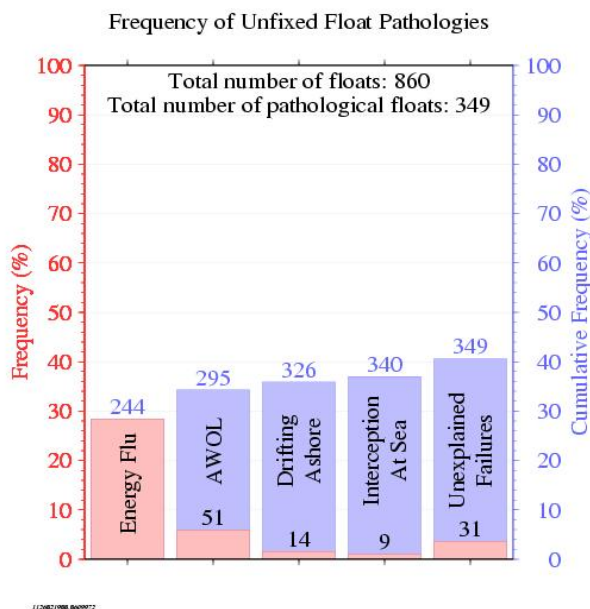
As noted, several of these problems have been fixed. Yet the largest source of failure by far, alkaline energy flu, generally remains as a problem. Several fixes for this problem have been suggested, but it is not clear that these remedies have yet been successful (see Figure 2).

**Figure 2:** Frequency of float failure due to currently unfixed problems based on the analysis of the failure of 366 APEX floats (supplied by Dana Swift., UW).

1. Use the *Park and Profile* feature (ie, do not go to 2000 m on every profile), particularly if using alkaline batteries (see below).
2. Deploy away from islands and coasts.
3. Monitor the engineering data from each float on each profile (this can be automated).
4. Avoid deployments of large numbers of floats with of new features until the performance has been documented (the motor backspin problem is an example of this, where large numbers of floats profiling to 2000 m were deployed before this capability was fully tested by the manufacturer and the user community).

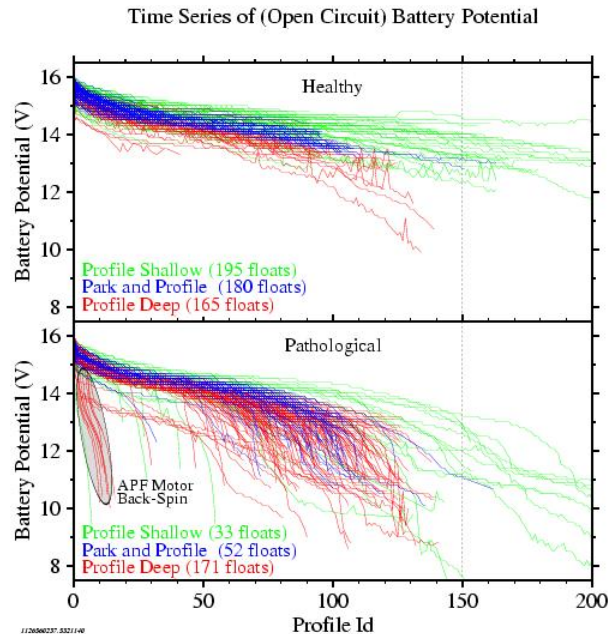
Based on laboratory testing done at UW, an APEX float with alkaline battery packs should achieve 300 shallow (1000 m) profiles, 220 park and profile cycles (to 1000 m on three out of four profiles, and to 2000 m on the fourth), 160 2000 m profiles. Note that one reason for the larger number of shallow profiles is that a lighter weight hull can be used, allowing an additional battery pack be carried by the float. However, many floats are not meeting these theoretical projections. An analysis of the battery voltage records from the float ensemble clearly shows that floats with alkaline batteries that profile to 2000 m on every cycle consistently showed premature battery failure, and failed prematurely in greater numbers than floats that only profiled to 1000 m (see Figure 3).

**Figure 3:** Battery voltage as a function of profile number. Top – floats operating normally. Bottom – floats exhibiting energy flu (from D. Swift, UW).

It is now believed that running the float pump at high pressure results in high peak currents drawn from the battery packs. These currents are thought to cause individual alkaline cells in the battery packs to fail; once a cell fails, its high impedance breaks the circuit in the battery pack and the energy in the pack becomes inaccessible to the float.

1. **Do not profile deep as often.** Deep profiling requires pumping at high pressures and causes high peak currents to be drawn from the battery packs. By reducing the frequency of deep profiling, damage to alkaline cells is reduced. This is clearly indicated in D. Swift's analysis showing higher longevity of alkaline powered floats that do not profile deep frequently. Hence, if alkaline battery packs are to be used alone, we recommend that floats park and profile to 1000 m, with a 2000 m profile only every fourth cycle.

2. **Install lithium batteries.** Lithium batteries do not suffer from failure under high peak currents and do not exhibit energy flu. CSIRO has been replacing two alkaline packs with lithium batteries since 2000. Among 61 APEX floats powered by such mixed packs, none have shown evidence of energy flu, even the 18 which have profiled over 80 times to 2000 m. Similar results have been obtained by UW and PMEL in younger floats. UW now uses lithium batteries exclusively.

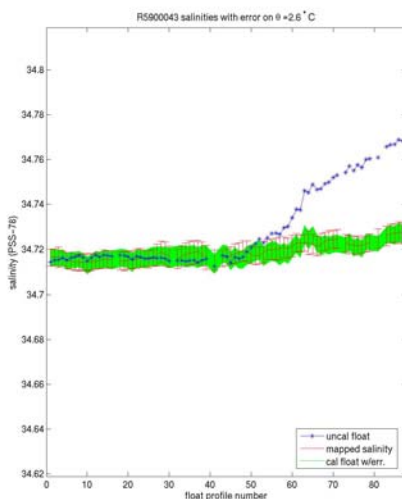
**Figure 5:** An example of a salty drift error in salinity reported by an SBE41 on an Australian float. Salinity is shown on a deep isotherm, with red showing climatological values and green for corrected values at the float (supplied by T. Tchen, CSIRO).

While most conductivity sensor problems will cause the salinity to drift to low values, a significant number of SBE41s on APEX have drifted *high* – sometimes by as much as 0.1 (PSS-78). In the UW ensemble, 22 floats exhibit this behavior. Australia has 5 floats with clear drifts to higher values of salinity. Physically, this can only occur if the conductivity cell is bored out (the volume of water in the cell is increased) or becomes coated with a substance more conductive than seawater; both of these scenarios seem somewhat unlikely. Alternatively, these errors could be generated by a warm drift in temperature of between 0.1 – 0.01°C, which would not be easily detectable in the data. Appendix D contains a table of examples identified with a slow salty drift error. We believe that these errors are correctable in delayed-mode analysis, as they appear well behaved – that is, constant for each profile and slowly changing in time.

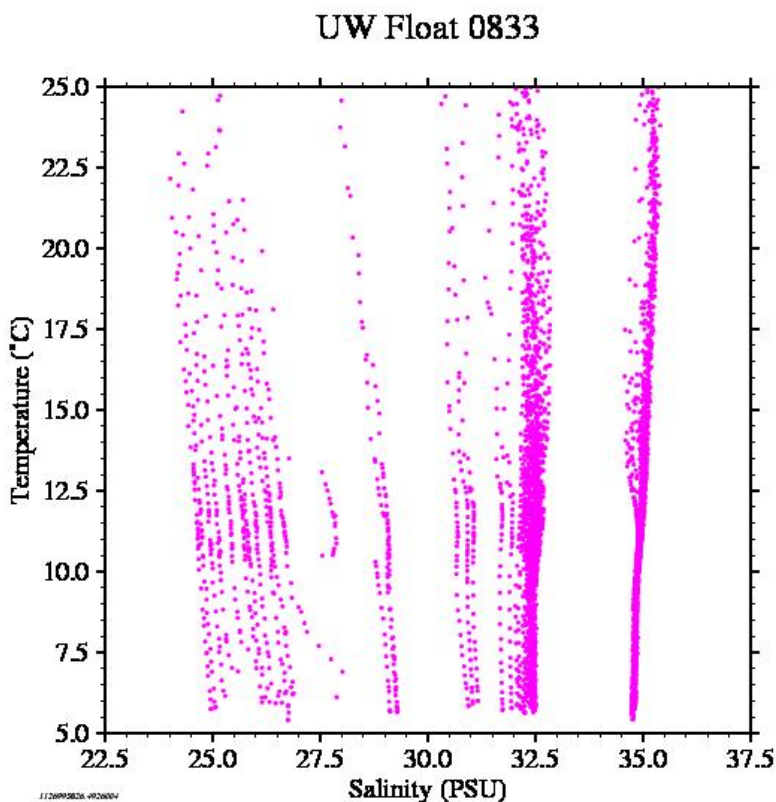
**Jumps in Salinity:** In the UW study ensemble, 26 floats exhibited large (~1 PSU) jumps in salinity during their lifetime, as shown in Figure 6. Presently, we have no understanding of the possible causes of such an error. As the salinity jumps are very large and the shape of the potential temperature/salinity curve changes, these data are currently deemed uncorrectable.

**Figure 6:** Example of large jumps in salinity reported by an SBE 41 over a number of profiles (D. Swift, UW).

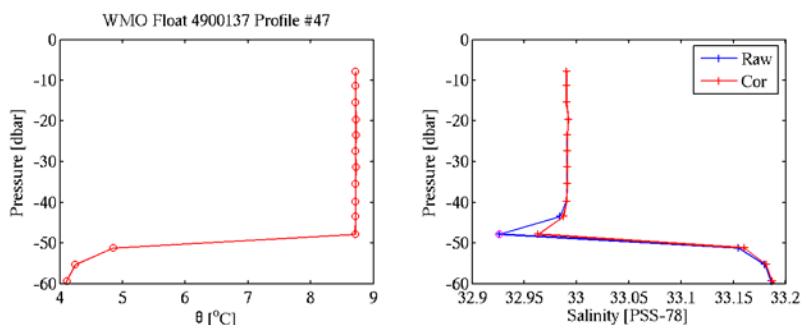
**Figure 7:** Temperature verses pressure (left) and salinity versus pressure (right) for a float exhibiting a thermal lag error. Note the 0.05 PSU fresh spike at the base of the mixed layer.

On APEX floats, we typically only profile when the float is rising, which means that the conductivity cell is usually colder than the water entering it. During its passage through the cell, the water is cooled by thermal diffusion at the cell wall, resulting in lower conductivities (a

difference of 0.001°C leads to a salinity error of 0.001 PSU) and thus lower calculated salinities. The salinity error scales with the rate of change of temperature with time. Thus, errors will be largest when a float is passing through very strong temperature gradients, such as found at the base of the mixed layer (Figure 7) producing spikes in salinity of over 0.05 PSU. Also of concern is that this error is a fresh BIAS error that exists all through the profile. While for most of the water column the error will be very small ( $< 0.001$  PSU), in the tropical thermocline bias errors can be as large as  $-0.005$  to  $-0.01$  PSU. G. Johnson showed that this error is correctable to some extent, and he showed examples of how this might be done. The accuracy of the correction relies on knowledge of temperature change with time. For continuously sampling CTD units (the SBE 41CP) a correction could be made on board in the instrument software, while for the more common burst sampling done by SBE41 units, the correction will have an error due to imperfect knowledge of temperature changes over the seconds before a sample is taken. It is recommended that we routinely do this correction in delayed mode. This problem and its potential future solutions were discussed in more detail with SBE.

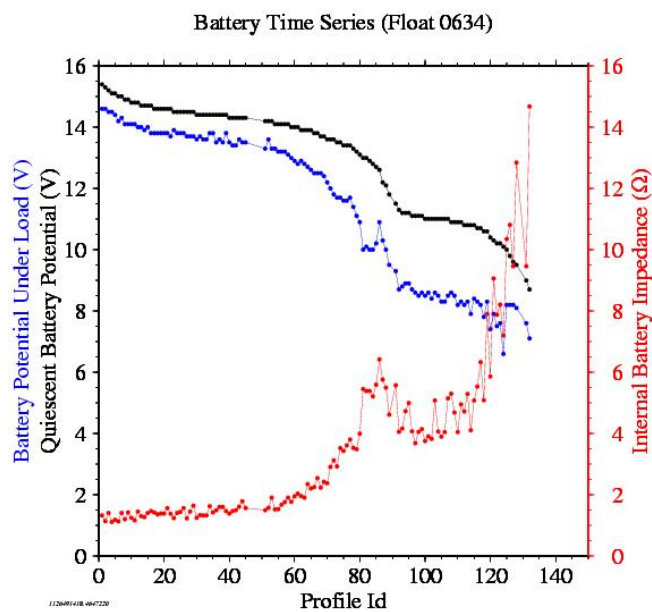
Alkaline energy flu can easily be seen in the voltage data returned by APEX floats. Voltage will drop quickly over 5-6 profiles and then plateau again. The plot below shows a typical example (from D. Swift).

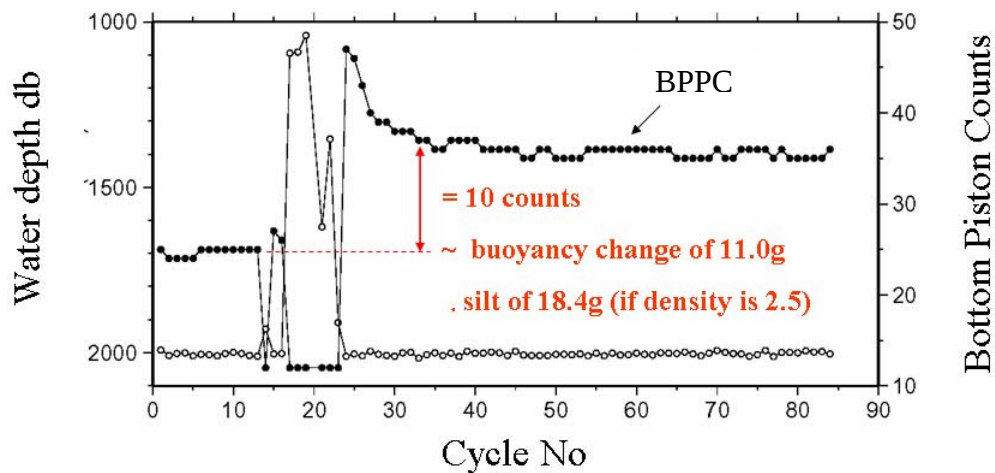
Grounding can be detected both in the pressure data and also in the bottom piston position counts (BPPC). If the float collects sediment during grounding events, this will be detectable in an increase in the BPPC once the float has moved back into deep water. As the float is heavier with its sediment load, the float piston does not have to retract as far to reach the drift depth. Above is an example from N. Shikama of JAMSTEC.

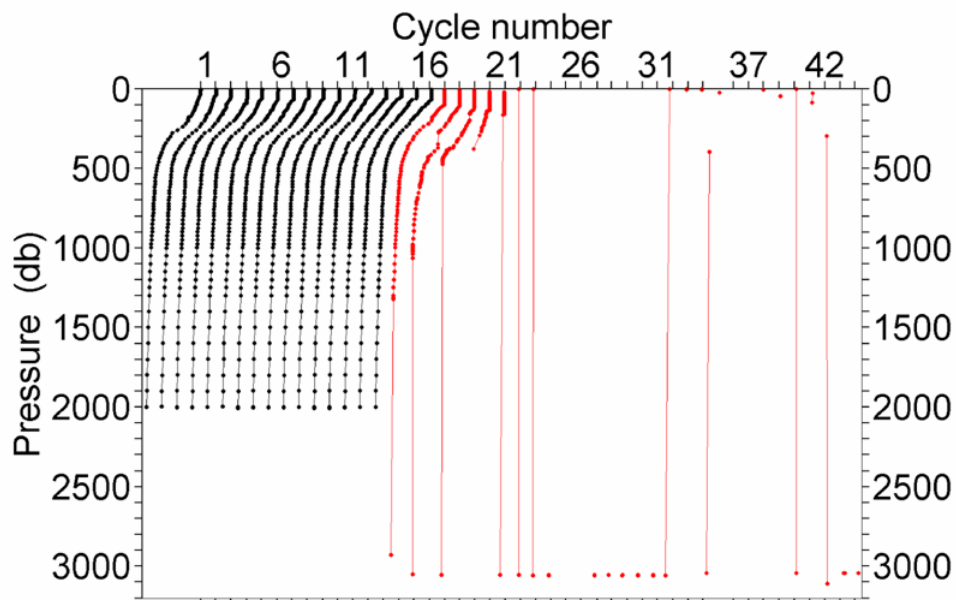
This plot shows the temperature and pressure data returned by a SBE-41 affected by the Druck sensor failure (supplied by N. Shikama, JAMSTEC). The earliest manifestation can be seen in the full-scale pressure readings near 3000 dbar around cycle 16. The float continues to measure pressure correctly sporadically until cycle 21. Eventually the pressure reading remains stuck at

full scale; the float tries to get to its park depth (1000-2000 dbar) by extending the piston until it becomes a surface drifter and ceases to operate.
