# A Modern Coastal Erosion Investigation: Kapa'a Beach, Kaua'i

Hawaiian Islands

Christopher Goody, P.E.  
Ocean Engineer, Sea Engineering, Inc.  
Makai Research Pier  
Waimanalo, Hawaii 96795  
[cgoody@seaengineering.com](mailto:cgoody@seaengineering.com)

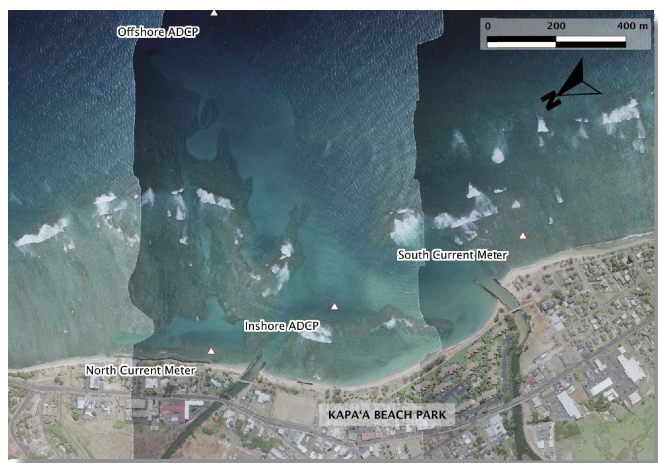
Figure 3. Oceanographic Monitoring Station Locations

The offshore monitoring station was located approximately 1.16 km (0.72 mi) offshore from Kapa'a Beach at a water depth of 12.2 m (40 ft), as shown in Fig. 3. This location allowed measurement of transitional depth waves as they begin to be transformed by shallow water, as well as regional tidal currents, and local wave driven currents. The offshore monitoring station, identified as 'Offshore ADCP', was occupied with a 600 kHz Teledyne RD Instruments acoustic Doppler current profiler (ADCP) with directional wave measurement capability.

The inshore and nearshore station locations were chosen to best characterize nearshore circulation patterns and current response to incident wave conditions recorded at the offshore gage. These instruments were deployed for three month intervals during the winter and summer. Their specific locations are shown in Fig. 3. The instrumentation consisted of a 2000 kHz Nortek Aquadop ADCP with directional wave measurement capabilities, and two single-point 640 kHz Greyline ultrasonic acoustic Doppler current meters. The ADCP was deployed in the channel just offshore of the inner fringing reef at Kapa'a, and identified as 'Inshore ADCP'. The ADCP deployment site was roughly 200 m (660 ft) from the shoreline in approximately 10 m (33 ft) of water. The single-point current meters were deployed at locations roughly 50 m (164 ft) from the shoreline in approximately 1 m (3 ft) of water on the broad reef shelf complexes to the north and south of Kapa'a Beach Park. The gages were rock-bolted into hard substrate for stability. Locations for these gages are shown as 'North Current Meter' and 'South Current Meter' in Fig. 3.

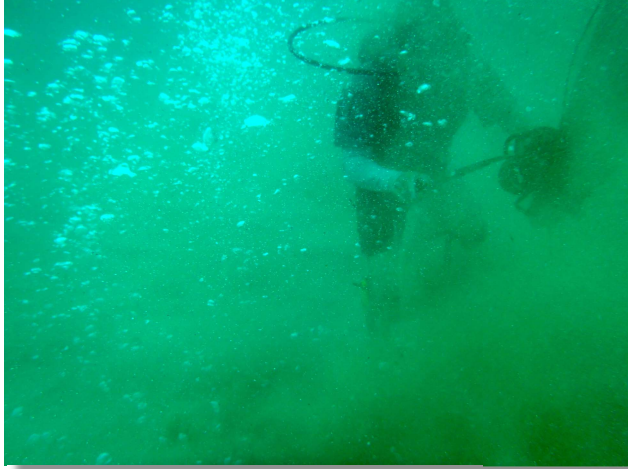
Figure 4. Diver Jet-probing at Kapa'a.

Potential nearshore sand deposits identified during the geophysical surveys were used to target areas for diver investigation by jet probing. Jet probing was conducted along four separate transects at Kapa'a, all within the nearshore basin formed by the confluence of Mo'ikeha and Waika'ea Canals. Probes were conducted at 15 m (50 ft) intervals along the transects, which were located utilizing differential GPS navigation. A 2.4 m (8 ft) stainless steel air-jet probe with portable air supply was used for the investigation. Fig. 4 is a photograph of an SEI diver jet-probing at the inshore basin at Kapa'a.
