# Recovery of an ice buoy at 60°S in the Southern Ocean

**Abstract**— Performing oceanographic measurements from the sea surface to the sea bottom is technically challenging under rough or icy sea conditions. In 2011, we tested measures for protecting a buoy under such severe conditions by incorporating anti-icing and tolerance to high winds and rough seas. Based on those results, we conducted detailed design of a suitable buoy system. In January 2012, we deployed the buoy in the Southern Ocean off the Adelie Coast at 60°S and 140°E. After 11 months on December 2012, we recovered all the mooring gear that we had deployed. This report describes the mooring system recovery operation and the data acquisition rate. Moreover, we provide some highlights of data found in addition to some data deficits. We infer the reasons why we were unable to sample some of the data from analyses of the data we gathered.

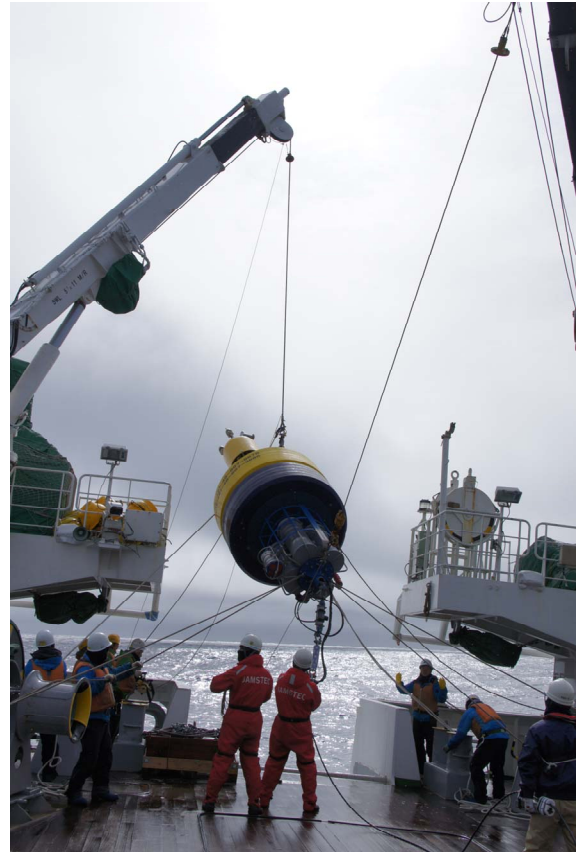
Fig. 2 shows the buoy-hoisting operation. We loaded the Southern Ocean buoy system onto the research training vessel "Umitaka-maru" managed by Tokyo University of Marine Science and Technology in early November 2011 in Tokyo Bay and headed to the Southern Ocean then reached at the deployment position on 17 January 2012. We deployed it at  $59.99^{\circ}\text{S}$   $139.99^{\circ}\text{E}$  in an environment of  $0^{\circ}\text{C}$  air temperature,  $4.4\text{ m/s}$  wind speed, and  $2.3\text{ m}$  wave height. We chose the deployment date for calm sea conditions for the Southern Ocean because we had to handle some heavy materials such as the float ( $0.85\text{ ton}$ ) and the anchor ( $3.3\text{ ton}$ ).

We deployed the buoy system smoothly. However, after we let all the steady brace ropes go, the buoy drifted toward the vessel and overtook it because the slowly moving vessel. One wind speed sensor that was not equipped with a heater was hit by the vessel and was broken.

Fig.2 Picking up the float on UMITAKA.

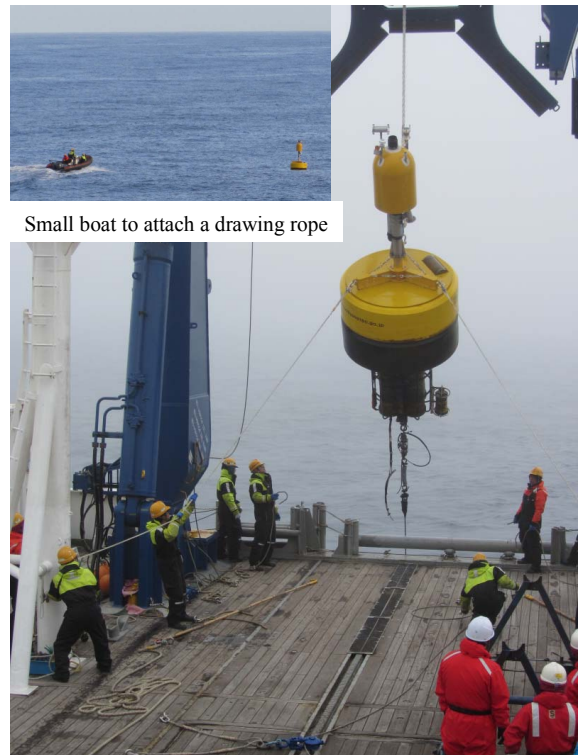
Fig.3 Winching up the float for recovery by "Mirai".

Fig. 3 shows winching up of the float during recovery and a small working boat heading to the float. We first launched a small working boat to the float from "Mirai" and attached the drawing rope to the float. It was the most important and dangerous operation during recovery. The sea conditions in the Southern Ocean are usually rough seas. For that reason, we chose clam sea conditions to launch our small working boat. We picked up the drawing rope knotted on the float and winched up the float. We recovered all mooring gear safely.

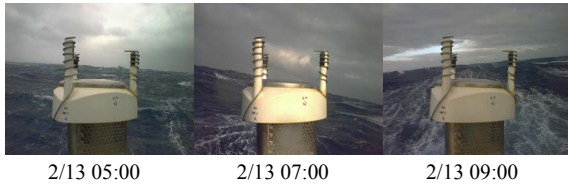
Fig. 5 shows wind speed and temperature / humidity value variations that occurred when they measured correct data. The sensors, including the tension sensor, were able to take measurements until February 13. In particular, the temperature / humidity sensor broke, although it had been set in the housing to protect it from ice spray and icing. The measuring stop date was subjected to maximum wind speed throughout the monitoring period. The temperature fell rapidly to 1 °C. Apparently, the sea conditions on that date were extremely rough. Fig. 6 presents photographs of the monitoring camera, which took photographs every 1 hr, for

the wind speed sensor on February 13. We attached two monitoring cameras taking photographs every 1 hr on the float (Fig.1). One of the two was set outside the housing on the top of the sensor pole, which stood on the center of the float, to monitor the icing circumstances of the wind speed sensor. The other was set in the middle of the sensor pole to monitor the icing situation on the float deck. From the background of the photographs, sea levels were leaning over: sea conditions were extremely rough.

Fig.6 Wind speed sensor and sea conditions on 2/13.
