# NOAA's Recent Field Testing of Coastal Water Quality Monitoring Systems – Quantifying Impacts of Biofouling and Investigating Chloride Measurement Techniques

Grace Browder Gray  
Robert Heitsenrether

National Oceanic and Atmospheric Administration  
Center for Operational Oceanographic Products and Services  
Chesapeake, VA

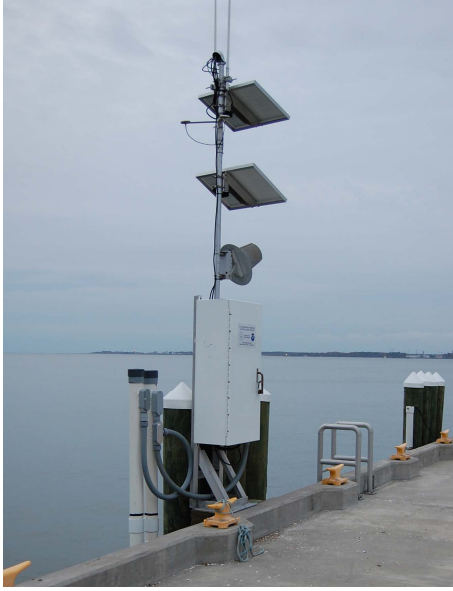
Fig. 1. Test water quality system on the VIMS Pier at Gloucester Point, Va., consisting of an electronics enclosure and mast with antennas and solar panels. The two PVC wells house the test instruments. The CBNERR reference sensor is deployed in the PVC well on the piling to the right of the test system.

Both test sondes were incorporated into a typical CO-OPS real-time measurement system (Fig. 1). Such a system is standalone and powered by solar panels and rechargeable batteries. The infrastructure consists of an electronics enclosure housing batteries, a Sutron data collection platform (DCP), a Sutron Satlink Geostationary Operational Environmental Satellite (GOES) transmitter, and an IP modem. Masts containing solar panels and antennas for GOES and GPS are mounted to the enclosure. Each test sensor was polled by its own DCP every six minutes and the data were transmitted via GOES. Both systems were also equipped with IP modems to enable two-way communication and back-up data download capability.

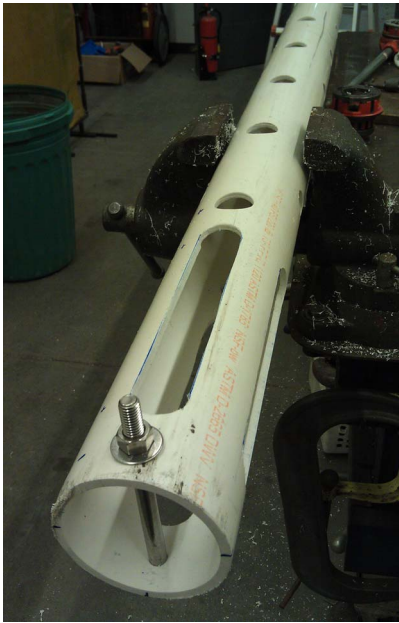
Fig. 2. One of the PVC wells that house the test sensors shown here during fabrication. The base of the water quality sonde rests against the bolt and the large holes allow sufficient water to flow past the probes.

Each test sensor was housed in a 4-inch PVC well based on the CBNERR design, with holes drilled to allow sufficient water flow while still affording protection from debris in the water column (Fig. 2). The wells were painted with antifouling paint. Other antifouling measures included copper tape on the water quality sonde probes and a brass probe guard on each sonde (Fig. 3).

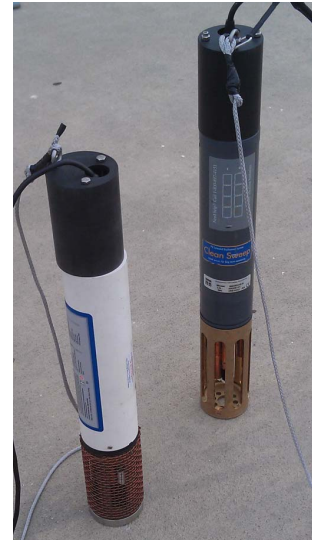
Fig. 3. The test Hydrolab (left) and test YSI (right) before deployment at Gloucester Point, Va. for the first phase of field testing.
