## Workhorse Sentinel Battery Pack Wing Nuts

Date: May 17, 2000

Workhorse Sentinel ADCPs

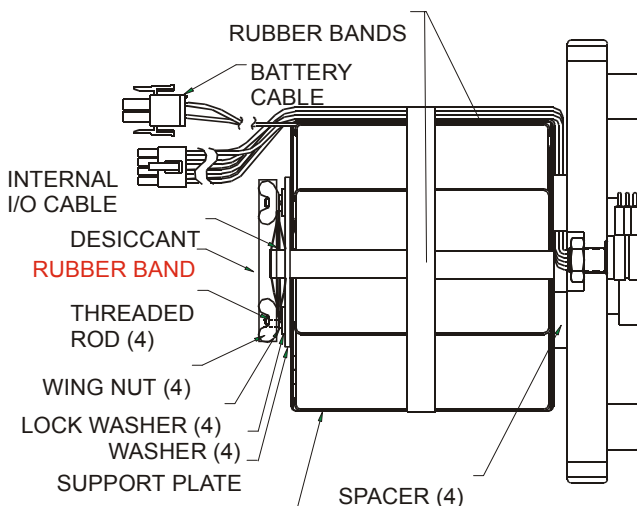
The Workhorse Sentinel battery packs are held in place by four sets of washers, lock washers, and wing nuts. If the wing nuts are not tight, the assembly of washers and wing nut can become loose and eventually fall onto the PIO board. This has caused the PIO board to short out.

Tighten the wing nuts firmly against the battery pack support plate. Place a battery pack rubber band (two spare rubber bands are provided with each new battery) around all four wing nuts. This will prevent the wing nuts from backing off the post.
