RE: Monterey Bay Aquarium Research Institute (MBARI) MARS Cable Monitoring

MBARI MARS Cable Impact Survey

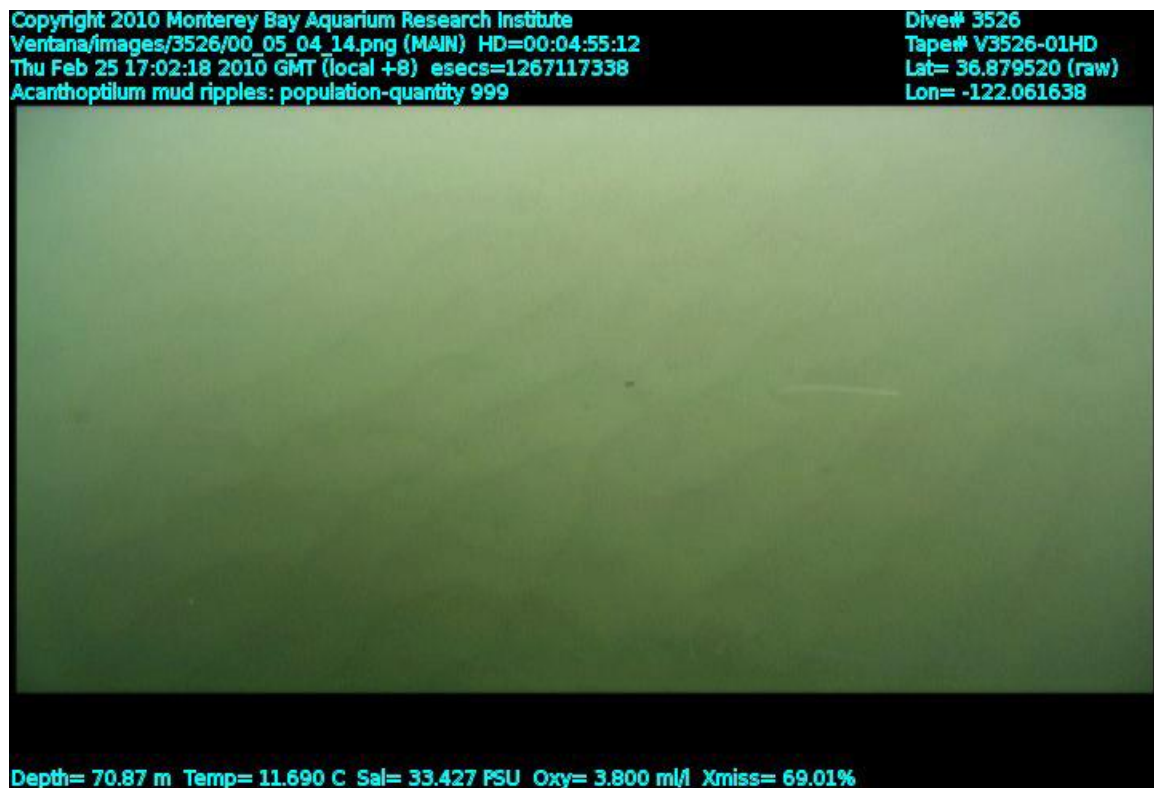
Figure 2. The majority of the MARS cable (over 50%) is buried in sandy mud. No sediment disturbance is evident.

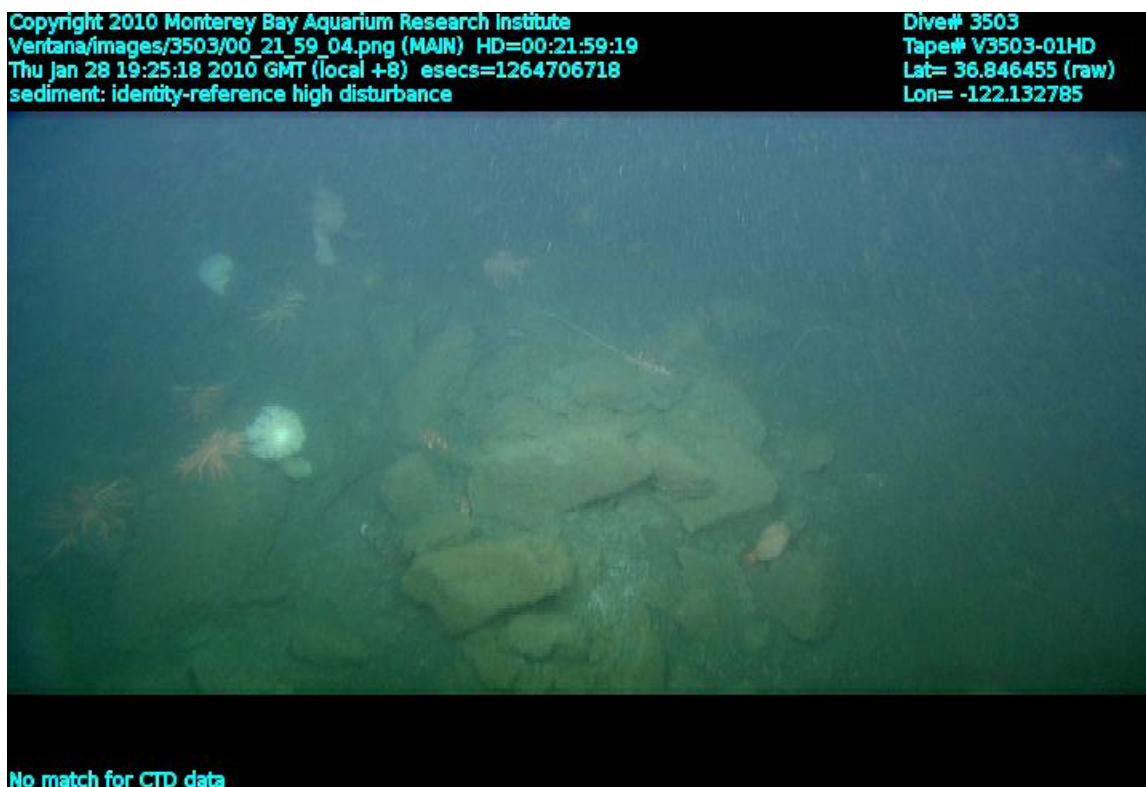
Figure 4. Along a short section of the route at around 106 m depth, clay blocks displaced during cable installation are still evident on either side of the cable trench.

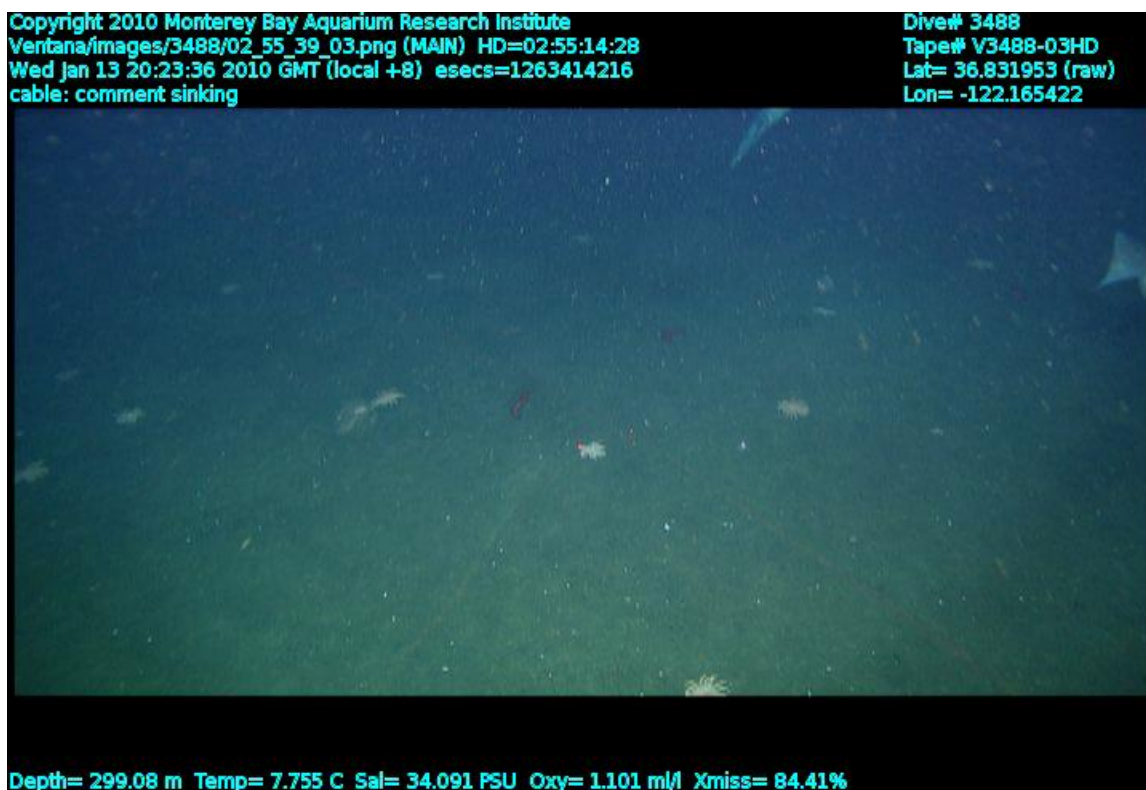
Figure 5. The cable is not buried along the neck of Smooth Ridge. In many sections, the cable is on the seafloor and sinking into the mud.

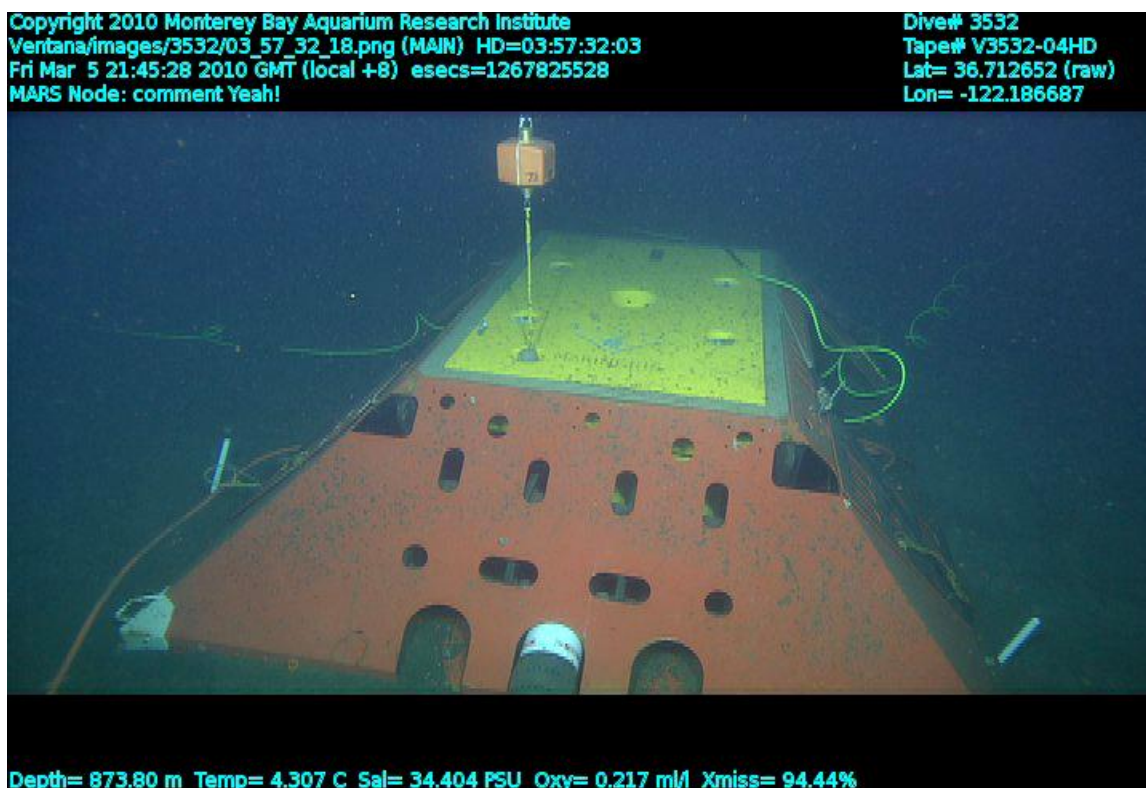
Figure 7. The MARS node with cables attached to four working science instruments.
