| CIMT ISUS Puck Wiring | | |

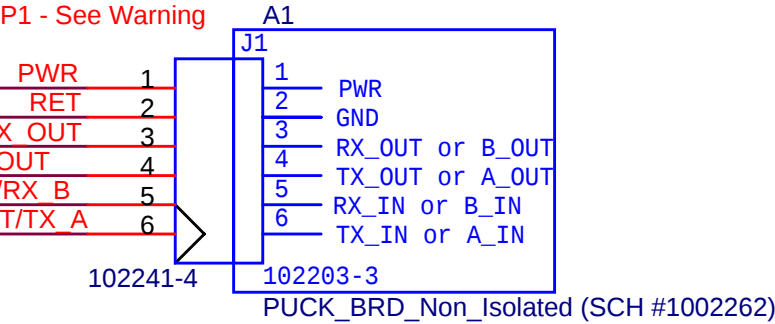
WARNING  
P1 Needs to be wired OPPOSITE of  
its physical markings. Use the triangle  
marking as an indicator for pin 6

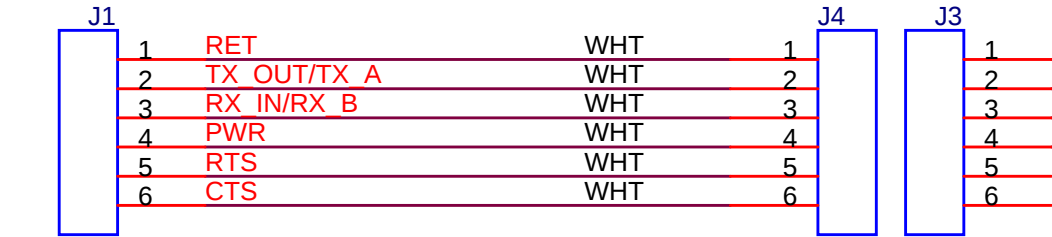
From MMC

To ISUS
