# CLIFF EROSION AND BLUFF RETREAT ALONG THE CALIFORNIA COAST

Gary B. Griggs

Institute of Marine Sciences

University of California, Santa Cruz, California

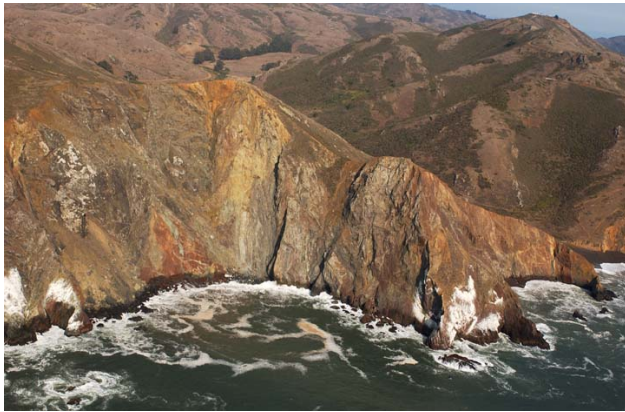
Fig. 1 Steep coastal cliffs in Marin County.  
Copyright © 2002 Kenneth Adelman. All rights reserved.

On a statewide scale, the coastline of California is extremely diverse, from the steep coastal mountains along the Big Sur and Mendocino coasts to the broad coastal plains and wide beaches of Los Angeles County. California's coast can be divided into: 1] steep coastal mountains and sea cliffs with hundreds of meters of relief (Figure 1), 2] uplifted marine terraces and sea cliffs a few meters to

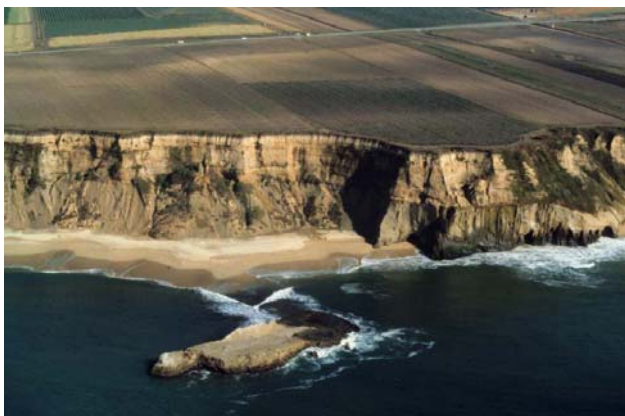
Fig. 2 Marine terrace and eroding cliffs in San Mateo County.

perhaps 100 meters in height (Figure 2), and 3] coastal lowlands with beaches, and often sand dunes and wetlands (Figure 3). The great majority (1267 km or 72%) of the California coast consists of actively

Low bluffs characterize much of the coastline of San Diego, Orange, Santa Barbara, San Luis Obispo, Santa Cruz, and San Mateo counties or cliffs cut into uplifted marine terraces, typically consisting of Tertiary sedimentary rocks (Figure 2). Along the northern California coast, portions of the Sonoma, Mendocino, Humboldt and Del Norte county coasts are also eroded into marine terraces. The number of terraces exposed along the coast of California ranges from one in Santa Barbara to as many as thirteen on the Palos Verdes peninsula of Los Angeles County. The existence and distribution of these flat, nearly horizontal marine terraces, adjacent to the shoreline, have allowed California's extensive and intensive coastal development to take place (Figure 5).

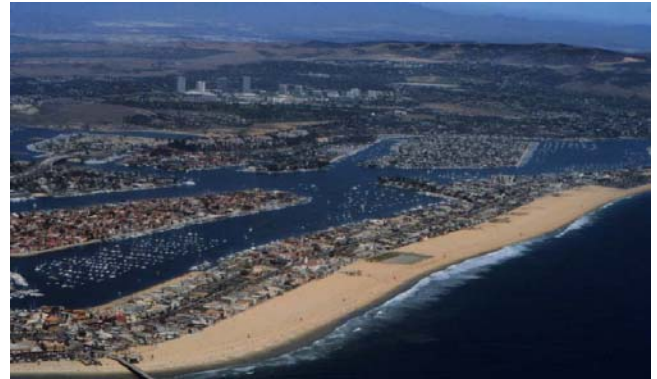
Fig. 3 Coastal lowlands (Newport Bay). Orange County

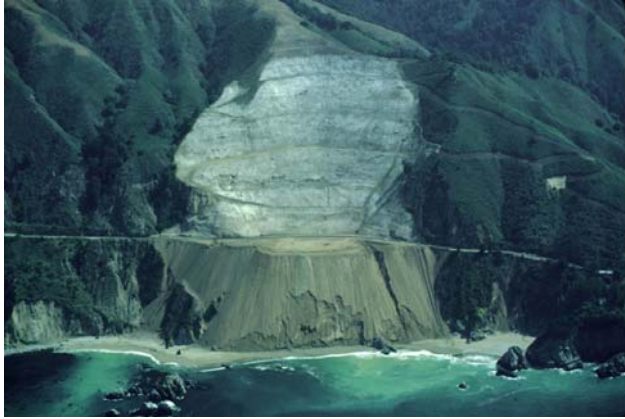
Fig. 4 Large landslide repair along Big Sur coast.

The high relief, steep cliffs or coastal mountains are located predominantly in northern California from Del Norte County to Mendocino county, at the Marin Headlands just north of the Golden Gate, in the Pacifica to Montara area of San Mateo County, and along the Big Sur coast of Monterey and San Luis Obispo counties. Steep cliffs and headlands also occur in the Santa Monica Mountains and at Pt. Loma in San Diego County. These cliffed areas of coast typically consist of older and more resistant rock types such as the Franciscan Formation, as well as granitic and volcanic rocks. Along the northern California coast, Pt. St. George, Trinidad Head, and Pt. Delgada are all Franciscan Formation outcrops. Bodega Head, Pt. Reyes, Montara Point, Pt. Pinos and Pt. Cypress are all granite. Proceeding southward, Pt. Sur, Pt. San Martin, Piedras Blancas and Pt. San Luis are all Franciscan Formation. These are resistant rock types that erode very slowly, but in the case of some units of the Franciscan, may also be subject to large-scale landsliding or slumping as along the Big Sur coast (Figure 4).

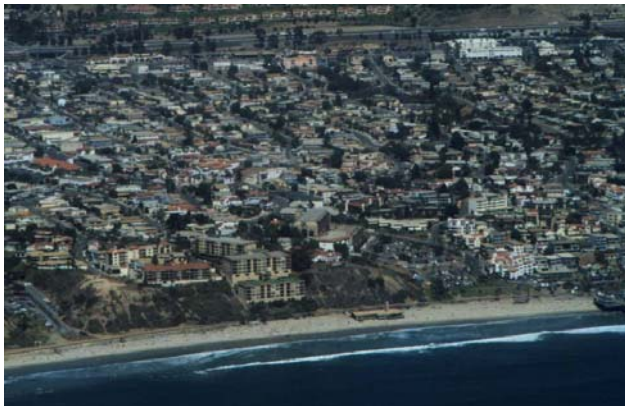
Fig. 5 Intensively developed coastal terrace in San Diego County.

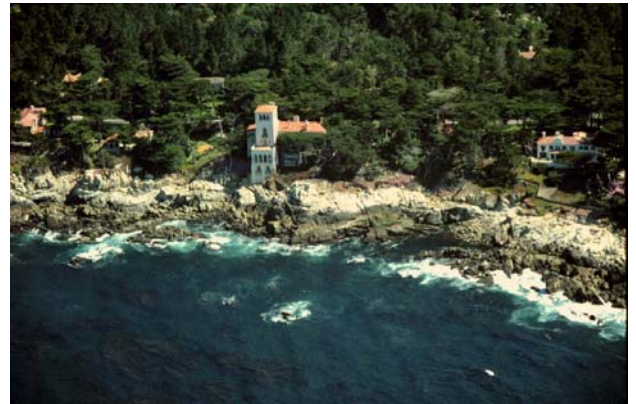
Fig. 6 Granitic coastline of the Monterey Peninsula.

While the overall long-term, statewide rates of cliff erosion or retreat are primarily a function of the rate of sea level rise and the coastal topography, there are significant local or regional differences in the rates of sea cliff erosion. Sections of coast consisting of unweathered crystalline rock usually erode at very slow rates. At some locations on the Monterey Peninsula, for example, which consist of granite, virtually no change has been detected between photos taken over a 50-year time span (Griggs and Savoy, 1985). Within these generally resistant areas, however, erosion rates can vary considerably. Waves attack the weaker zones over time, the fractures and joints for example, to form inlets and coves (Figure 6). The more resistant rock is left behind as points, headlands and sea stacks.

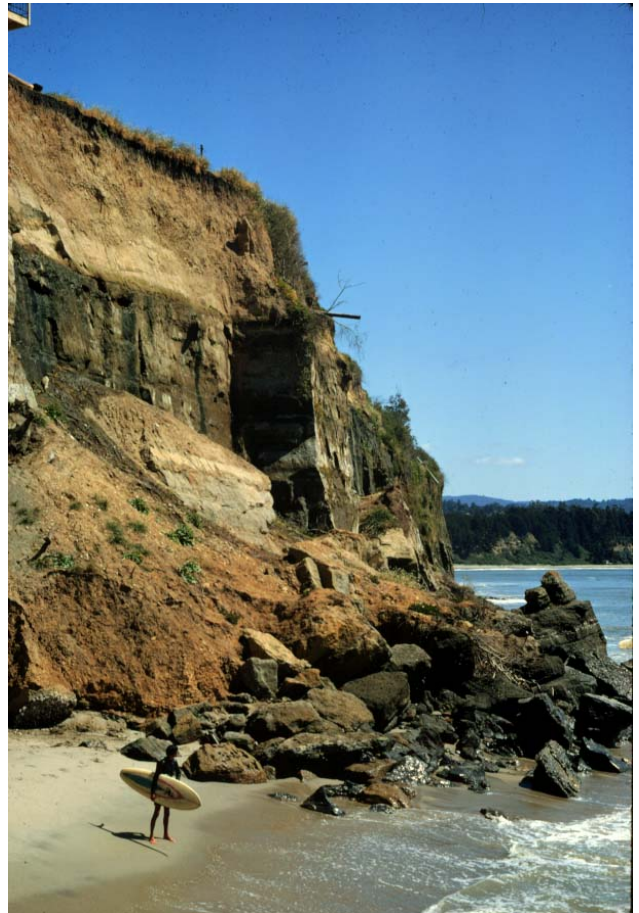
Fig 9. Large-scale cliff failure along joint sets in Northern Monterey Bay.

It has been long recognized by coastal researchers working with sea cliff evolution and erosion that cliff or bluff retreat is usually an episodic process (Figure 9). Most of the major episodes of cliff erosion occur during the simultaneous occurrence of high tides and large storm waves, typically combined with heavy rainfall. At these times, waves can reach high enough up on the shoreline to attack those areas that are less frequently inundated and the material that has been

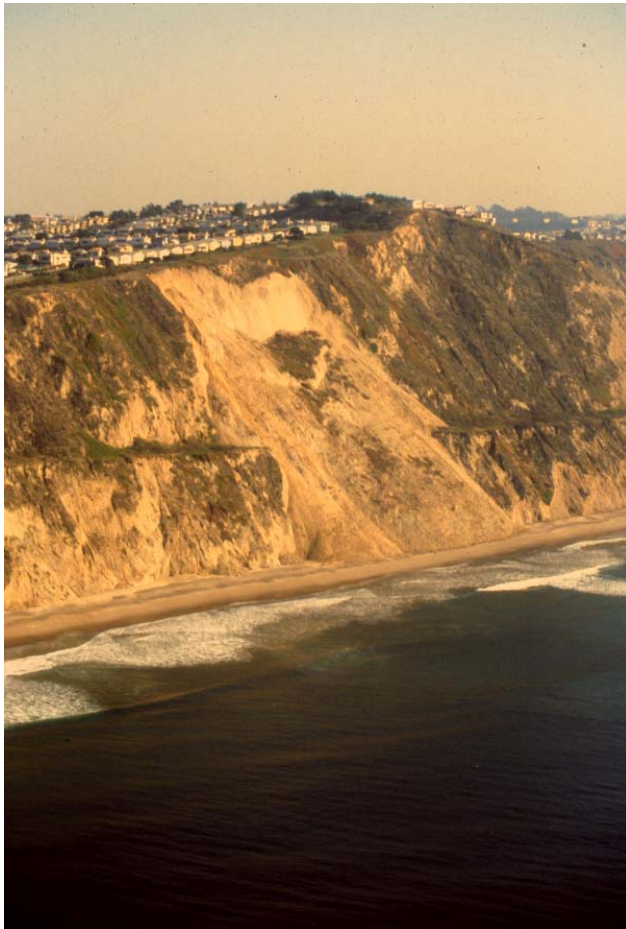
Fig. 10 Seismically induced bluff failure at Daly City, 1989 Loma Prieta Earthquake.

coastal hazard, primarily due to the infrequent nature of large earthquakes (Figure 10). The potential for earthquakes that can affect coastal cliffs is high along the entire length of the state's coastline (Griggs and Scholar, 1997; Plant and Griggs, 1990 a,b). No part of the coastline of California is more than 25 km from an active fault (Jennings, 1975), and many areas are considerably closer. Future earthquakes, particularly in southern California, can be expected to produce widespread failure of the heavily populated cliffs and bluffs of areas like San Diego County where removal or demolition of at least one large building is now being contemplated (Figure 11).

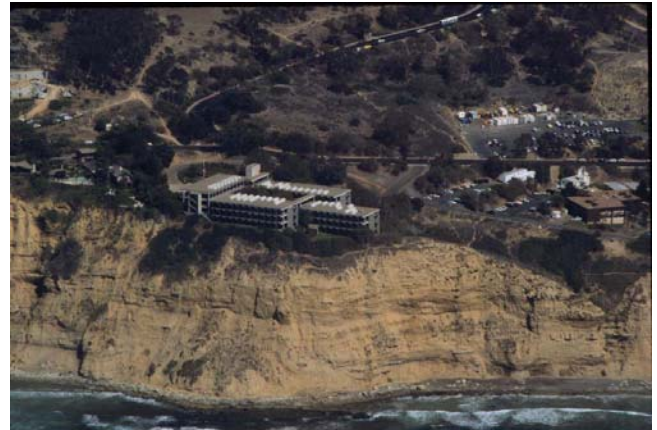
Fig. 11 National Marine Fisheries Service Building perched precariously on steep cliff in La Jolla.

In the Torrey Pines area of San Diego County, cliffs exceeding 90 meters in height have been eroded into Eocene sandstone and shale. Subaerial mass wasting is the dominant failure mechanism in this area and many landslides have occurred (Figure 11). In 1982, a 175 m long section

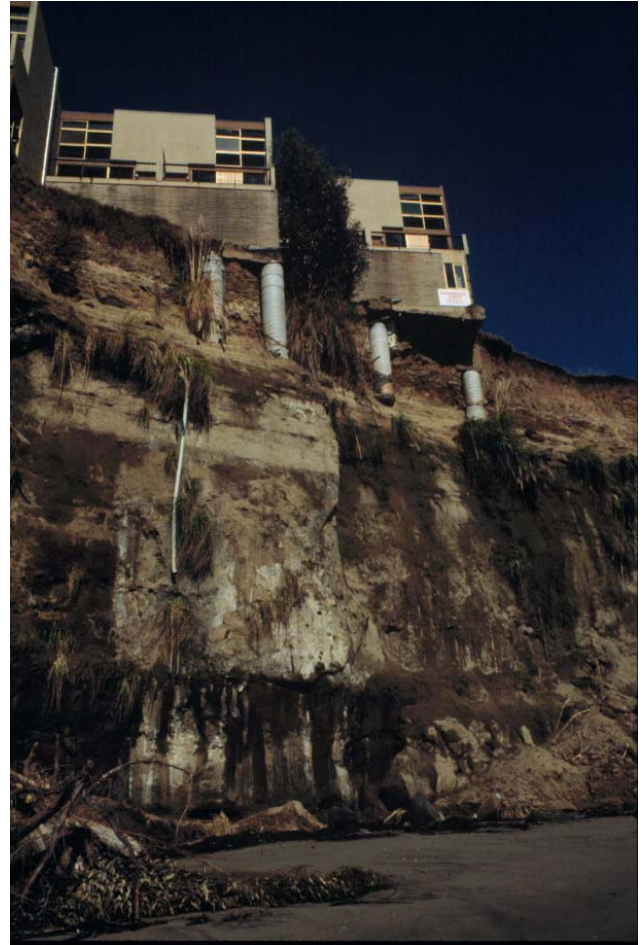
Fig. 12 Coastal cliff failure at Capitola during the Loma Prieta earthquake led to demolition of these apartments.

Coastal communities from one end of the state to the other have lost entire oceanfront streets, utility lines, lots of record and homes through the

ongoing process of cliff erosion over the last century (Figure 12).

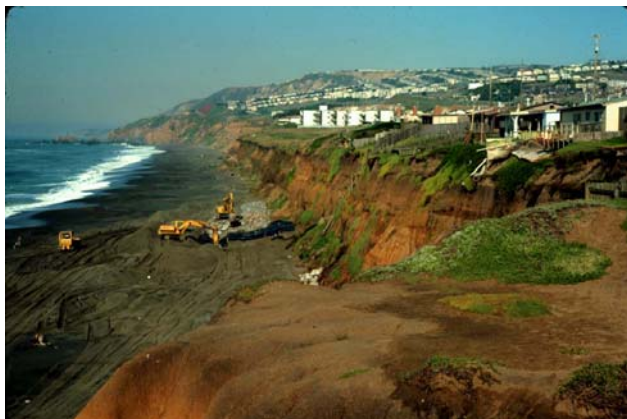
Fig. 13 Bluff failure in Pacifica during the 1982-83 El Niño winter.

In Pacifica, a row of oceanfront homes was built on an uplifted marine terrace consisting of poorly consolidated Tertiary marine sediments, terrace and eolian deposits. During the 1982-83 El Niño, these homes were threatened but undamaged (Figure 13).

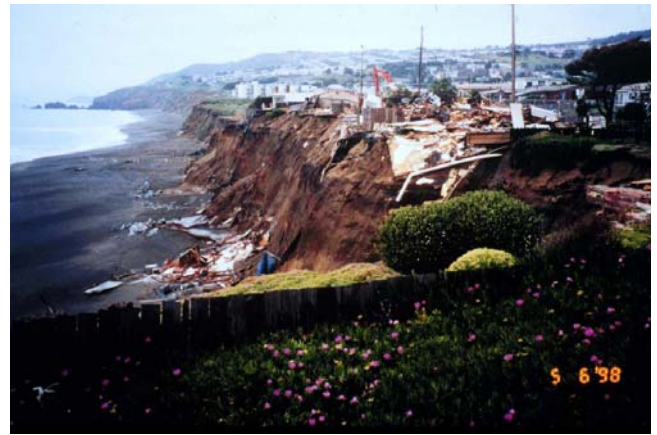
Fig. 14 1997-98 El Niño failure at Pacifica that led to loss of homes.

A protective rock revetment was subsequently built at the base of the bluff. When the 1997-98 El Niño high tides and storm waves struck,

the revetment was undermined and collapsed. The waves attacked the unprotected bluff and groundwater weakened the cliff sediments—erosion proceeded until most of the oceanfront houses were undercut or collapsed to the point where they had to be destroyed (Figure 14).

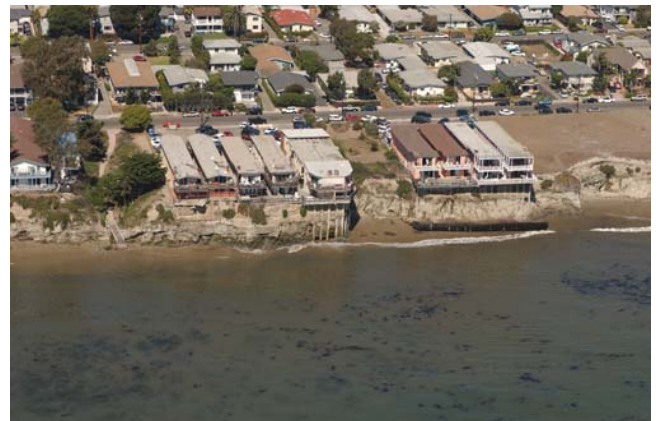
Fig. 15 Eroding cliffs in Isla Vista area of Santa Barbara County.

In the Isla Vista area of Santa Barbara County, a number of apartment buildings were built on a coastal bluff cut into weak sedimentary rocks in the 1960's and 1970's to accommodate the rapidly growing student population of a University campus. The beaches appear to have narrowed in recent years from sand supply reduction, and a number of dwellings are now being undermined with structural collapse a very real threat to their survival (Figure 15).

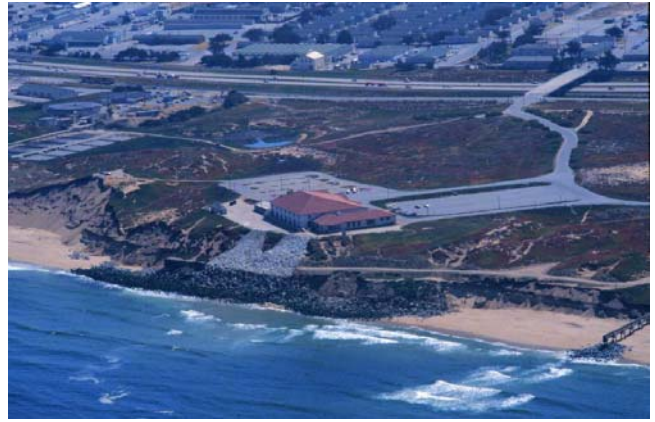
Fig. 16 Passive erosion in Central Monterey Bay due to placement of riprap.

A concern has arisen in recent years in California with the impacts of seawalls and revetments (Griggs, 1999). These include visual or aesthetic impacts, potential loss of beach access, loss of beach through placement of revetments, the loss of beach sand that would have been provided by the continued erosion of the bluffs, as well as passive erosion, or the ultimate loss of beach as sea level rise and coastal retreat impacts a hard or armored shoreline (Figure 16).
