# NAVAL SHIP RESEARCH AND DEVELOPMENT CENTER

## THE STRUCTURAL BEHAVIOR OF GLASS PRESSURE HULLS

June 1972

Report 3863

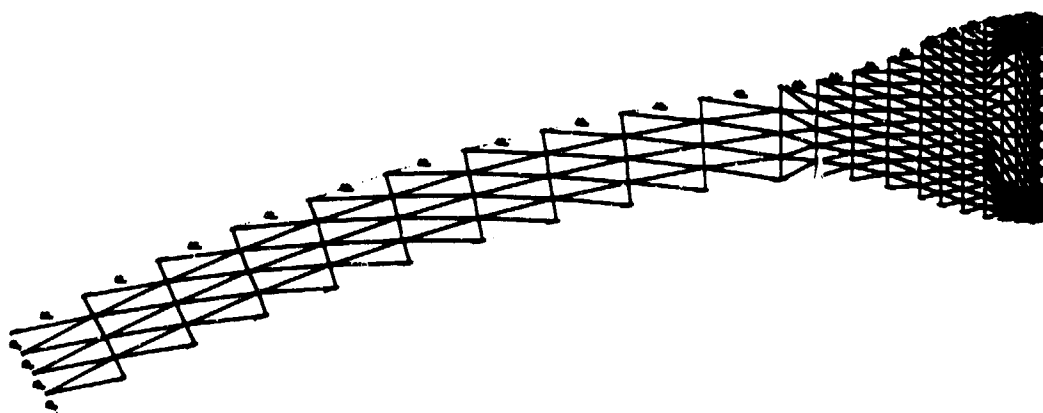
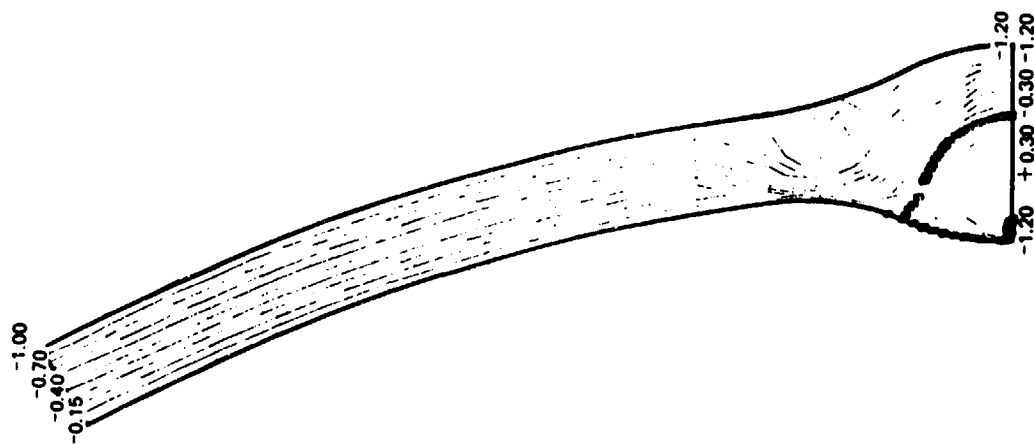
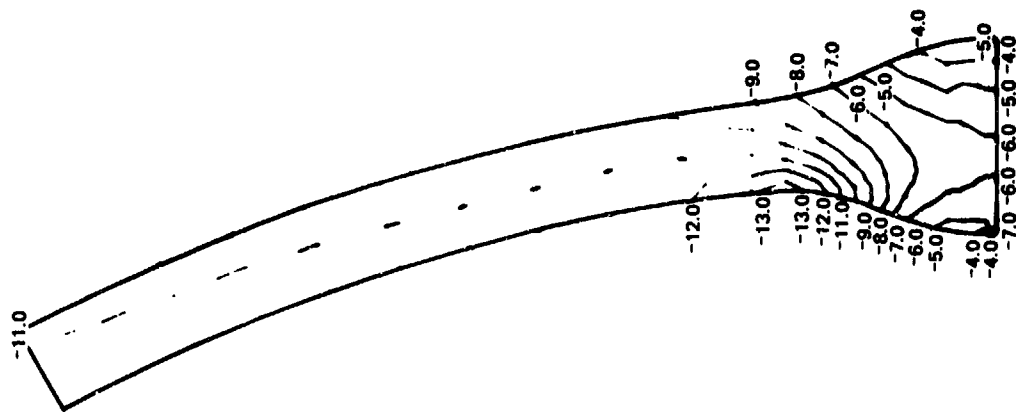
Figure 4 - Analysis of Reinforced Joint Design

Figure 4a - Structure Idealization

Figure 4b - Radial Stress

Figure 4c - Meridional Stress

structure used in the analysis is shown in Figure 4a and the results of the analysis are shown in Figures 4b and 4c. Note the tensile stress in the radial direction. This stress is relatively low and would not be expected to cause fracture in Chemcor 0312 glass for the tensile stress (3,000 psi) that was applied during most of the tests. Fractures nevertheless did occur and an example is shown in Figure 5. It is suspected that flaws also played a significant role in these tests.

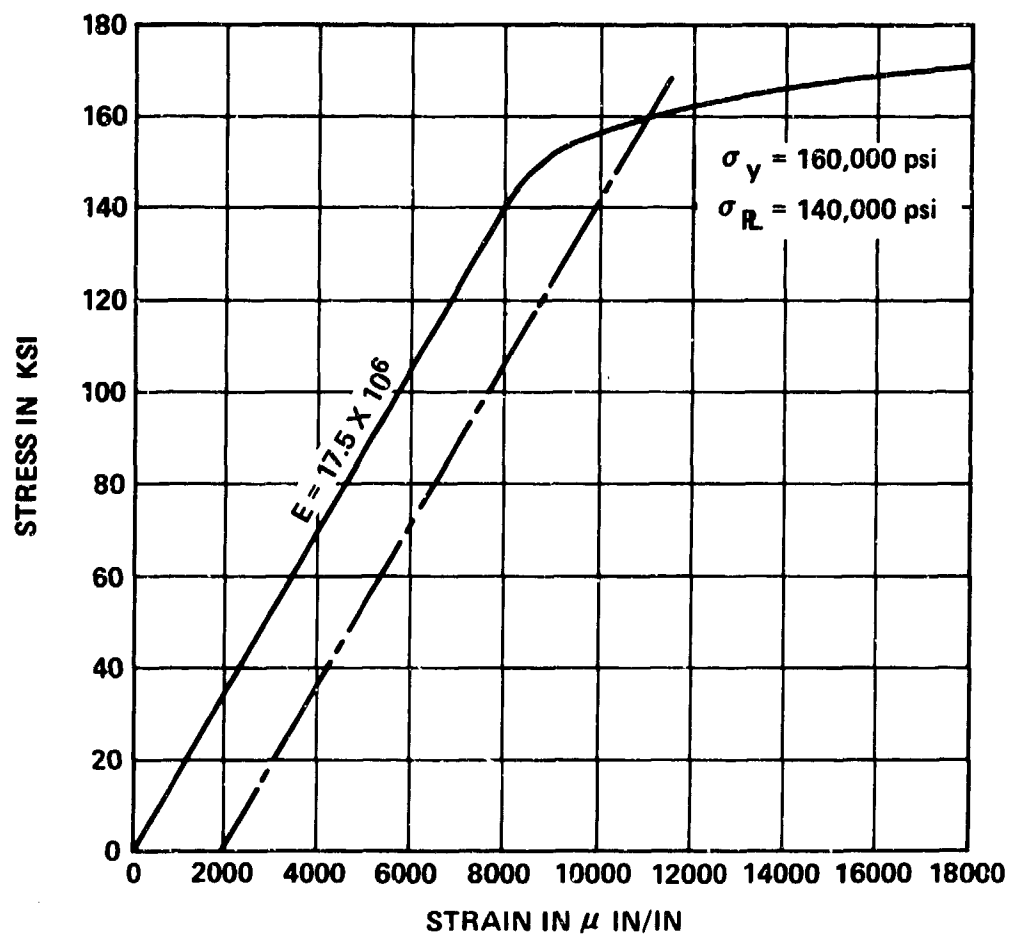
Figure 9 - Compressive Stress-Strain Curve for 662 Titanium

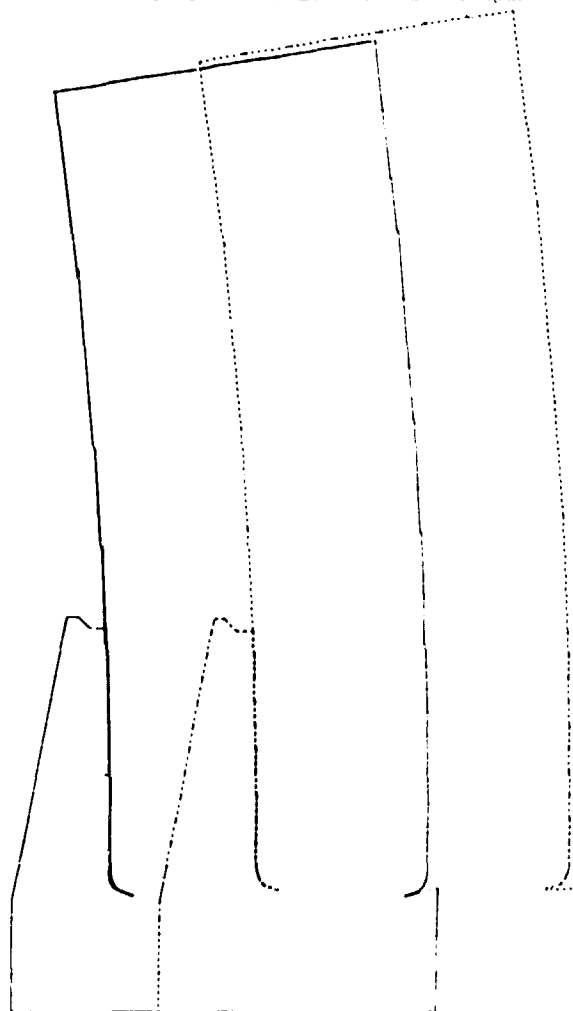
**Figure 10b - Mod 1 Displaced Structure**

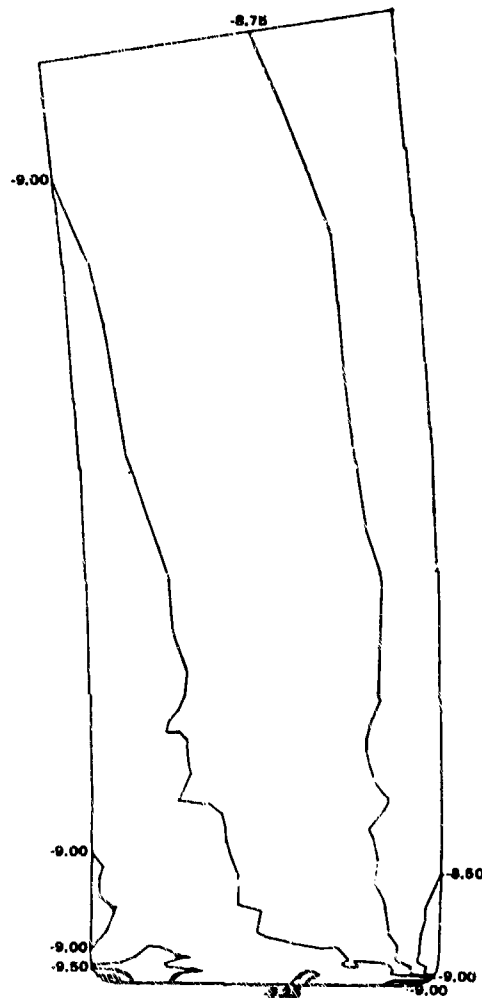
Figure 10d - Mod 1 Circumferential Stress

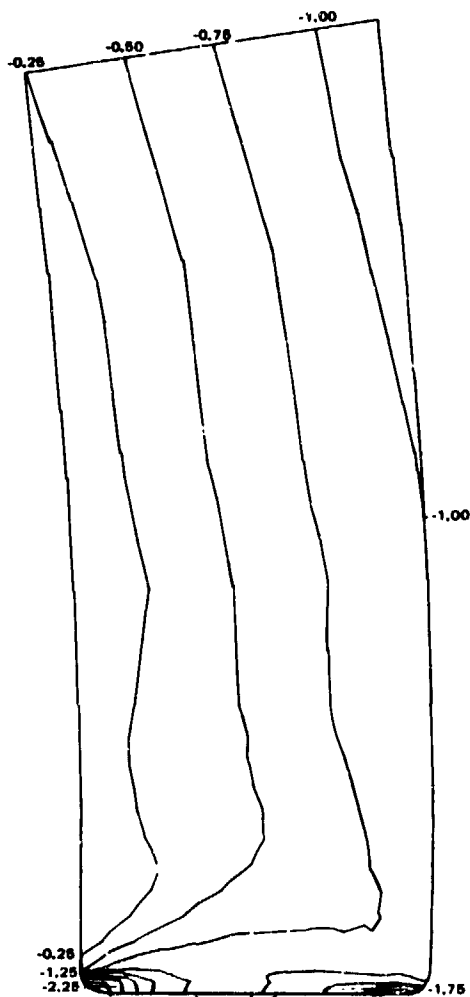
Figure 10e - Mod 1 Radial Stress

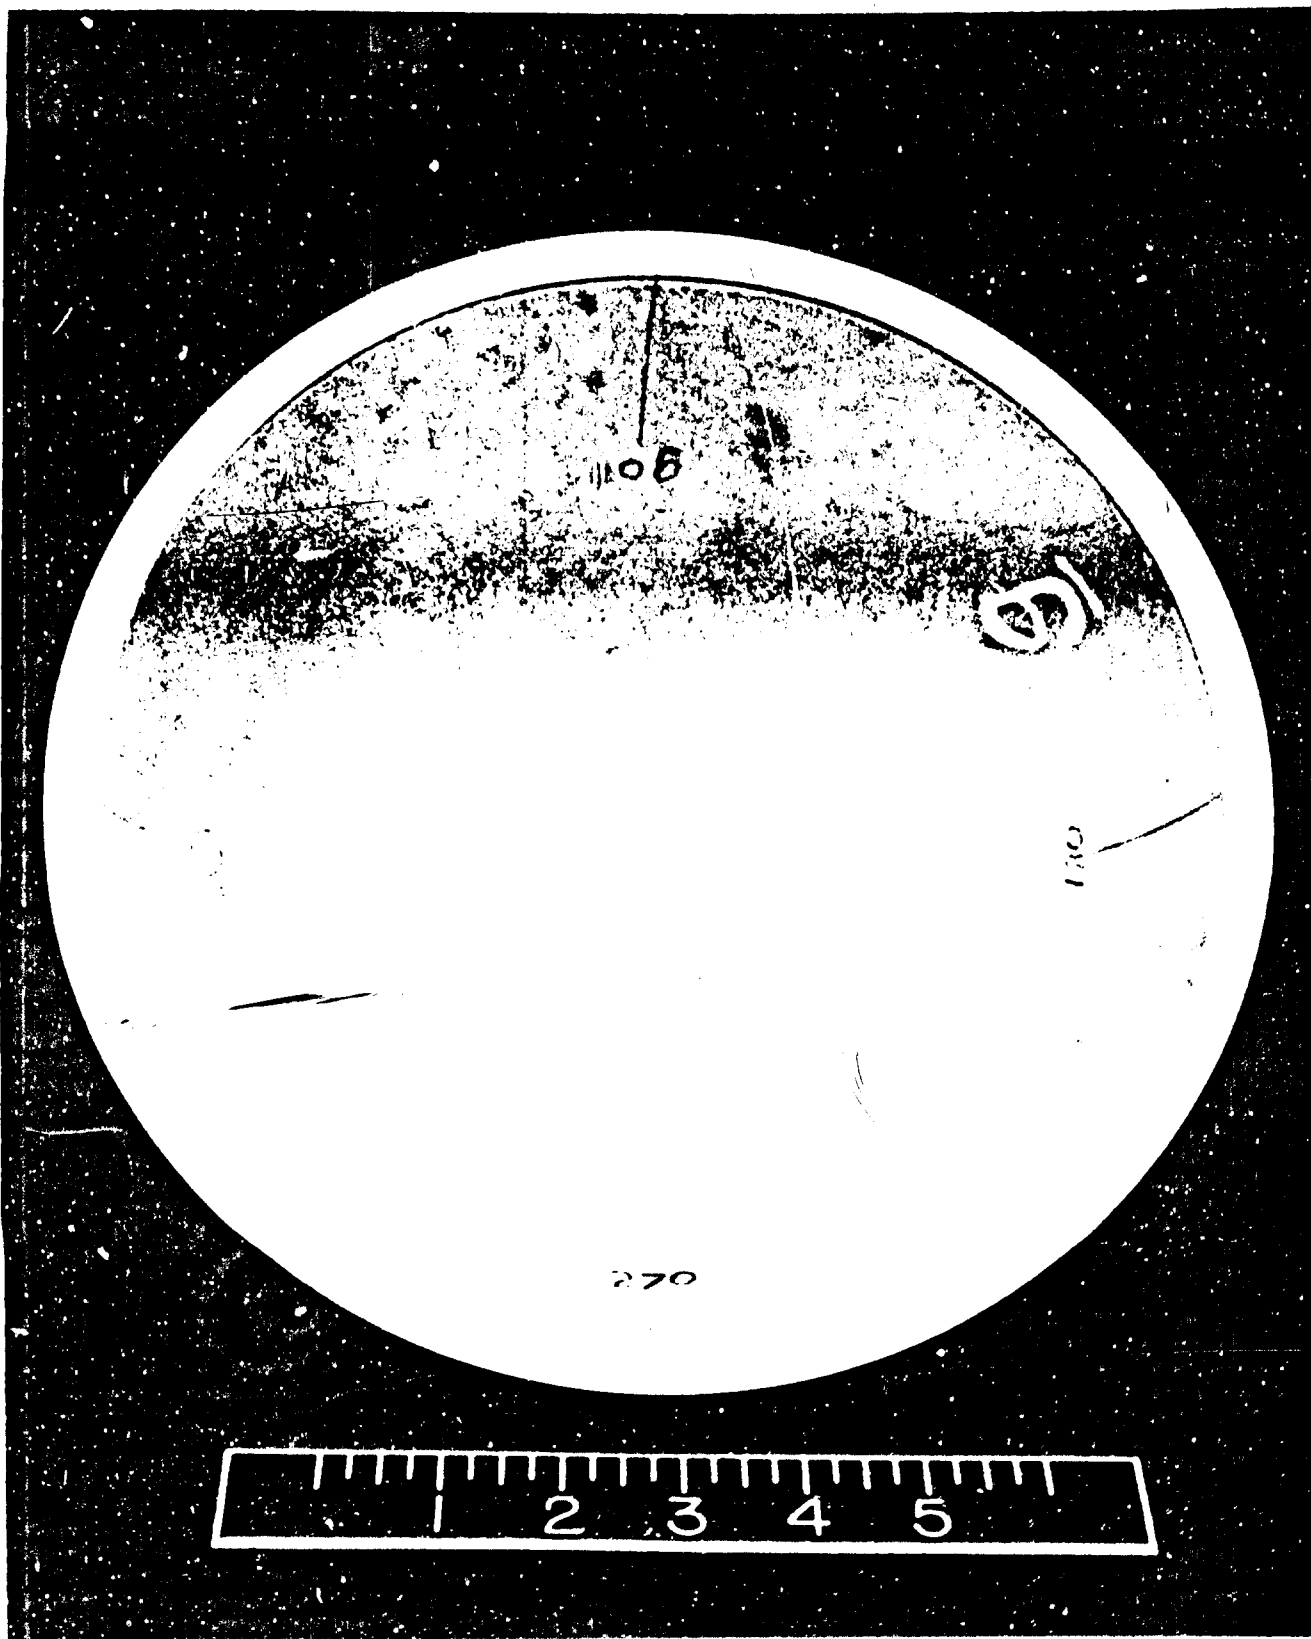
Figure 11 - Glass Hemispherical Shell

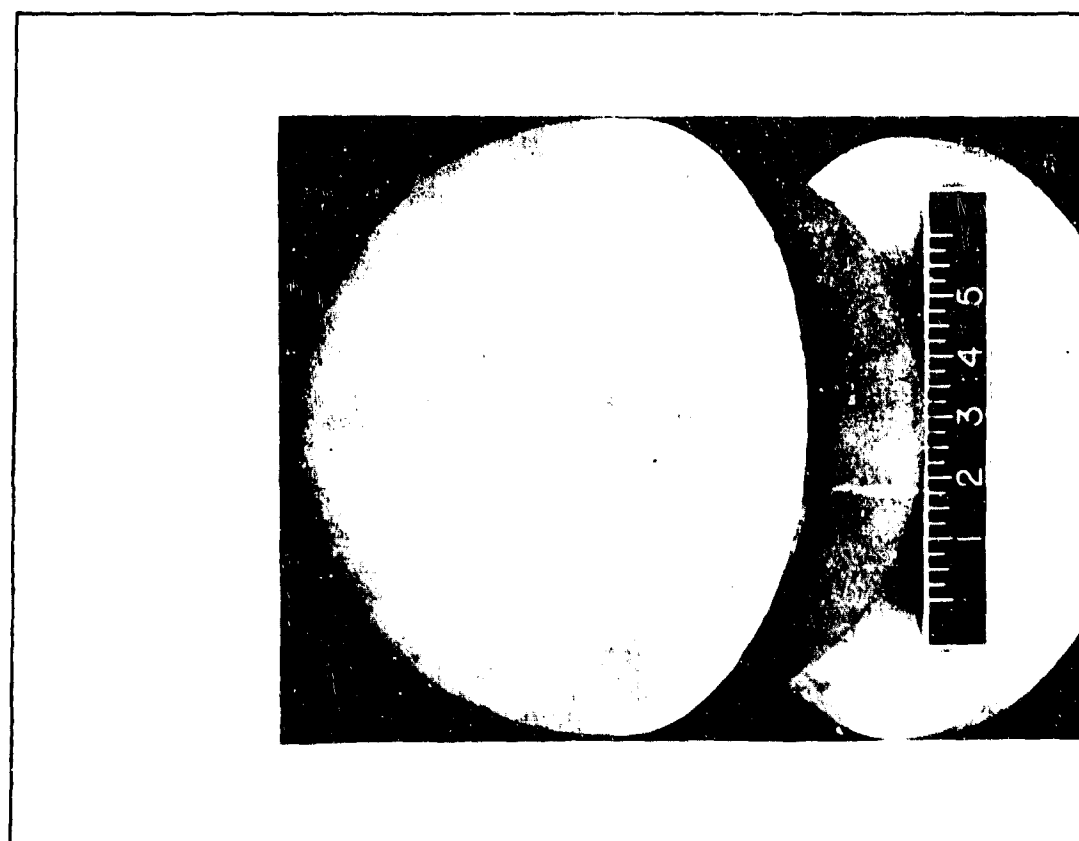
Figure 12 - Assembled Spheres

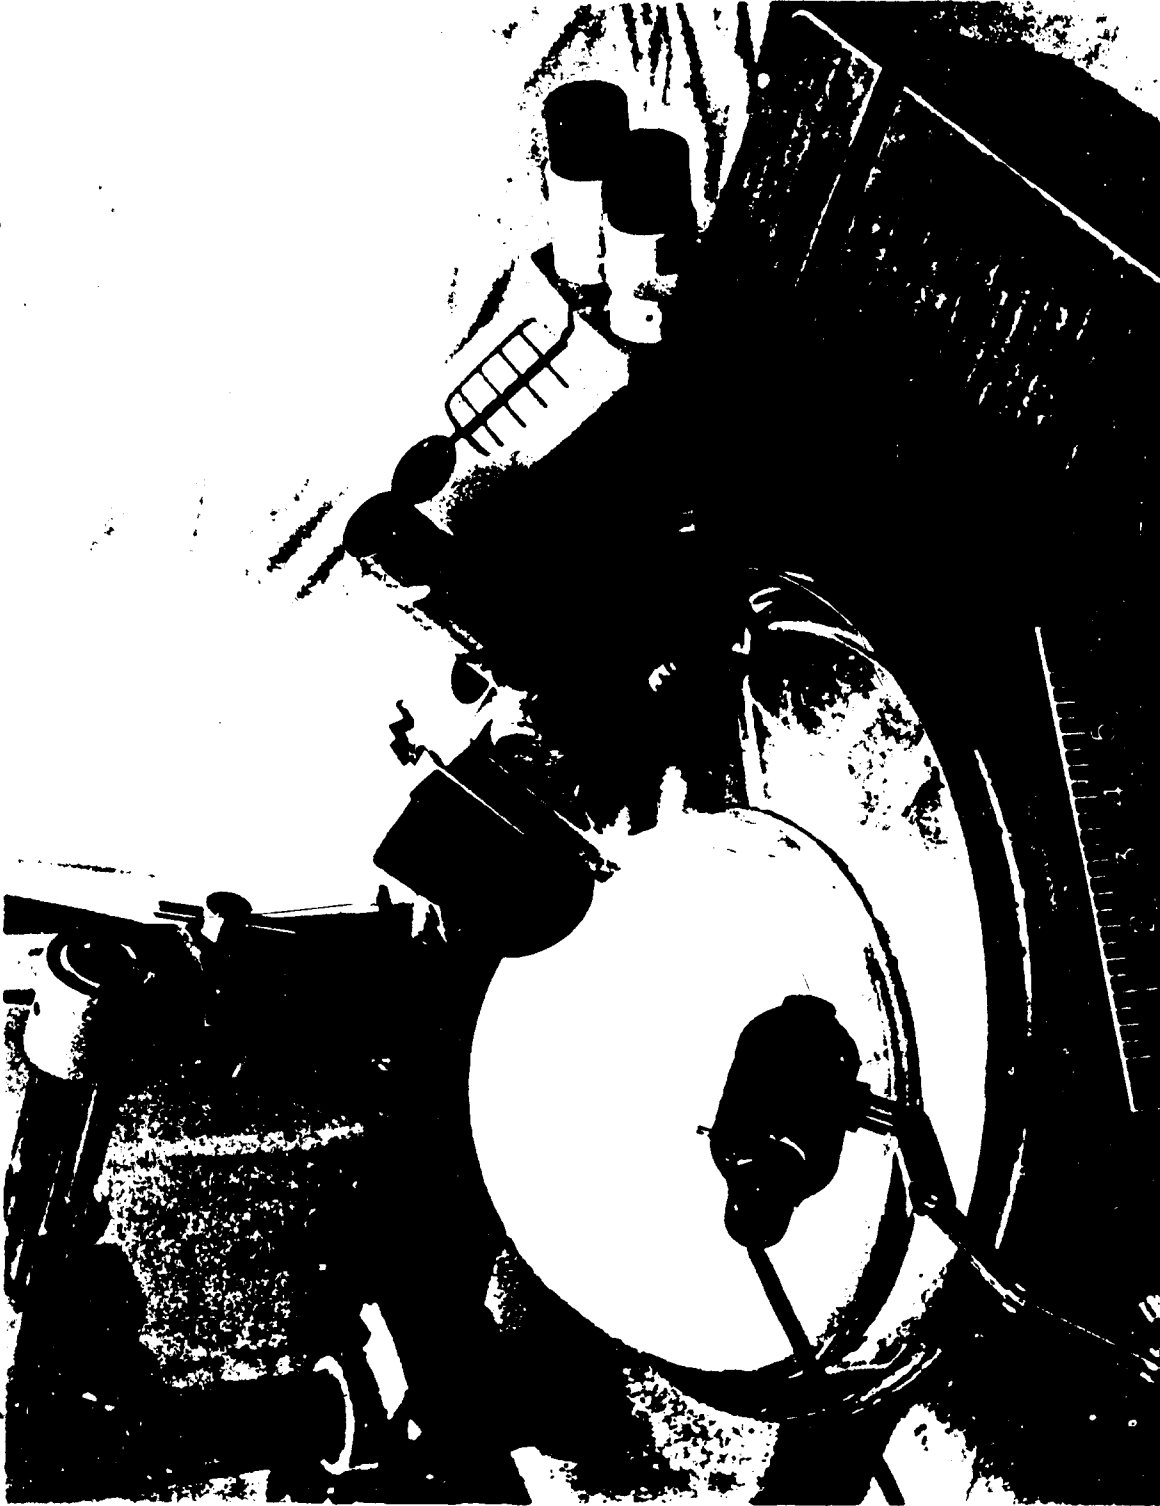
Figure 14 - Inspection Set Up

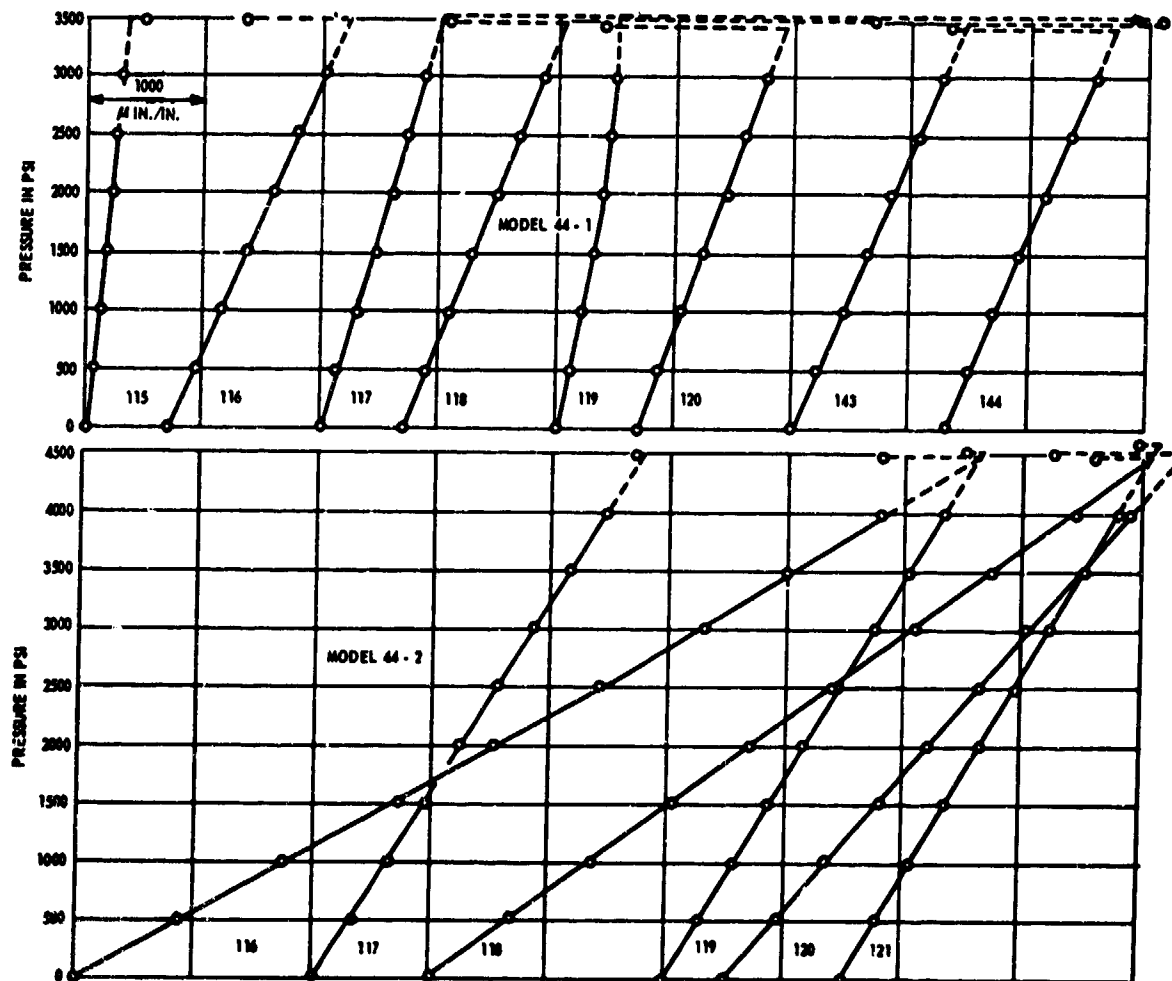
Figure 24 - Pressure Strain Plots for 44 Inch Glass Sphere
