# Proof testing of deep water camera port

Monterey Bay Aquarium Research Institute

May 24, 2016

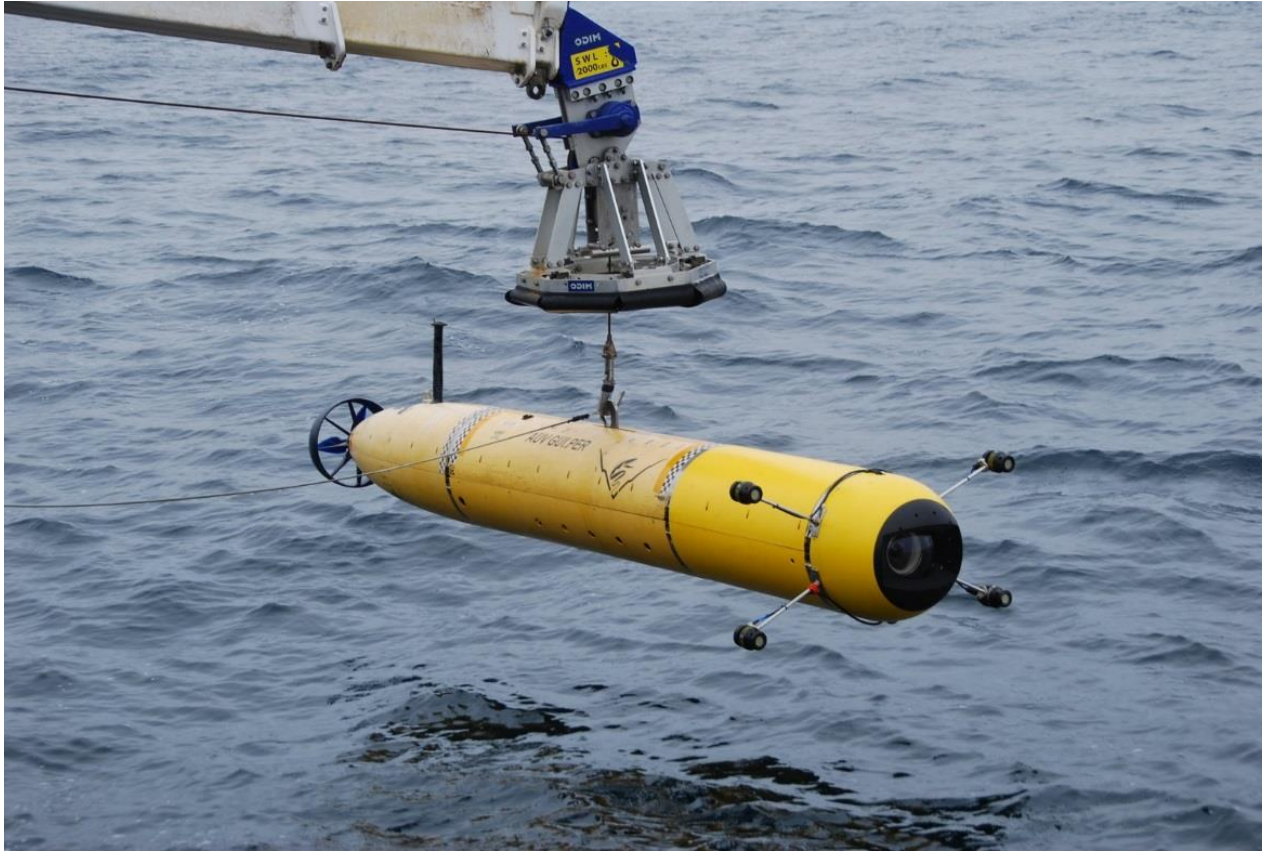
# Application

AUV (autonomous underwater vehicle) based imaging of midwater animals from 50m to 1500m depth.  
Only 1 unit will be built.

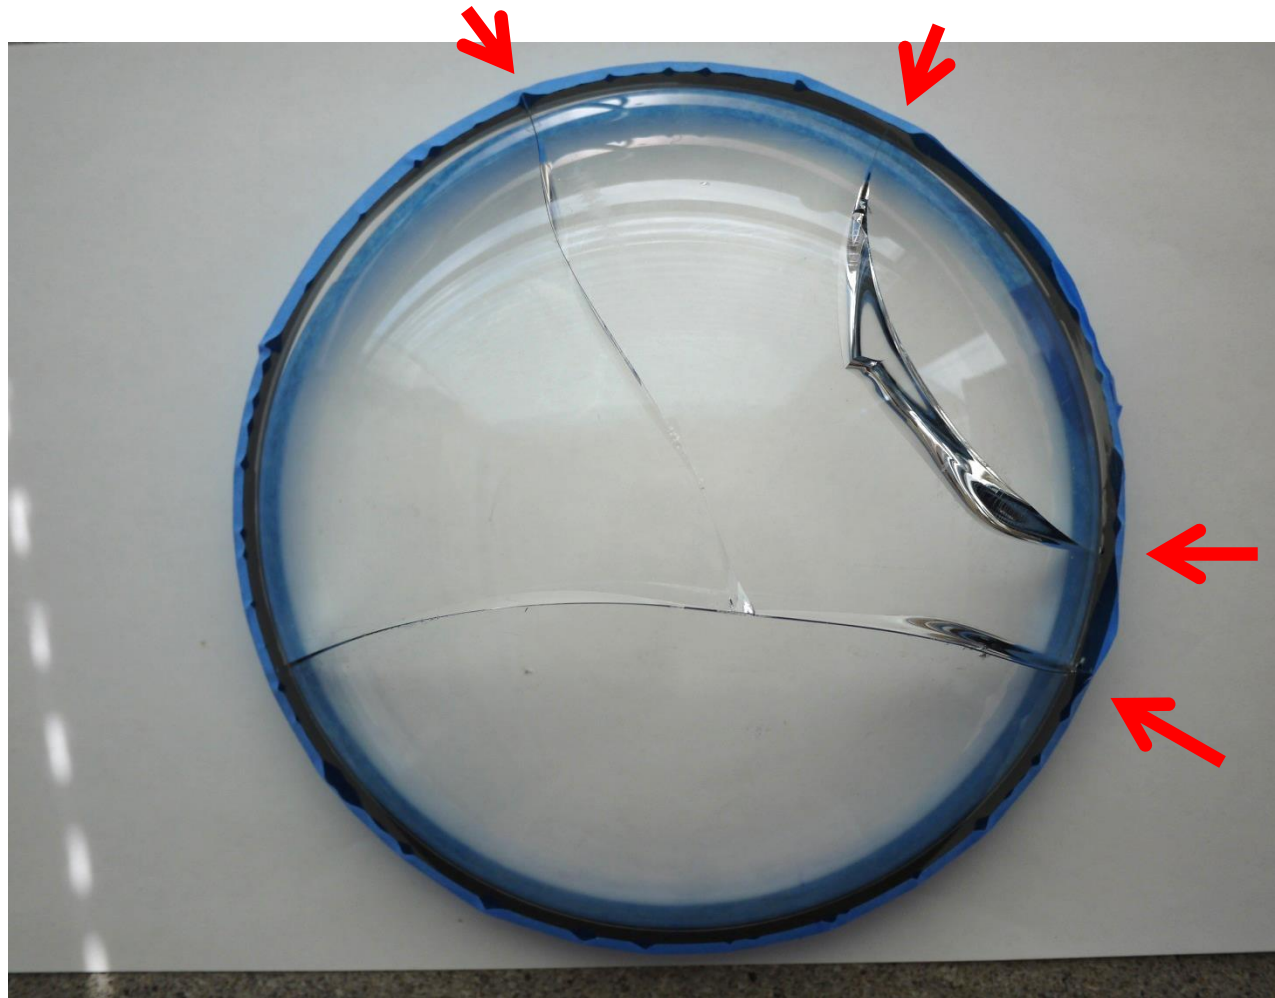
# Design #1 Dome Failure

Initial  
failure  
points?

| Pressure Test Description | Date | Max. pressure<br>(meters depth) | Max. pressure<br>(PSI) | Number of Cycles | Failure pressure<br>(meters depth) | Failure pressure<br>(PSI) |
|---|---|---|---|---|---|---|
| Test design #1 : Solid support ring, .005" Kapton. Problems identified; dome lacked specified inner corner break. | 4/30/2015 | 1020 | 1500 | 1 | pass | |
| | 4/30/2015 | 1883 | 2750 | 9 | pass | |
| | 5/4/2015 | 1883 | 2750 | Soak 72 + hours | 1883 | 2750 |

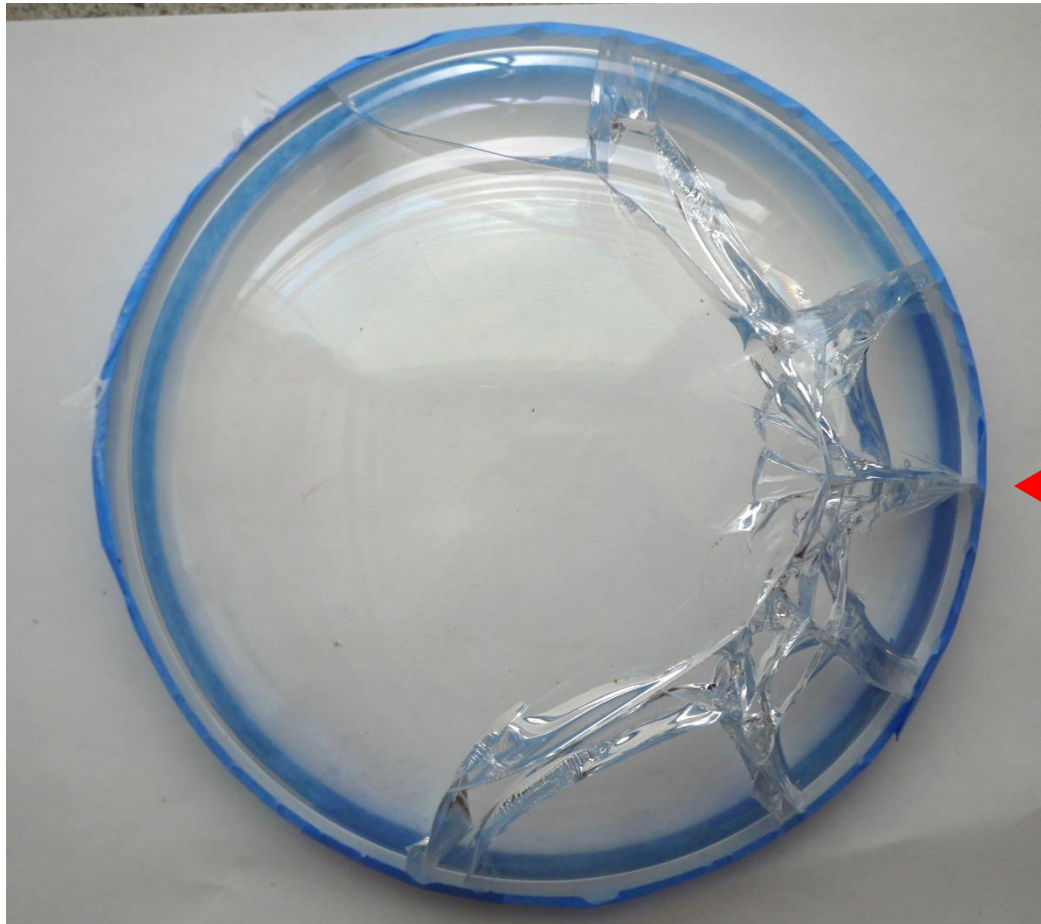
# Design #2 Dome Failure

Initial  
failure  
point?

| Pressure Test Description | Date | Max. pressure<br>(meters depth) | Max. pressure<br>(PSI) | Number of Cycles | Failure pressure<br>(meters depth) | Failure pressure<br>(PSI) |
|---|---|---|---|---|---|---|
| Test design # 2: Dome inner corner chamfered, no tampoprint ink, dome mating surface polished, .005" Kapton replaced with .020" Kapton gasket, Titanium support ring changed to flexure. Test date 4FEB16 | 2/4/2016 | ? | ? | 1 | 1064 | 1563 |
