## TAILCONE SCREW INSERT INSTALLATION/REPAIR

10/15/13

P-200497-08.DWG

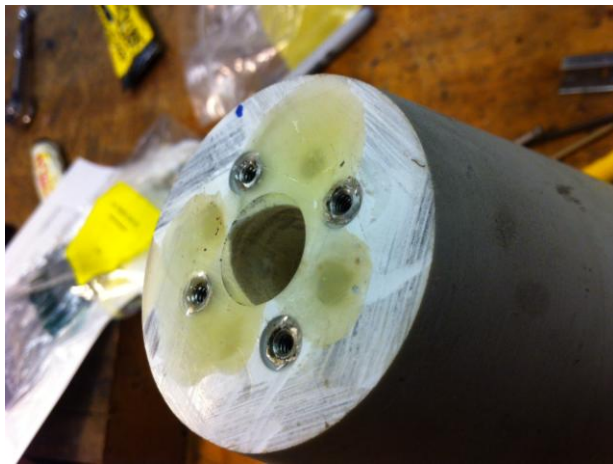
History-Some original  $\frac{1}{4}$ " inserts had failed when the syntactic foam fractured in a conical shape. 2 appeared to be an older fracture and the remaining 2 probably failed when Tethys hit the surf line 9/13. A repair was done and deeper  $\frac{1}{2}$ " inserts installed.

Conical fracture areas or new surface sanded and cleaned.

3M DP100 plus was chosen for low viscosity, strong bond and a slight flexibility. A cork (sprayed with silicon) sealed up the center hole and scotch tape made a temporary outer edge. Overnight cure for strength.

The resulting surface was milled/filed back to original deck height. This image shows the end result but this was a 2 step process.

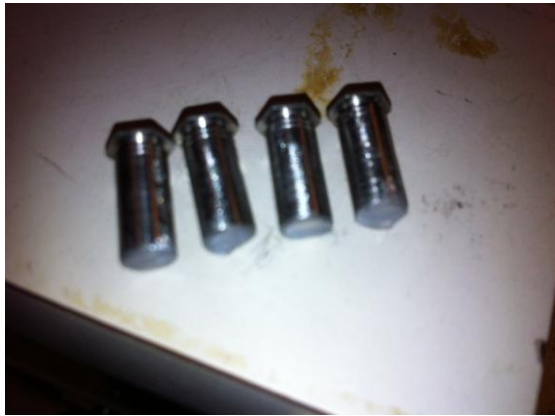
The holes are on a 1.219" Bolt Circle, bored 0.221 dia. 0.65" deep. In addition a 0.060" deep counterbore provided room for the head of the insert allowing for a flush finish. A mill was used to ensure accuracy.

Since the inserts were thru bored a short bottom seal of 1 minute epoxy was used and allowed to cure for an hour before installation.

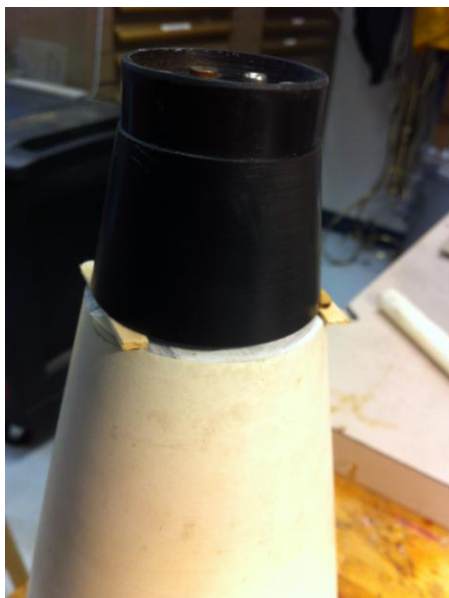
The 6-32 screws were silicon sprayed so no adhesion occurred in the next step.

This step aligns the inserts to the screws. The inserts were threaded on a few turns so the black plastic bearing carrier could be spaced away from the tailcone. A 0.1" spacing worked well. A small amount of DP 100 plus was placed in the hole and on the inserts, work quickly, only a 4 minute work time.

Align and push the inserts into their respective holes with a slight twisting motion, push all the way in with the screw heads and hold for a few minutes till the adhesive starts to set. Air in the hole could push the insert back out. In 20-30 minutes make sure the screws can be turned without twisting the insert. Let set overnight. Remove screws, file or mill mating surface flat, reassemble.
