# T3 issues

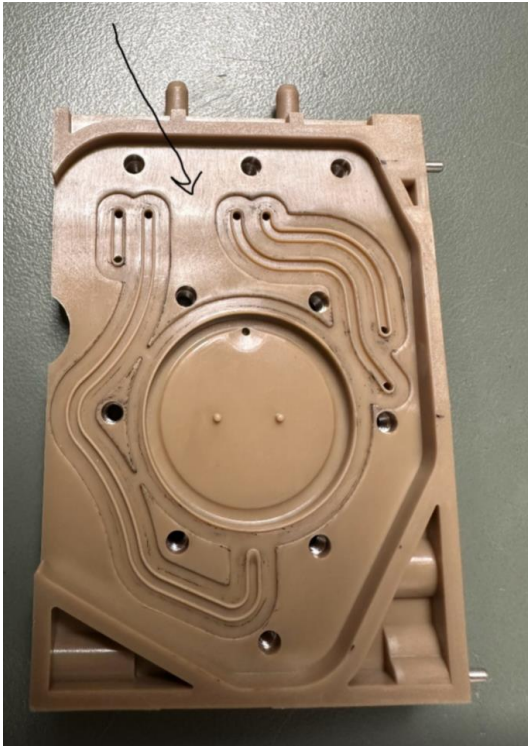
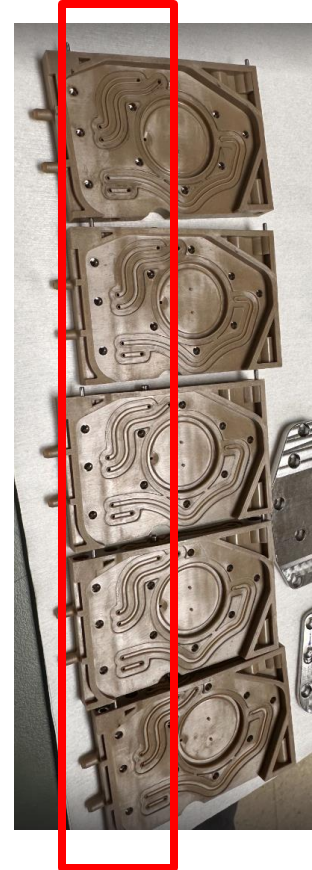
Sink around PV bore

- Not currently an issue but there is noticeable bump on cartridge due to changes in thickness around PV bore
- Keep an eye
