# DGO-1: A Metal Coating/Surface Treatment Resistant to Cathodic Delamination

Naval Undersea Warfare Center, Division Newport

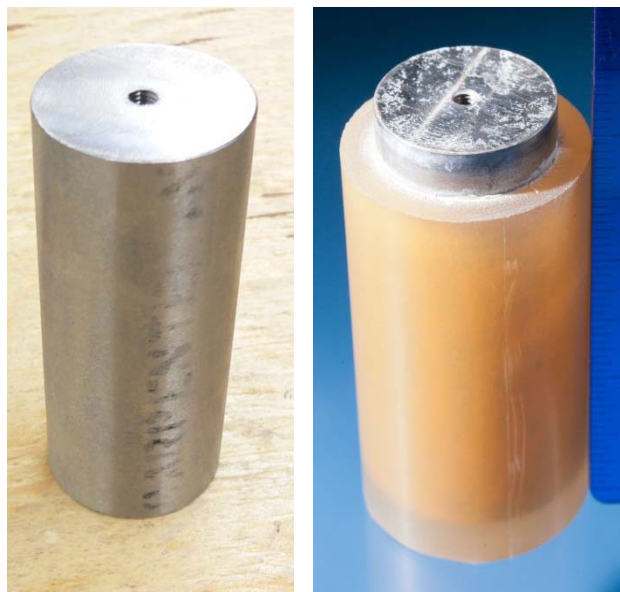
**Fig. 4.** Uncoated and coated cylindrical “round-stock” samples. Note that the coated sample is uniformly overmolded with a 0.25 inch (6.4 cm) thick layer of polyurethane except for the last 0.25 inches (6.4 cm) of the top end of the cylinder.

Cylindrical, “round-stock” samples were made using solid monel 400 alloy cylinders 3.38 inches (8.58 cm) tall and 1.32 inches (3.35 cm) in diameter (figure 4). A small, threaded (10/32) hole was drilled into one of the circular faces of the cylinder so that a small sacrificial zinc anode could be attached at that location. These samples were designed to simulate connector backshells and were encapsulated with polyurethane for their entire length except for the last 0.25 of an inch (6.4 cm) of the “top” of the cylinder (the end with the threaded hole) where a sacrificial zinc anode would later be attached. Leaving some of the length of the sample uncovered by polyurethane simulated the bare metal that is typically

Machine Shop, where they were mounted on a lathe and any polyurethane extending over the last 0.25 inches (6.4 cm) of the cylinder was cut away. The end result was a sample that looked like the one in the right hand portion of figure 4.

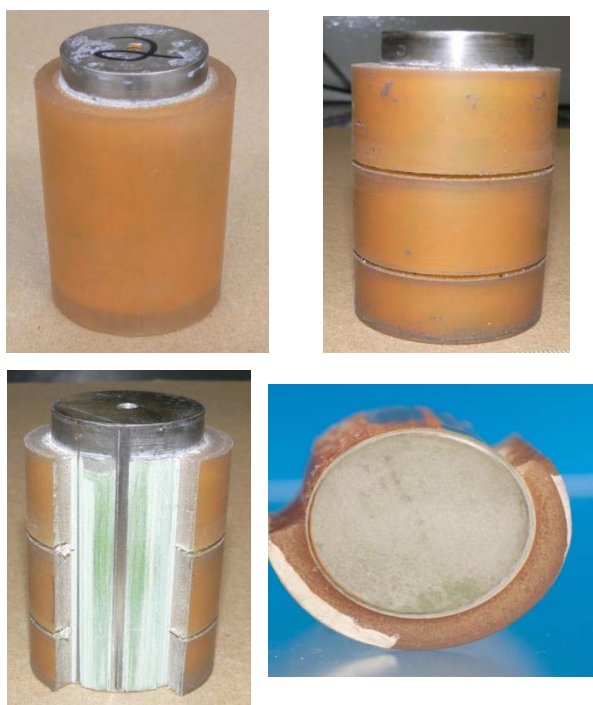
**Fig. 7.** Preparation of a cylindrical sample for peel testing. First row, left to right: the zinc anode is removed and the sample is cleaned prior to machining; two parallel cuts are made through the polyurethane to the DGO-1 layer. Second row, left to right: a 1.0 inch (2.54 cm) wide cut is made down the side of the cylinder, removing the polyurethane down to the DGO-1 layer; and the bottom 0.25 inch (6.4 cm) portion of the polyurethane layer is removed.

Before the cylindrical samples could be peel tested, they needed to be machined. After removal from the ALT tank, each sample was rinsed in fresh water and scrubbed clean of any deposits and zinc anode decomposition products. The samples were then sent to the NUWC Division Newport Machine Shop they were first given two circumferential cuts down to the DGO-1 coating (figure 7). These cuts were necessary to allow the samples to be peeled circumferentially. Initially, it was intended that there would be three 1.0 inch (2.54 cm) wide circumferential peel strips per sample, but because of a miscalculation in the size of the cylindrical substrates, the third (bottom-most) peel strip was only 0.75 inches (1.9 cm) wide. The bottom 0.25 inches (6.4 cm) of polyurethane was also removed by the Machine Shop so that it would not interfere with the peeling of the bottom-most circumferential peel strip. Lastly, a 1.0 inch (2.54 cm) wide cut was made length-wise along the side of the cylindrical samples, removing all of the polyurethane down to the DGO-1 coating (or to bare metal if no such coating was present). This cut allowed a technician to undercut the polyurethane material of each peel strip for approximately one inch (2.54 cm) in one direction so that the grip of the Instron machine could “grab” the so-generated polyurethane tab and therewith begin the peel test. A special fixture was used to mount and hold the samples onto the Instron machine during the peel test. The fixture allowed the sample to freely rotate during the peel test, thereby ensuring that the peel tab was always at a 90° angle to the surface of the cylindrical substrate during the peel test.

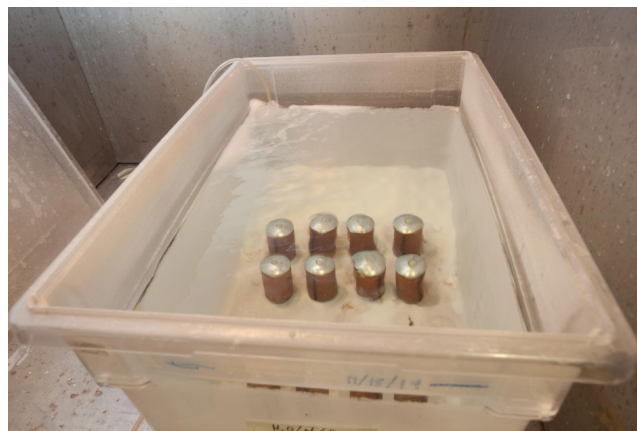
**Fig. 8.** The ALT tank being bubbled with oxygen gas (back left corner). Eight cylindrical samples are in the tank.

Once completed, the samples were placed into an ALT tank that contained a 3.5% (by weight) solution of sodium chloride in distilled water. The tanks used were made from polycarbonate and were 18 inches (45.7 cm) by 26 inches (66.0 cm) by 15 inches (38.1 cm) in size. These tanks came with properly sized lids which were used to minimize water loss through evaporation during the length of the ALT. The water temperature was maintained at 151°F (66°C). Flat bar samples were mounted in racks (figure 3) while the cylindrical samples were free-standing/sitting on the bottom of the polycarbonate tank (figure 8).

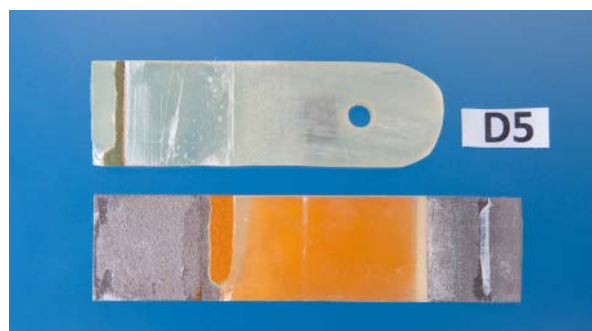
**Figure 9:** DGO-1 coated flat bar ALT sample after peel testing. This sample was overmolded with PR-420 primer and PR-1547 polyurethane and had spent one week in the 66°C ALT under cathodic delamination conditions before it was peel tested. The greenish material attached to the right side of the PR-1547 is DGO-1 that has debonded from the metal coupon in a quasi-“window-frame” like pattern.

Peel testing of DGO-1 coated metal coupons that had been exposed to salt water and cathodic delamination conditions during the ALT produced different results. For these samples, the polyurethane substrate eventually failed cohesively after some mixed failure modes were initially exhibited. In all cases (after 1-2 weeks in the 66°C (151°F) ALT under cathodic delamination conditions) some degree of adhesive failure between the DGO-1 coating and the monel 400 alloy was observed. This particular kind of failure tended to follow the classic “window-frame” pattern of failure seen on all other samples subjected to cathodic delamination conditions. In five out of the six samples, some degree of adhesive failure between the PR-420 primer and the PR-1547 polyurethane was also observed. Figure 9 is a photograph of one of the samples that had been in the ALT for one week before it was peel tested on the Instron machine.

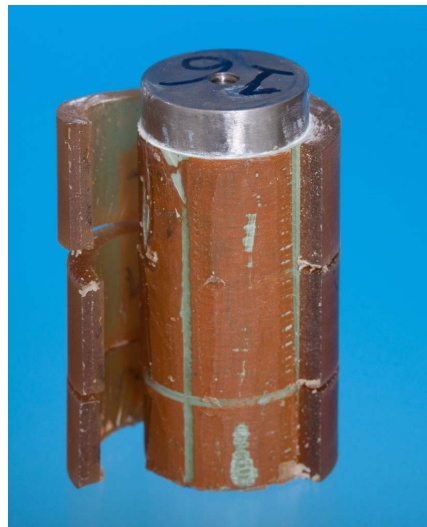
**Fig. 11.** EY16 cylindrical sample with DGO-1 coating after circumferential peel testing. Each of the three polyurethane peel strips failed cohesively.

Peel strips on DGO-1 coated cylindrical samples removed from the long-term ALT consistently failed via polyurethane cohesive failure (figure 11). The DGO-1 coating itself was never observed to have debonded from the monel 400 cylinders

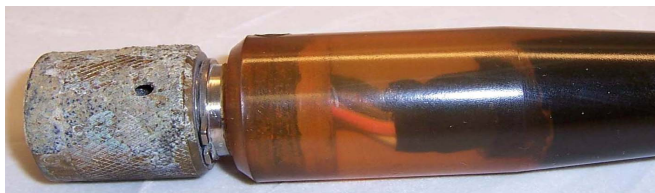
**Fig. 15.** Outboard cable connector suffering from cathodic delamination. The dark region on the backshell under the polyurethane overmold has already debonded; only the orange portion of the backshell is still bonded. Note that the debonding has proceeded inward from the exposed metal/coating edge.

One final attribute of the cylindrical samples is that they demonstrate cathodic delamination on outboard cables connectors will proceed from an exposed metal/coating edge, rather than through the coating itself. Although this effect was difficult to track on the DGO-1 coated samples (because they did not significantly degrade during the long-term ALT), it was quite obvious on the cylindrical samples with NCC coatings. On those samples, the first circumferential peel strip failed before the second circumferential peel strip, which failed before the third circumferential peel strip (which was farthest away from the exposed metal/coating edge). Outboard connectors fail in the same manner out in the field (figure 15) and it was gratifying to see that the controlled laboratory experiment essentially duplicated the connector failure mechanism seen in the field. The cylindrical samples can also be used to test more exotic cathodic delamination prevention technologies, such as the use of internal or external bands that rely at least partially on constrictive barrel stress around a cylindrical substrate to stop the debonding process. The design of the cylindrical samples maximizes the available space for
