# *The Chesapeake Bay Interpretive Buoy System and the Winter of 2015:*

## *Problems and Solutions*

*Katie Kirk & Nikiforos Delatolas*

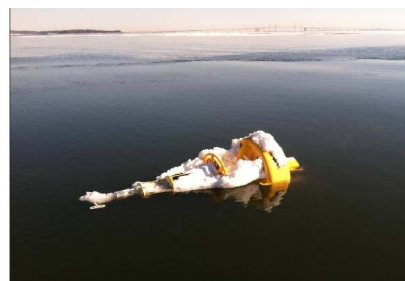
Since the start of the system in 2007, the three northern buoys (Susquehanna, Patapsco and Upper Potomac) are removed for the winter to avoid ice damage. However, the severe winter of 2015 was an anomalous year in weather and water conditions that caused significant damage to many of the buoys in the mid and lower Bay, including the Annapolis, Gooses Reef, Point Lookout and Jamestown buoys. Several strong, relatively late season cold air outbreaks (February 14 – 17, 2015) accompanied by gale force winds were followed by sustained low temperatures. The freezing temperatures with sustained high winds and increased wave heights led to significant events of freezing spray and splash, which accumulated and remained on the buoy superstructures. The iced buoy's righting moments decreased until they were horizontal, and several froze into the surface ice in that position for extended periods of time (Fig. 2).

Fig. 2. Annapolis buoy on February 18, 2015. Photo credit: NOAA LTJG Philip J. Klavon.

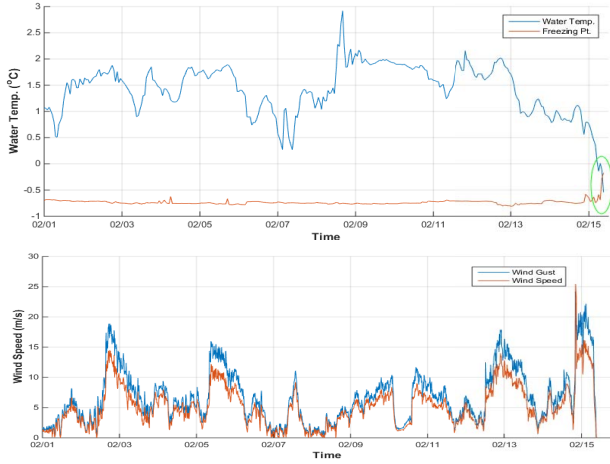
The Annapolis, Gooses Reef and Jamestown buoys measured surface water temperatures that dropped below the

calculated seawater freezing point (Fig. 3), which was the first time in CBIBS history this has been recorded and observed. Annapolis, Gooses Reef and Point Lookout buoys had sustained, high wind gusts ( $\sim 20$  m/s, Fig. 3) and all four buoys experienced increased significant wave height.

Fig.3 February 2015 Annapolis buoy seawater temperature & freezing point ( $^{\circ}\text{C}$ , top) and wind speed & gust (m/s, bottom) observations. The green circle indicates where the water temperature dips below freezing point.
