At sea during a multithousand dollar trip offshore.

A short bit of background info-

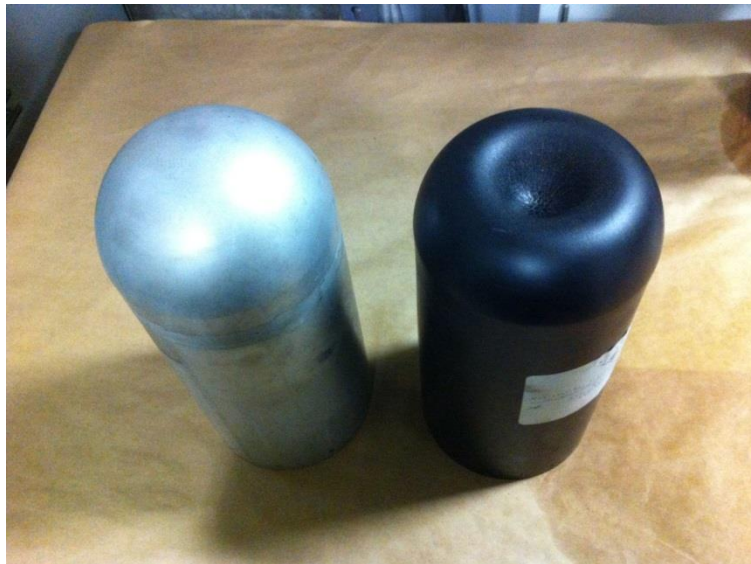
TIBURON Thruster Housings-These were sent out to a local fabricator for machining from a single billet (solid block) of Aluminum 6061 T6. The fabricator decided (without an OK) to weld the hemispherical end bells onto the cylindrical portion. Welding reduced the strength of the material ( designated by the T6 call-out) to something only 30-50% as strong. We were interested in what we did have so we checked them out. At 5100 psi the end bell inverted to this very unusual shape, normal is on the left. T6 aluminum just does not bend like this, it breaks, so this is very strange. We rejected the parts.

Most of the time, the housings tested do not fail catastrophically because of best engineering practices being followed during design and fabrication. However, when these practices are not followed - The following image is from many years ago but is very telling and these housings are still here in the Pressure Test Facility.
