## Radiometer Service Report

Date 10/29/19 SR #: 1005508931 Sensor Type: HyperOCR R

S/N 203 Customer MBARI

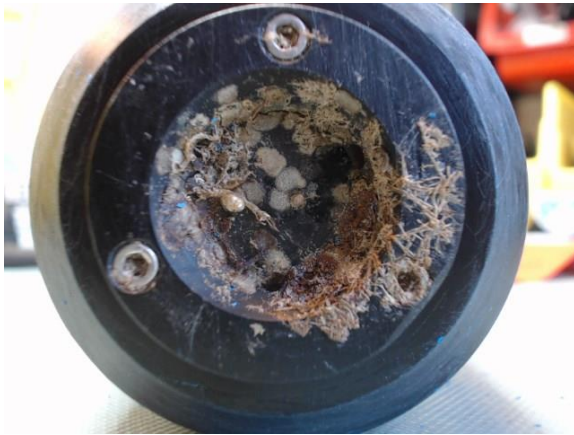
Received without Protective Cap.

Window was covered with Algae.

No Problems Found after cleaning window.

Standard Service.

Did Post Calibration after cleaning window.

Passed Calibration and Reality Check.

Added Protective Cap.
